## Home Inspection Report

**1000 Anywhere Street, Sacramento**

Ordered by: John Smith  
1000 Anywhere Street  
Hometown, CA 99999

Walter Backeroff  
March 15, 2013

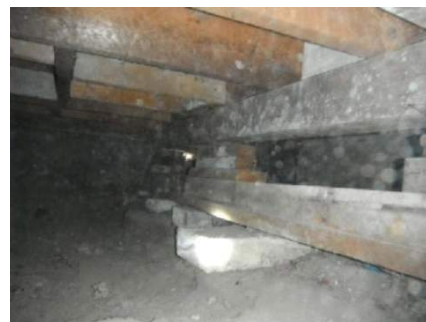
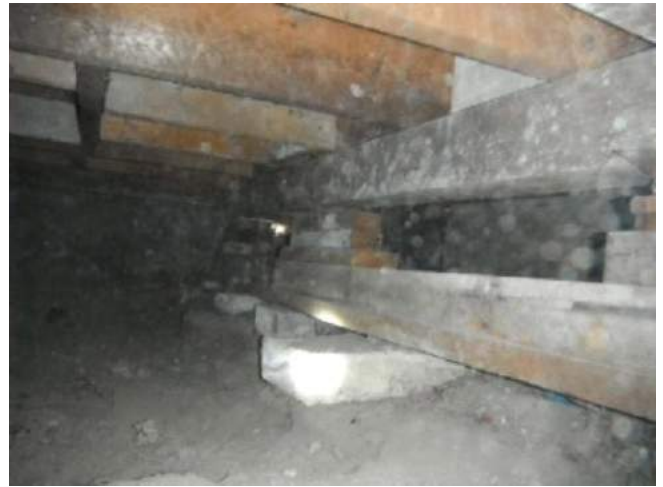
Photo 14

1. One or more girders, piers and/or post at the crawl space have been altered and added improperly. The existing configuration indicated improper design and/or workmanship. We recommend repair or replacement, in accordance with present standards. It is recommended that a qualified licensed contractor be consulted for further advice on structural improvements. (See Photo 14)

- ! 1. One or more girders, piers and/or post at the crawl space have been altered and added improperly. The existing configuration indicated improper design and/or workmanship. We recommend repair or replacement, in accordance with present standards. It is recommended that a qualified licensed contractor be consulted for further advice on structural improvements. (See Photo 14)

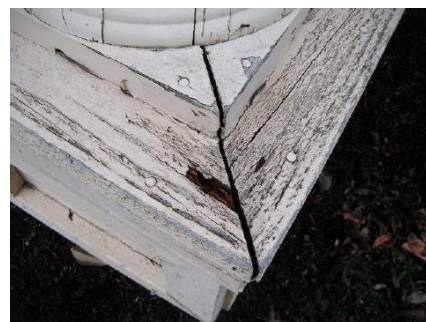
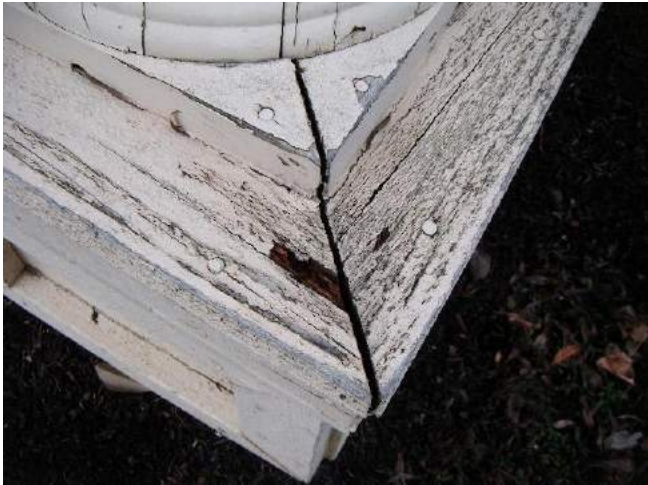
Photo 1

- ! 4. Water damage was observed to the exterior trim at the left side and rear. We recommend the services of a licensed general contractor and/or structural pest control company. (See Picture 1)

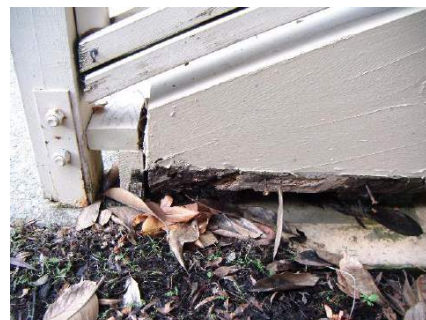
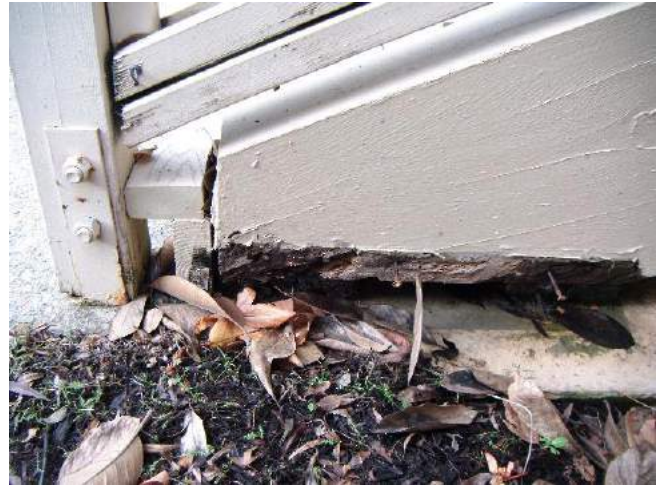
Photo 2

- ! 3. Water damage was noted at the front deck(s). We recommend the services of a licensed general contractor and/or structural pest control company. (See Picture 2)

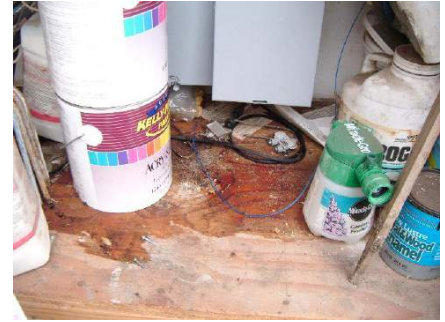
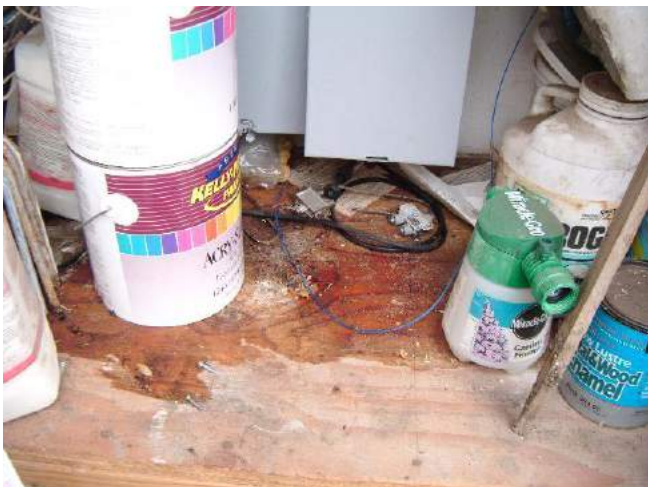
Photo 3

4. There is an unexplained water spot in the utility closet. This condition should be monitored and repaired if necessary. (See Photo 3)

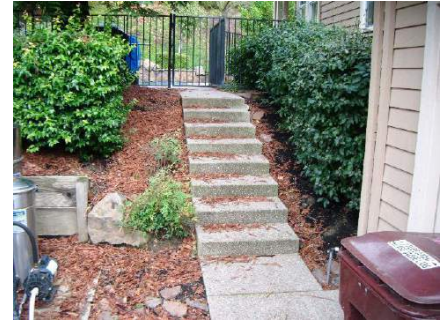
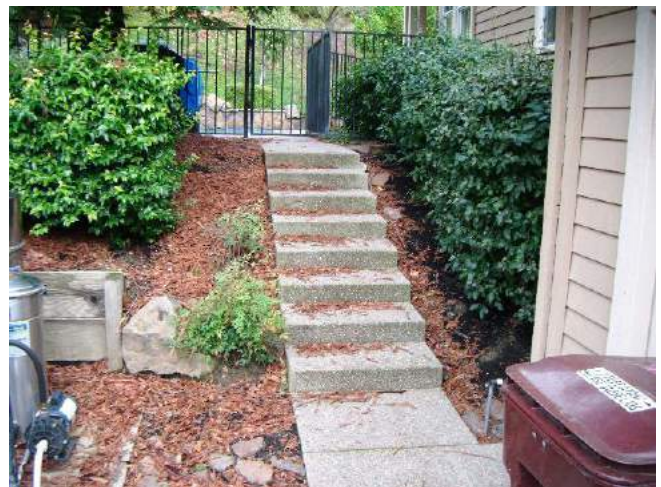
Photo 4

5. The steps at the left side do not have a railing. Railing should be provided for improved safety. (See Photo 4)

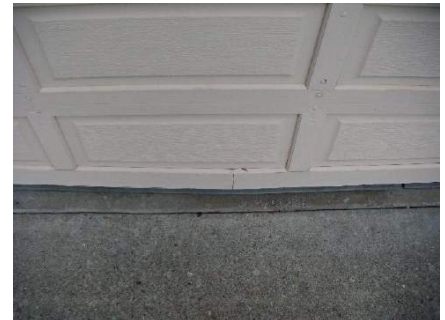
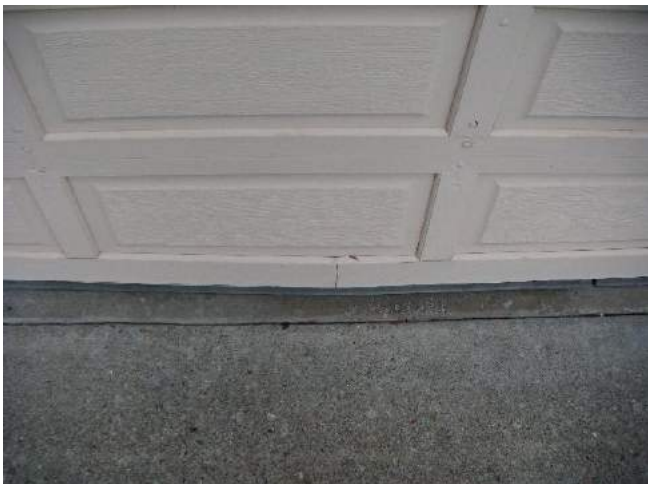
Photo 5

6. The main garage door is mechanically damaged. Repairs are recommended. (See Photo 5)

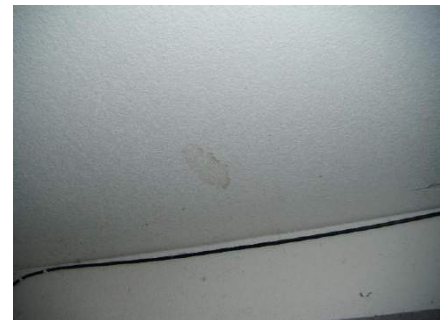
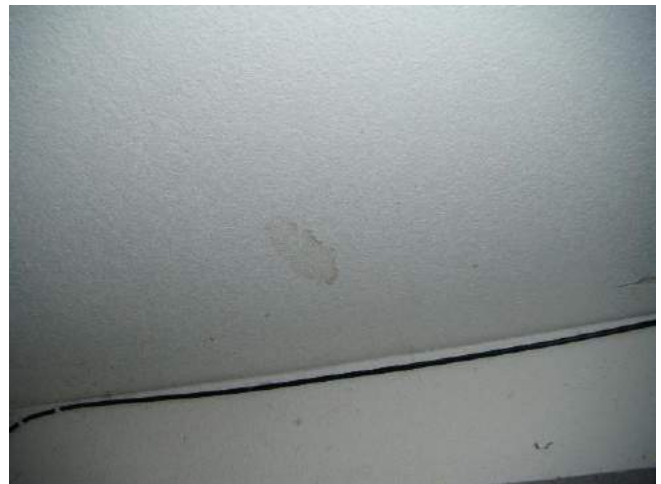
Photo 6

7. Water stains were noted on the ceiling of the garage. This is usually an indication of past plumbing or roof leaks. This area should be further evaluated by the appropriate trades. (See Photo 6)

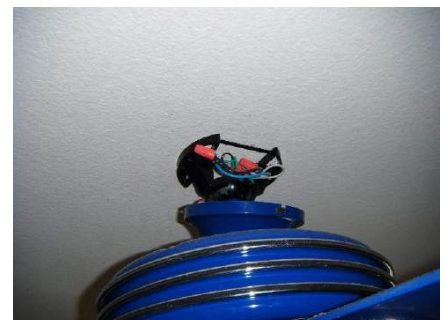
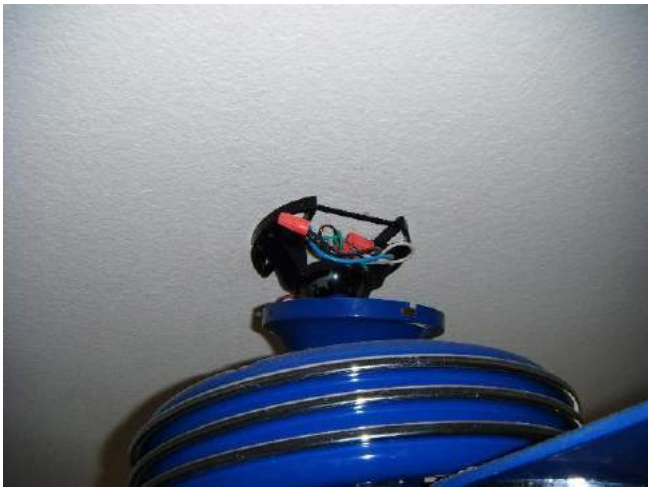
Photo 9

8. Running splices, which are improper connections outside of a junction box, were observed in the bedroom ceiling fan. We recommend connections be joined with approved connectors inside a junction box to prevent accidental contacts or mechanical damage. (See Photo 9)

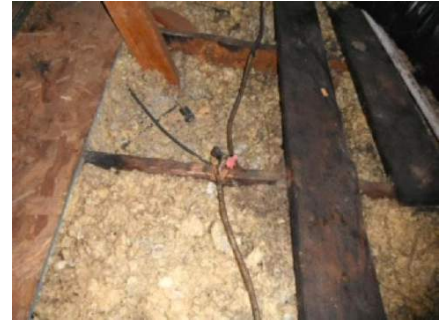
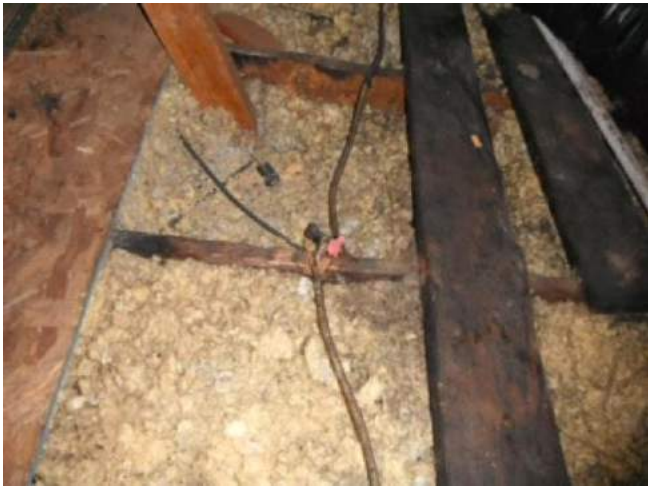
Photo 13

9. Running splices, which are improper connections outside of a junction box, were observed in the attic. We recommend connections be joined with approved connectors inside a junction box to prevent accidental contacts or mechanical damage. (See Photo 13)

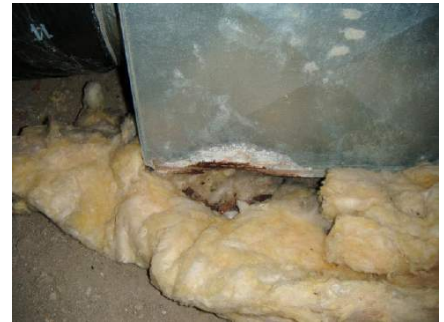
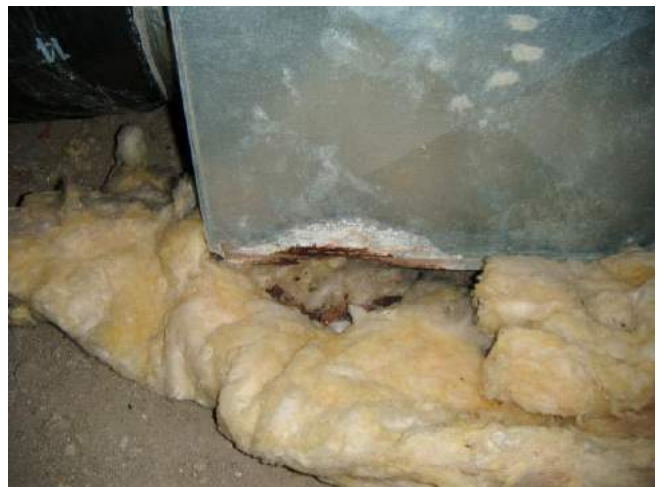
Photo 12

10. Severe rust and deterioration was noted to the heater housing, ducts and/or base of the heater plenum, the source of the rust/deterioration was unknown. We recommend further evaluation of this condition by a licensed HVAC contractor. (See Photo 12)

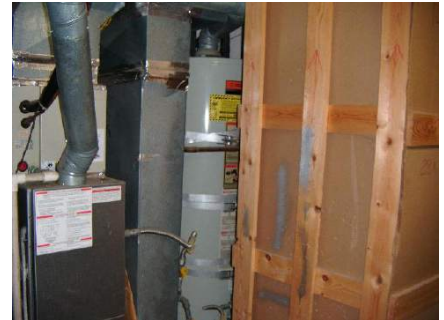
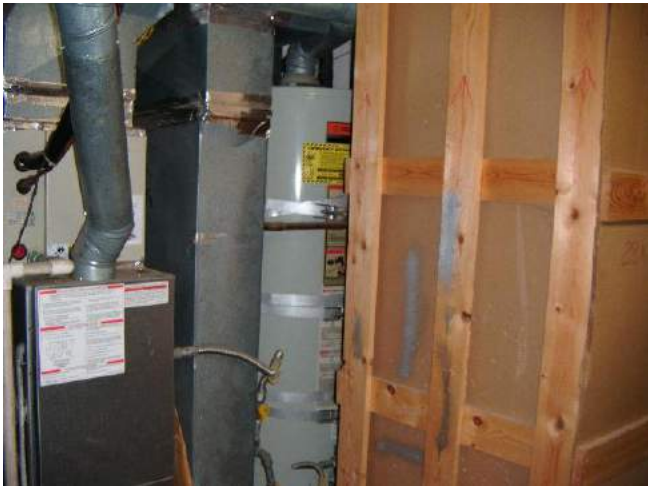
Photo 7

11. Due to the water heater closet being locked or heater being inaccessible at the time of our inspection, the water heater was not inspected. With access and an opportunity for a complete inspection, conditions in need of attention may be discovered. We recommend further inspection of the water heater by appropriate trades when access is provided. (See Photo 7)

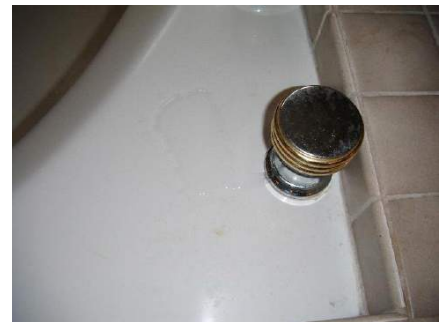
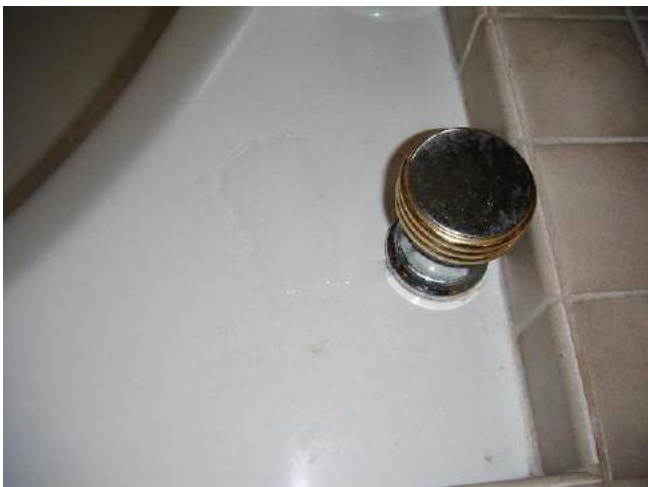
Photo 11

12. The master bathroom tub faucet and/or handles are leaking. We recommend all leaks be repaired. (See Photo 11)

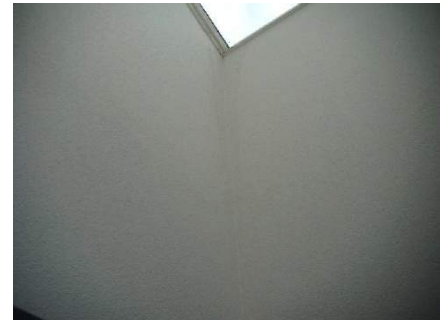
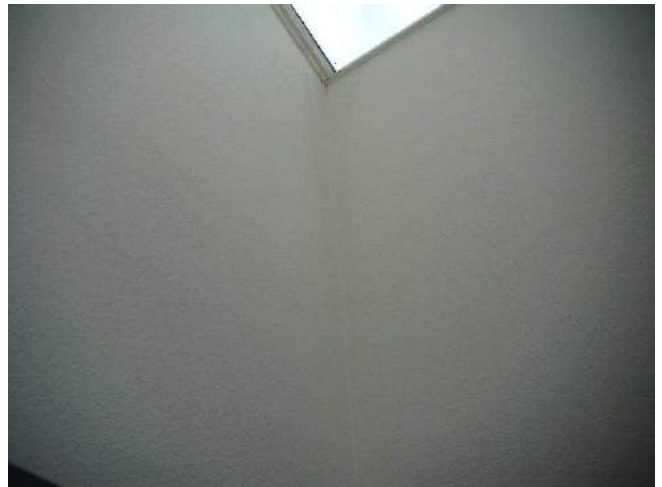
Photo 10

14. Evidence of prior leakage was noted at the hallway skylight. It should be monitored and repaired as necessary. (See Photo 10)

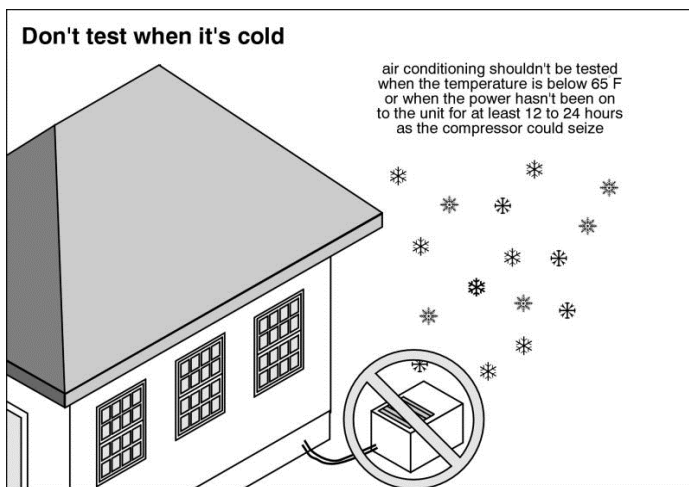
Illustration 6D

The air conditioning system could not be tested as the outdoor temperature was below 65 degrees F. (See Illustration 6D) We recommend a licensed HVAC contractor be retained for further evaluation of the cooling unit.
