WOOD DESTROYING PESTS AND ORGANISM INSPECTION REPORT

Building No. 1000	Street Anywhere Street	City Hometown	ZIP 99999	Date of Inspection 3/27/2013	Number of Pages Page 1 of 12
-----------------------------	----------------------------------	-------------------------	---------------------	--	--

HomeGuard Rpt #: **108611**

General Description: Two story, single family wood framed residence with stucco, wood and brick veneer exterior.	Inspection Tag Posted: Garage Other Tags Posted: A to Z Termite 1/13
---	---

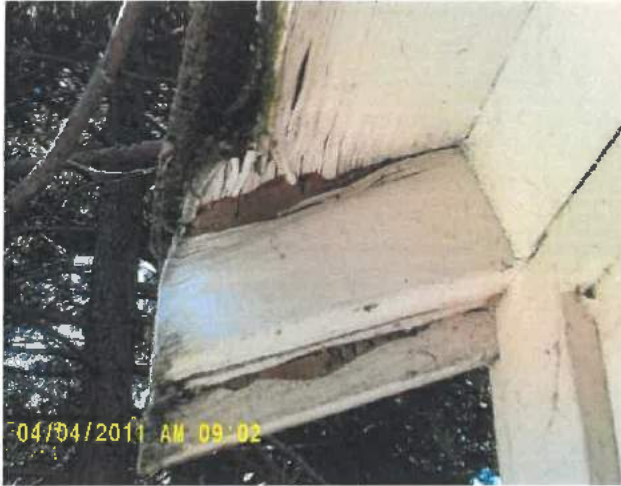
Picture 1

1A. FINDING: Fungus damage was noted to the rafter tail as indicated on the diagram. (See Picture 1)

1B. FINDING: Fungus damage was noted to the sheathing as indicated on the diagram. (See Picture 1)

RECOMMENDATION: Remove and replace the end of the damaged rafter tail and install a new sister section alongside for support.

RECOMMENDATION: Remove and replace the damaged sheathing to correct this condition. This bid includes replacement of the roof covering if disturbed by our repairs. If existing gutters need to be removed to perform the repairs then our bid also includes reinstallation of original gutters. If it becomes necessary or desirable to install new gutters this will be done only if authorized and at an additional expense. The guarantees on the roof covering are limited to the areas where the repairs were performed

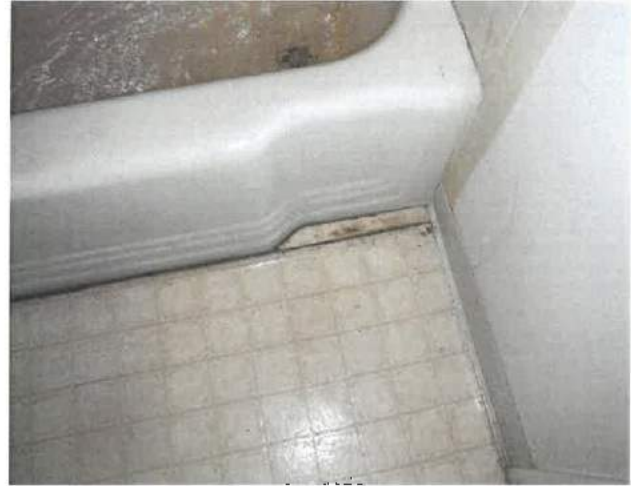
Picture 2

1K. FINDING: The upstairs hall bathroom floor is fungus damaged adjacent to the bathtub. (See Picture 2)

RECOMMENDATION: Remove the toilet and open the floor to repair damaged underlayment as required. Install new underlayment and a new standard grade, neutral colored, vinyl floor covering over the bathroom floor area. Reinstall the toilet using a new no-seep toilet seal. When the underlayment is removed, if fungus damage to the subfloor or walls is revealed, or a cracked toilet or damaged closet flange is found, we would issue a supplemental report and bid.

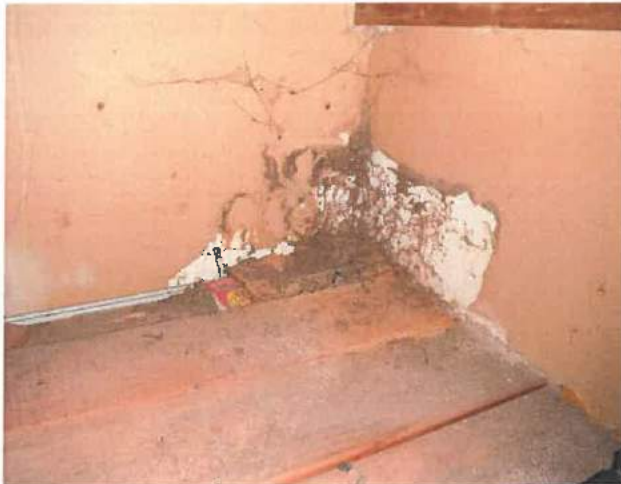
Picture 3

1L. FINDING: Subterranean termites have entered the structure from the earth fill under the garage slab. (See Picture 3)

RECOMMENDATION: Drill holes through the slab and inject Termidor SC (Fipronil:5-amino-1-(2,6-dichloro-4-(trifluoromethyl) phenyl)-4-((1,8,5)-trifluoromethyl)sulfinyl)-1-H-pyrazole-3-carbonitrile) into the earth below and break down and brush away all subterranean termite migratory tubes. We will be as careful as possible with our repair; however, we assume no responsibility for any damage to the surface covering the floor in the area to be treated. NOTE: In order to perform this treatment the property must be vacated during the treatment and three hours after the treatment is performed.

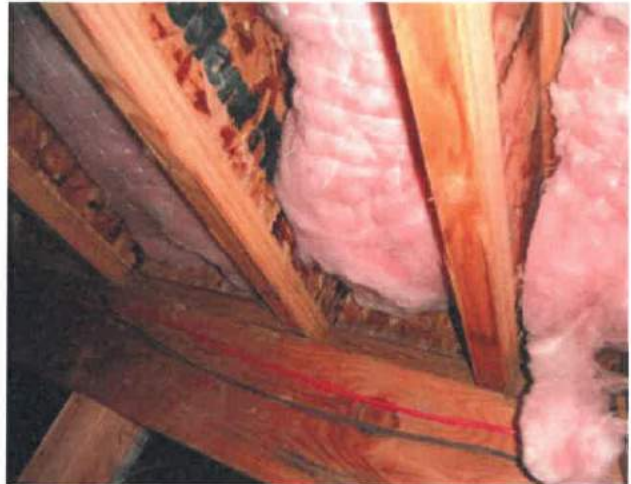
Picture 4

3B. FINDING: The subfloor was insulated; however, no outward infections of infestations were noted at this time. Further inspection is recommended. (See Picture 4)

RECOMMENDATION: Remove the insulation from the perimeter of the structure and at all water pipe penetrations. Inspect the exposed wood members, and issue a supplemental report listing all findings, recommendations, and bids. Reinstall the insulation where removed upon completion.

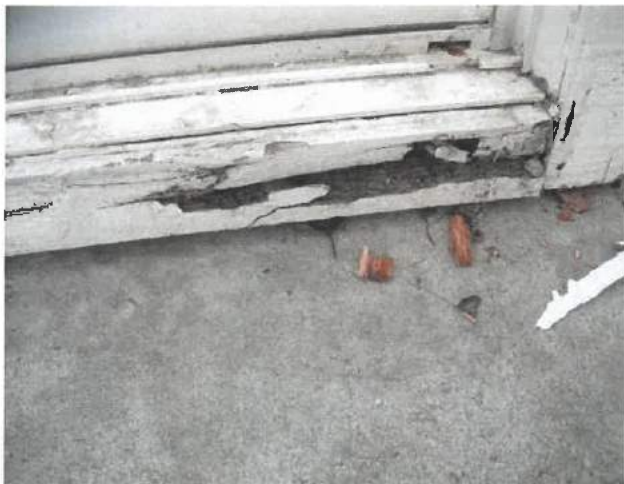
Picture 5

1C. FINDING: The threshold trim has been damaged by fungus at the rear sliding glass door. (See Picture 5)

RECOMMENDATION: Remove and replace the damaged threshold and trim. If any damage is found to extend into any enclosed areas a supplemental report and bid will be issued.

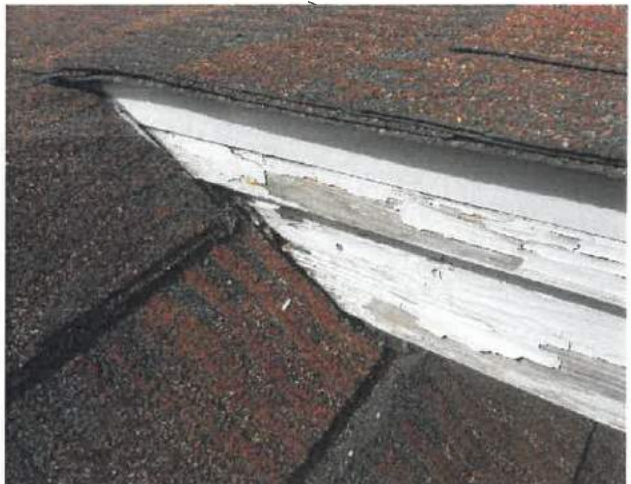
Picture 6

1D. FINDING: Fungus damage was noted to the barge rafter(s) as indicated on the diagram. (See Picture 6)

RECOMMENDATION: Remove and replace a section of the damaged barge(s) rafter to correct this condition. This bid includes replacement of the roof covering if disturbed by our repairs. If existing gutters need to be removed to perform the repairs then our bid also includes reinstallation of original gutters. If it becomes necessary or desirable to install new gutters this will be done only if authorized and at an additional cost. The guarantees on the roof covering are limited to the areas where the work was performed

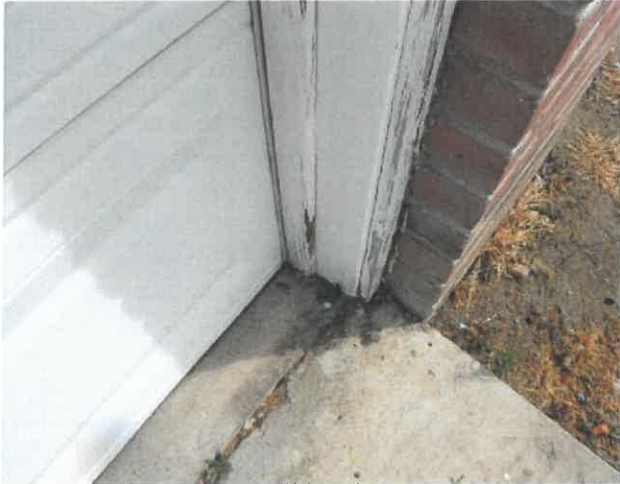
Picture 7

1E. FINDING: The main garage door jambs are fungus damaged. (See Picture 7)

RECOMMENDATION: Cut off the bottom of the door jambs and fill the void with concrete.

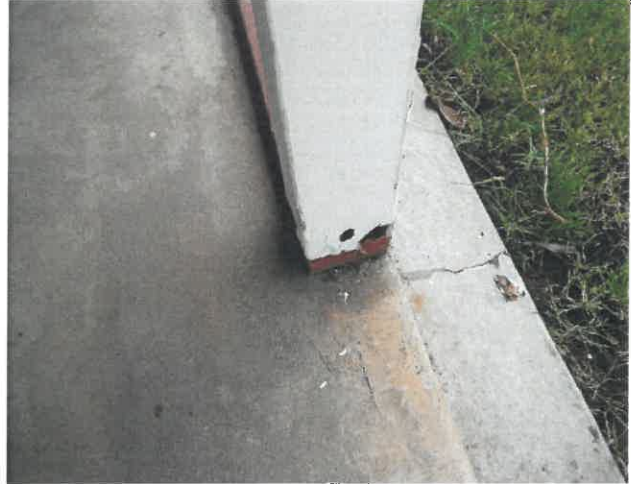
Picture 8

1F. FINDING: The post has been damaged by fungus at the front porch. (See Picture 8)

RECOMMENDATION: Remove and replace the damaged wood post. If any damage is found to extend into any enclosed areas a supplemental report and bid will be issued.

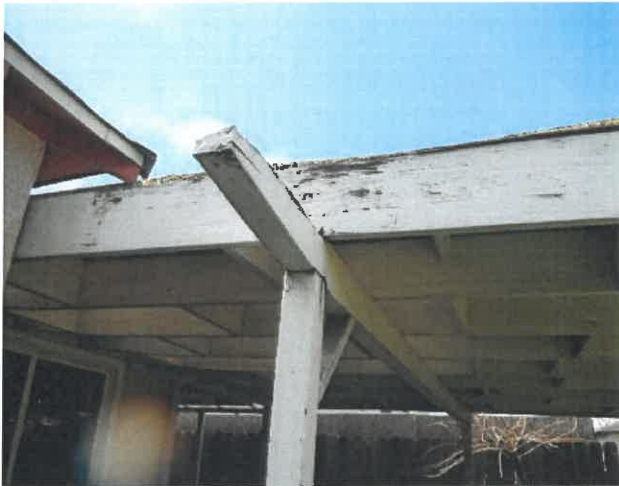
Picture 9

1G. FINDING: The wood members of the rear patio cover have been damaged by fungus. (See Picture 9)

RECOMMENDATION: Remove and replace the entire patio cover to eliminate these structural deficiencies.

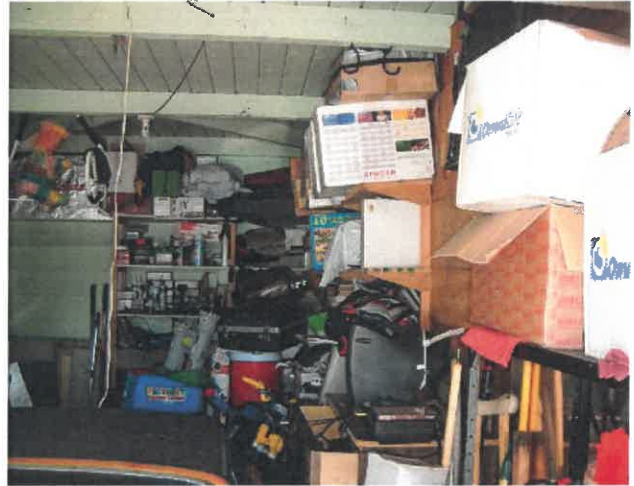
Picture 10

3A. FINDING: We were unable to inspect a portion of the interior of the garage due to stored personal property. (See Picture 10)

RECOMMENDATION: The owner should move the storage away from the garage walls to allow for further inspection. All findings, recommendations, and bids will be issued in a supplemental report.

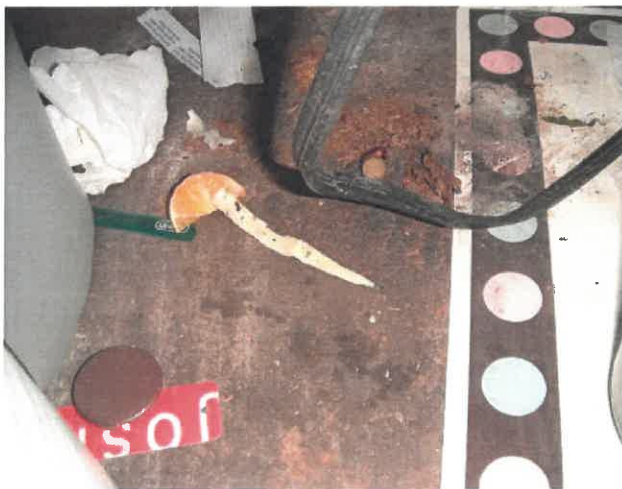
Picture 11

1H. FINDING: The shelf under the kitchen sink is fungus damaged. (See Picture 11)

RECOMMENDATION: Remove and replace the shelf as necessary. NOTE: If during the course of our repairs to the sink shelf, it becomes necessary to modify/repair the adjacent plumbing facilities a supplemental report and bid will be issued.

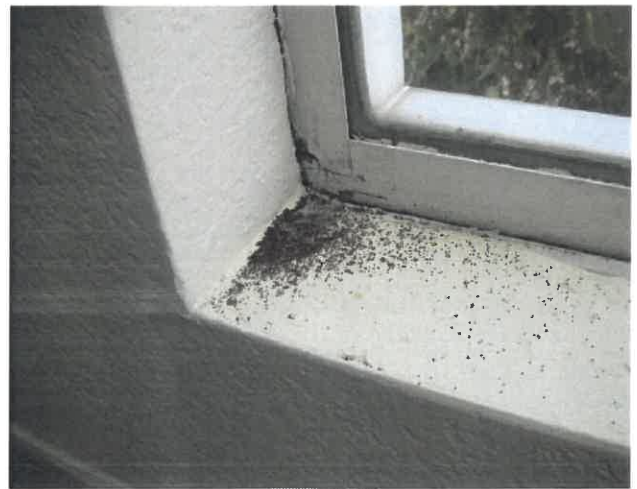
Picture 12

1I. FINDING: Infestation by Drywood Termites was noted at the bedroom windows and subarea. (See Picture 12)

1J. FINDING: Drywood termite pellets were evident as noted in the above recommendation. (See Picture 12)

RECOMMENDATION: Due to the nature of these infestations, it will be necessary to seal the entire structure and fumigate it with Vikane (sulfuryl fluoride), using Chloropicrin as a warning agent. The entire structure must be vacant for this process. It is the owners responsibility to make any preparations required by the fumigators or to have someone to do so at a separate expense and to have the gas turned back on when the fumigation is complete. Due to current Cal OSHA Safety Standards work above 7.5 feet demands fall protection, this requires the installation of anchor points at the roof ridge line. HomeGuard will repair any damage caused by the installation of the anchor. However, in the case of metal roof coverings it is the owners responsibility to make areas on the roof ridge accessible to secure the anchors. HomeGuard Incorporated guarantees all fumigations for a period of two years from the date of completion.

RECOMMENDATION: Remove and/or mask over all accessible termite pellets. It is possible for the drywood termite pellets to sift down or reappear in these areas where they have been masked over.

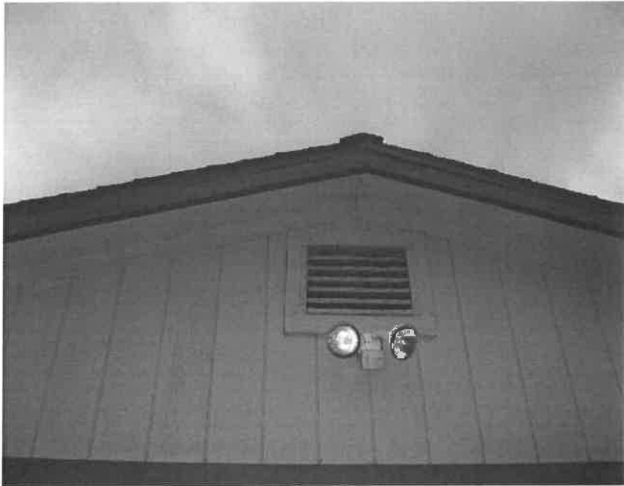
Picture 13

1M. FINDING: The wall was noted to be damaged above the garage door. The damage was so extensive at the time of this inspection that no determination could be made as to the scope of the work. (See Picture 13)

RECOMMENDATION: Remove the siding in this area to allow for further inspection. All findings, recommendations and bids will be issued in a supplemental report.
