Home Inspection Report

2623 Anywhere Street, Hometown

Ordered by: John Doe
2623 Anywhere Street
Hometown, CA 99999

Travis Palser
February 28, 2020

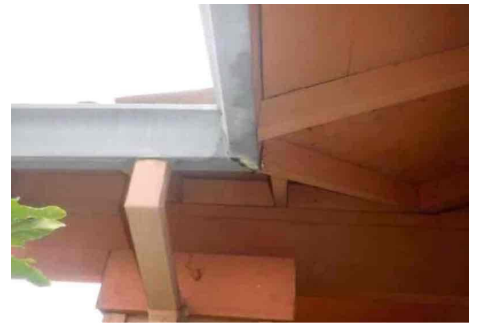
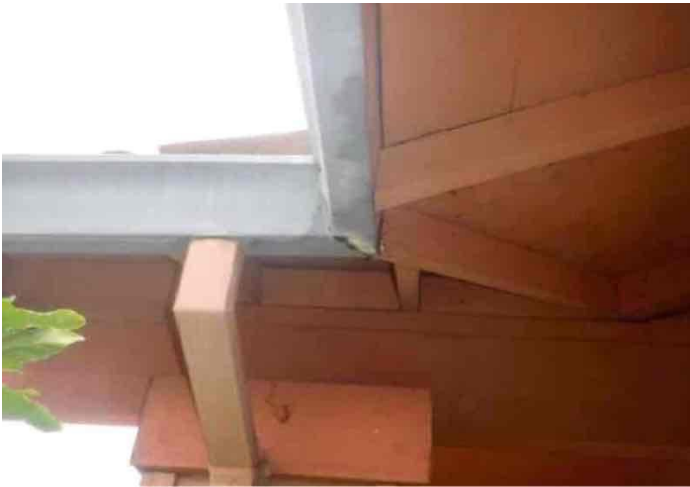
Photo 07

1. Leaks were noted in the downspouts and/or gutters at the front. During wet weather conditions these areas are more obvious and during dry weather conditions they are noted from the stains at the areas where the leaks have occurred. We recommend all leaks be repaired. (See Illustration 2D) (See Photo 7)

- !** 1. Leaks were noted in the downspouts and/or gutters at the front. During wet weather conditions these areas are more obvious and during dry weather conditions they are noted from the stains at the areas where the leaks have occurred. We recommend all leaks be repaired. (See Illustration 2D) (See Photo 7)

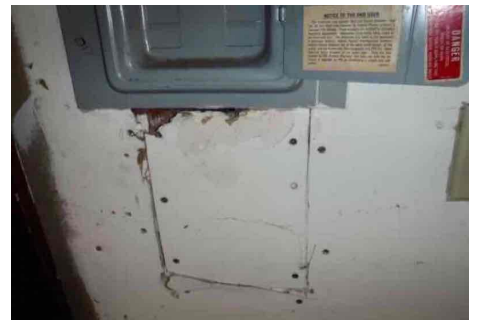
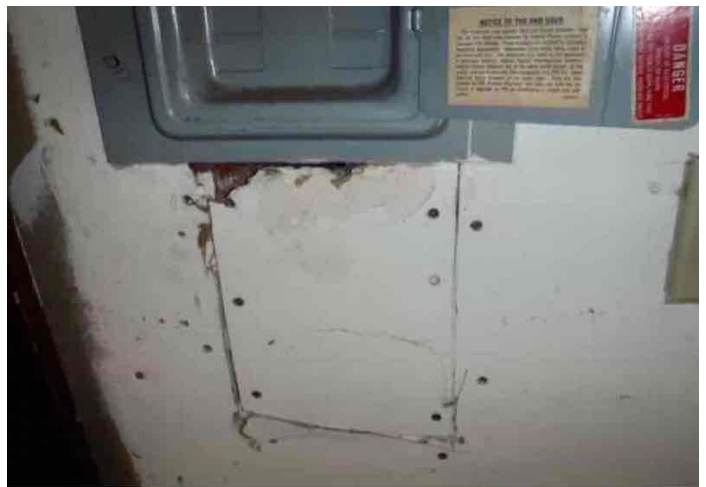
Photo 10

- ! 1. Damaged, open or missing wall and/or ceiling finishes of attached garages should be repaired and sealed where they abut the interior of a house. This reduces the potential of toxic automobile gases entering the house and serves as a fire break. Current standards require all walls/ceilings common to the finished living spaces be covered with 5/8" fire resistant sheetrock double taped at all seams. (See Illustration 3A) (See Photo 10)

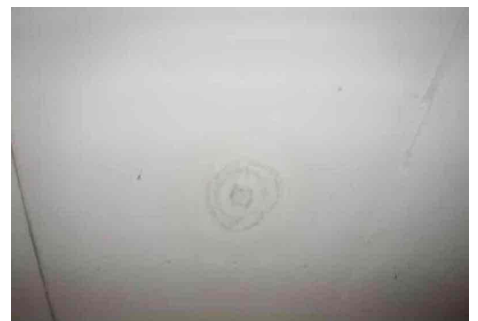
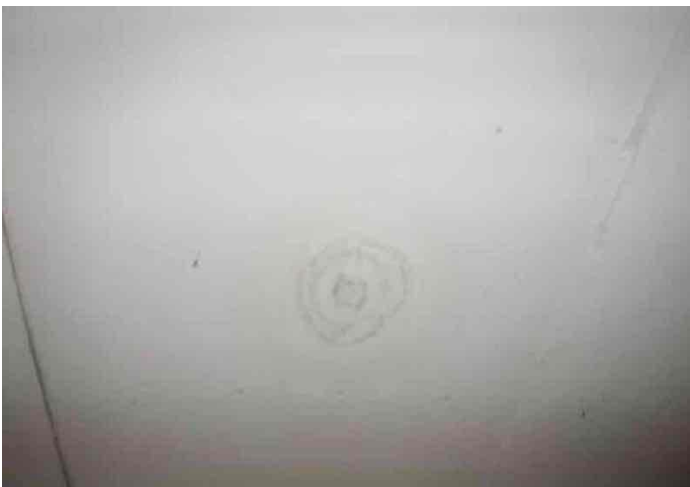
Photo 15

2. Damaged, open or missing wall and/or ceiling finishes of attached garages should be repaired and sealed where they abut the interior of a house. This reduces the potential of toxic automobile gases entering the house and serves as a fire break. Current standards require all walls/ceilings common to the finished living spaces be covered with 5/8" fire resistant sheetrock double taped at all seams. (See Illustration 3A) (See Photo 10)
3. Water stains were noted on the ceiling of the garage. This is usually an indication of past plumbing or roof leaks. This area should be further evaluated by the appropriate trades. (See Photo 15)

- ! 2. Water stains were noted on the ceiling of the garage. This is usually an indication of past plumbing or roof leaks. This area should be further evaluated by the appropriate trades. (See Photo 15)

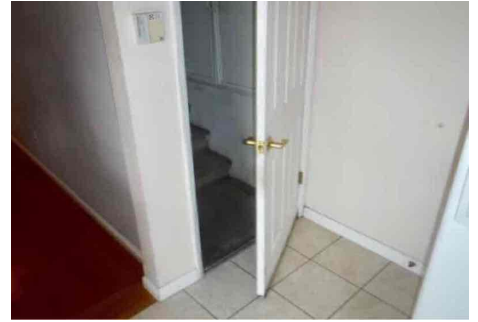
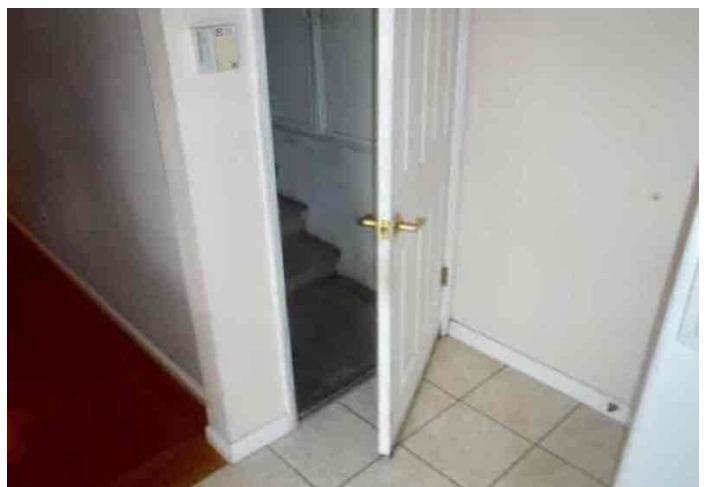
Photo 18

4. The door between the garage and the house did not have an automatic closing mechanism. The door between the garage and the interior of the house should be fitted with an automatic closing mechanism. This will reduce the potential of toxic automobile gases entering the house and serves as a fire break. (See Illustration 3G) (See Photo 18)

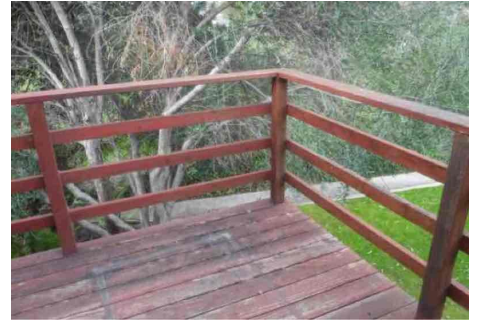
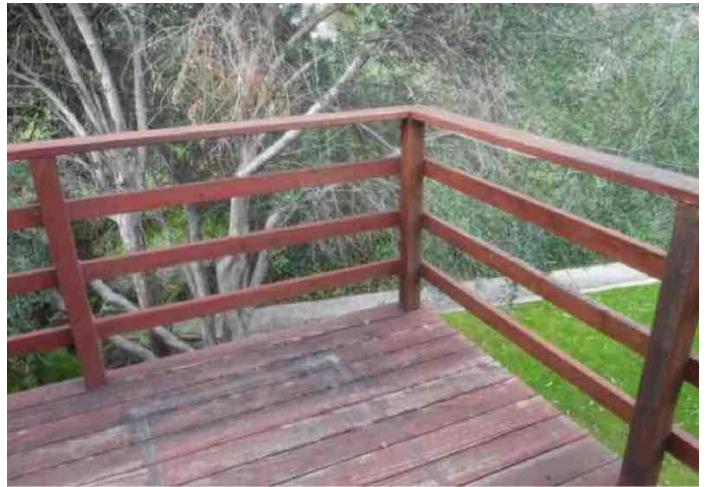
Photo 14

5. The openings in the deck railing(s) are larger than 4" inches and contain horizontal infill. It is recommended that this be corrected for improved safety. (See Illustration 3N) (See Photo 14)

- ! 4. The openings in the deck railing(s) are larger than 4" inches and contain horizontal infill. It is recommended that this be corrected for improved safety. (See Illustration 3N) (See Photo 14)

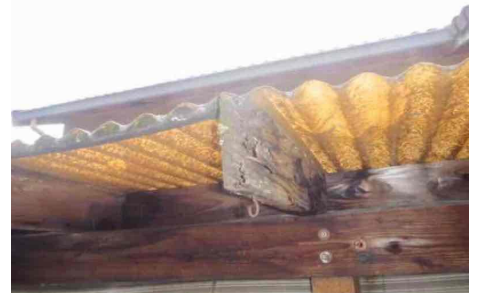
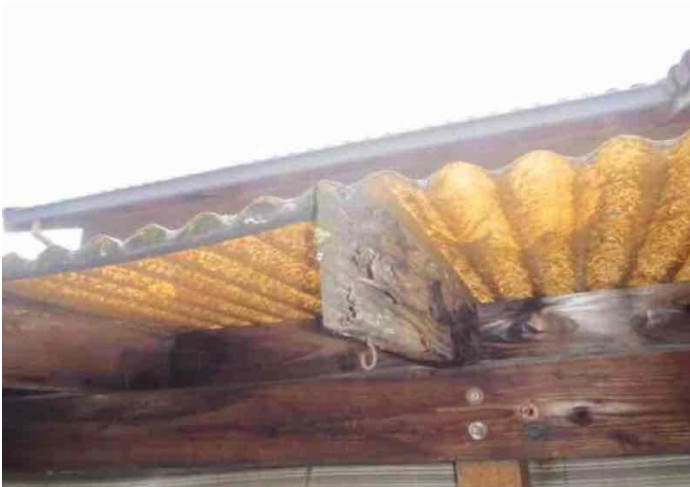
Photo 01

6. Evidence of water damage was noted at the patio cover. Consult a licensed structural pest control company regarding necessary repairs. (See Photo 1)

- ! 5. Evidence of water damage was noted at the patio cover. Consult a licensed structural pest control company regarding necessary repairs. (See Photo 1)

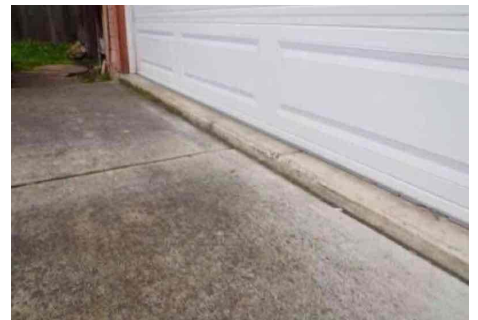
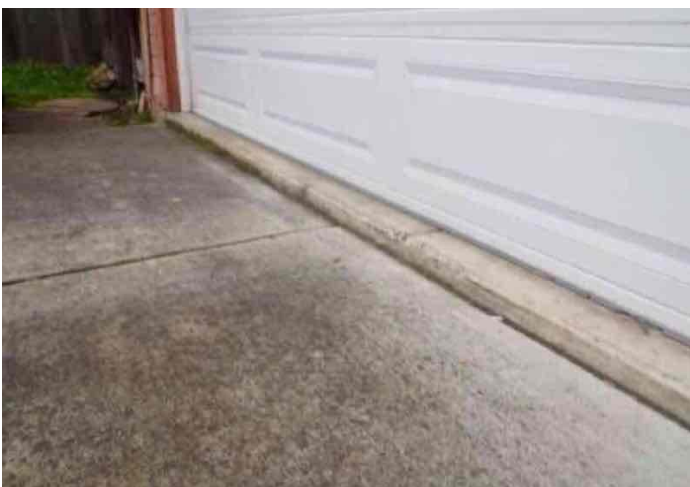
Photo 05

7. The raised section of the driveway present a trip hazard. This condition should be corrected for improved safety. (See Photo 5)

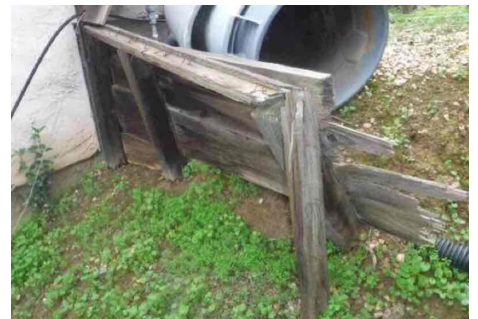
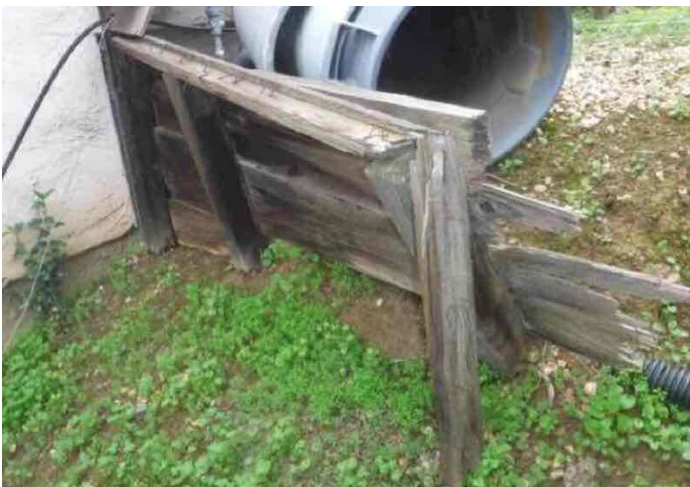
Photo 03

8. The wood retaining wall at the left side shows evidence of substantial water damage. It is difficult to determine when rebuilding will become necessary. Rebuilding may be necessary in the short term. Further evaluation of this condition by the appropriate tradesperson is recommended. (See Illustration 3Y) (See Photo 3)

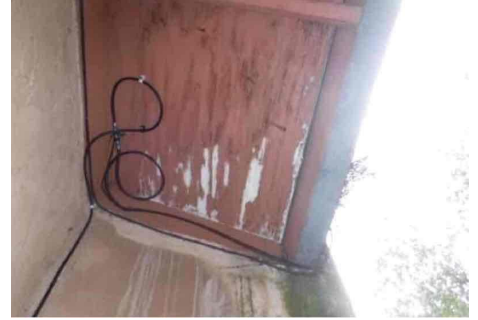
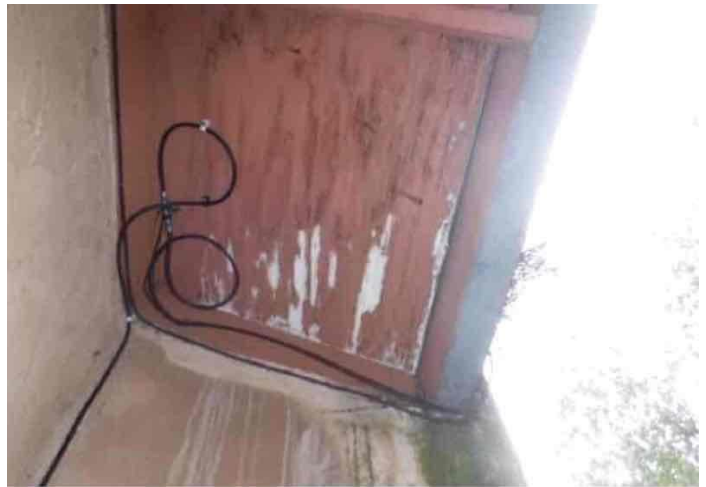
Photo 02

9. Water damage was observed to the roof eaves/sheathing at the rear. We recommend the services of a licensed general contractor and/or structural pest control company. (See Photo 2)

- ! 8. Water damage was observed to the roof eaves/sheathing at the rear. We recommend the services of a licensed general contractor and/or structural pest control company. (See Photo 2)

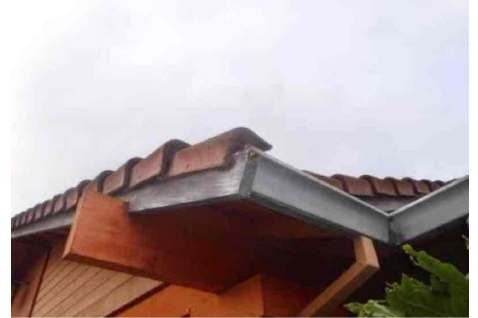
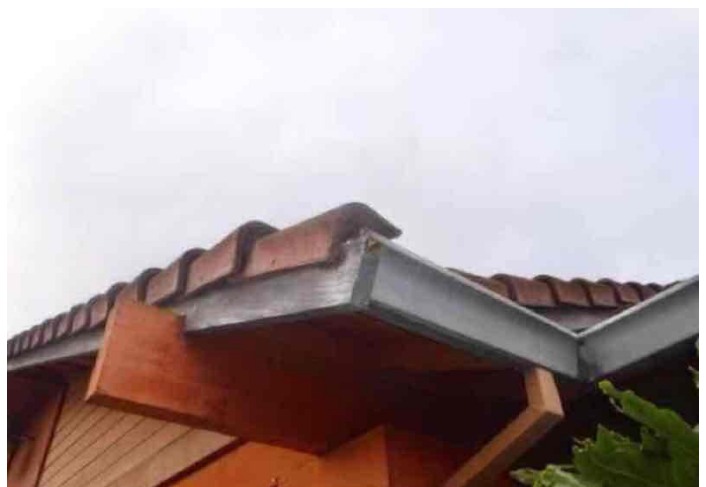
Photo 06

10. Water damage was observed to the rafters at the front and various areas. We recommend the services of a licensed general contractor and/or structural pest control company. (See Photo 6)

- ! 9. Water damage was observed to the rafters at the front and various areas. We recommend the services of a licensed general contractor and/or structural pest control company. (See Photo 6)

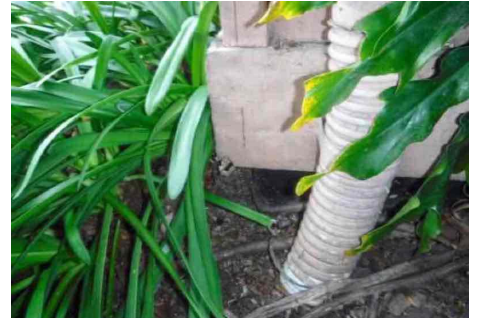
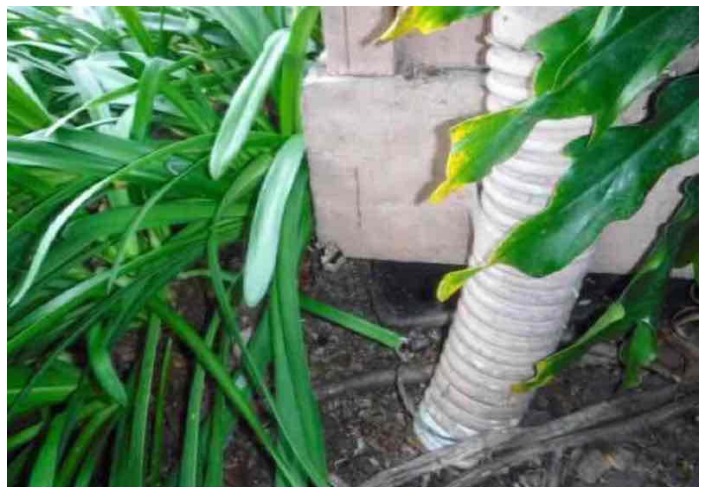
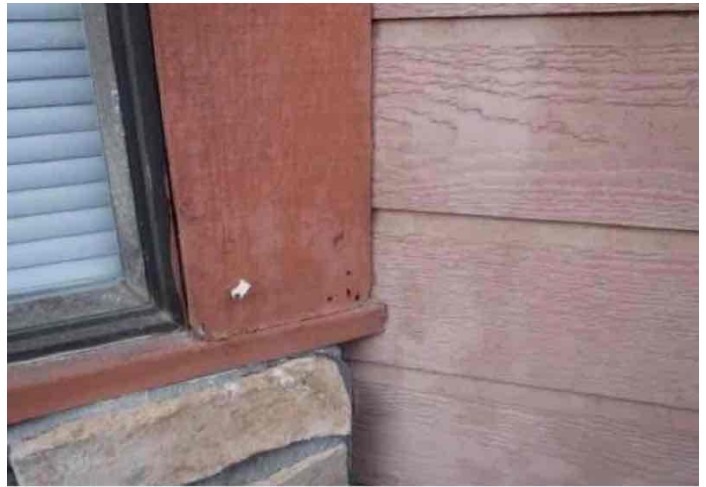
Photo 04

11. Water damage was observed to the exterior trim at the front and various areas. We recommend the services of a licensed general contractor and/or structural pest control company. (See Photo 4) (See Photo 8)

- ! 10. Water damage was observed to the exterior trim at the front and various areas. We recommend the services of a licensed general contractor and/or structural pest control company. (See Photo 4) (See Photo 8)

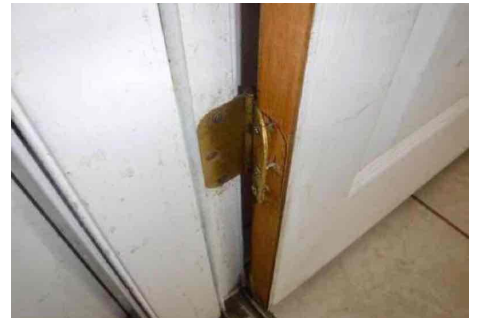
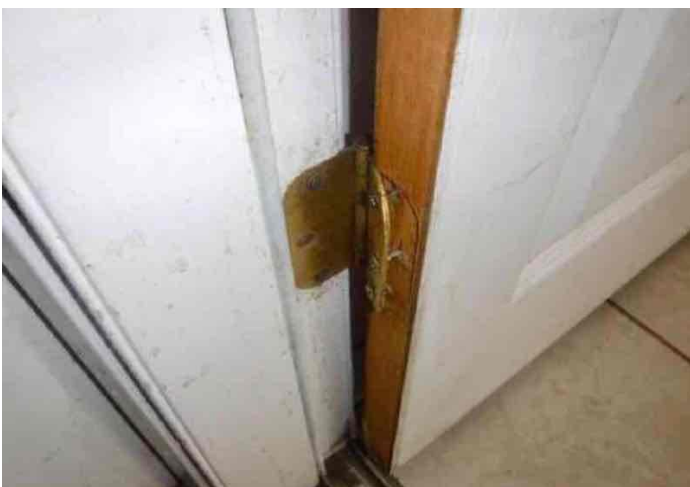
Photo 17

12. The hinges for the garage passage door are loose or broken. We recommend they be repaired or replaced as necessary. (See Photo 17)
13. Less than two drowning prevention safety features were noted. State law requires that during the course of our inspection we observe at least two of seven drowning prevention safety features outlined in the Health and Safety Code.
They are as follows:

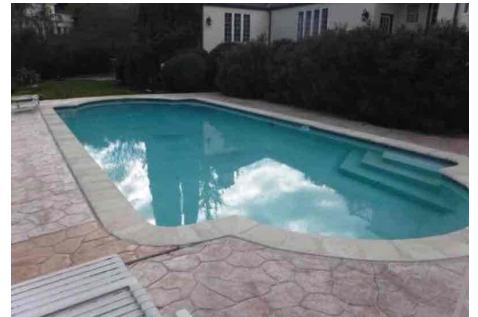
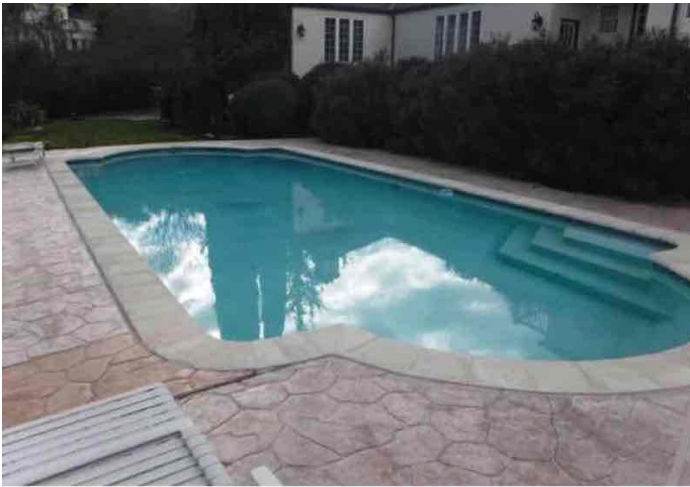
Photo 19

(6) An alarm that, when placed in a swimming pool or spa, will sound upon detection of accidental or unauthorized entrance into the water.
(7) Other means of protection, if the degree of protection afforded is equal to or greater than that afforded by any of the features set forth above and has been independently verified by an approved testing laboratory.
The owner is advised to contact the appropriate trades to rectify this condition. (See Photo 19)

The owner is advised to contact the appropriate trades to rectify this condition.

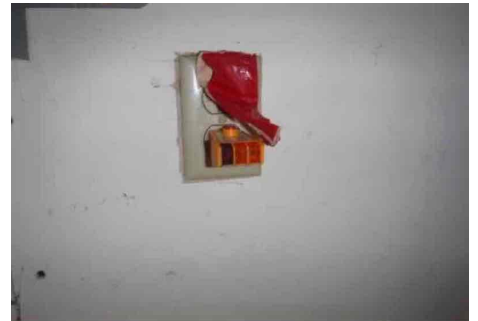
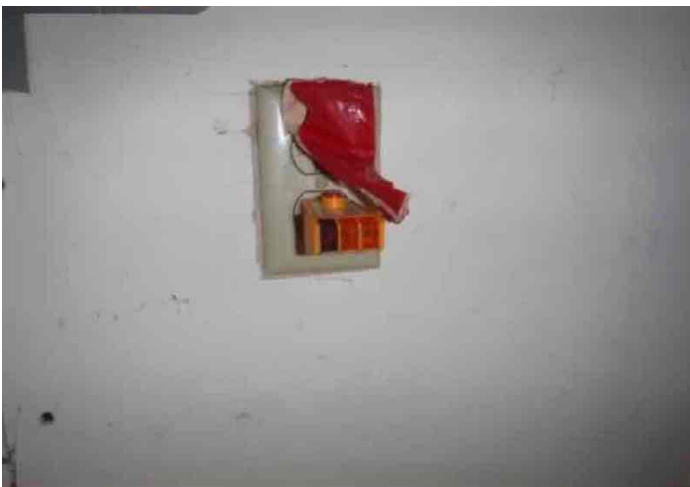
Photo 09

14. One or more outlets at the garage were inoperative at the time of our inspection. Possibly due to turned off switches which were not located during our inspection. These outlets and circuits should be investigated and corrected as necessary. Based upon our inspection of a representative number of outlets, we recommend testing of every outlet at a later date. Repairs or rewiring are recommended at all deficient locations. (See Photo 9)

- ! 1. One or more outlets at the garage were inoperative at the time of our inspection. Possibly due to turned off switches which were not located during our inspection. These outlets and circuits should be investigated and corrected as necessary. Based upon our inspection of a representative number of outlets, we recommend testing of every outlet at a later date. Repairs or rewiring are recommended at all deficient locations. (See Photo 9)

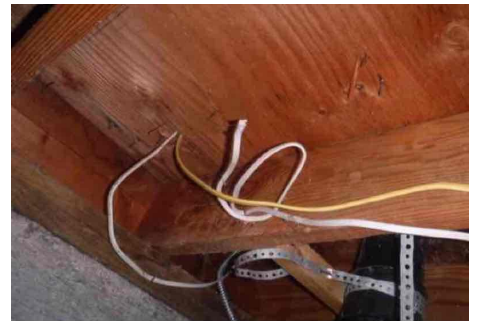
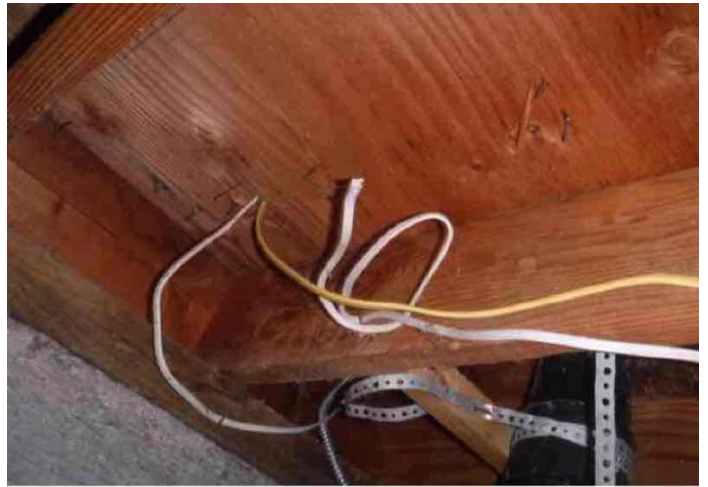
Photo 20

15. Abandoned wiring was noted in the crawlspace under the master bathroom. We recommend the wiring be disconnected at its source or terminated in an approved manner in a covered junction box. (See Photo 20)

- ! 6. Abandoned wiring was noted in the crawlspace under the master bathroom. We recommend the wiring be disconnected at its source or terminated in an approved manner in a covered junction box. (See Photo 20)

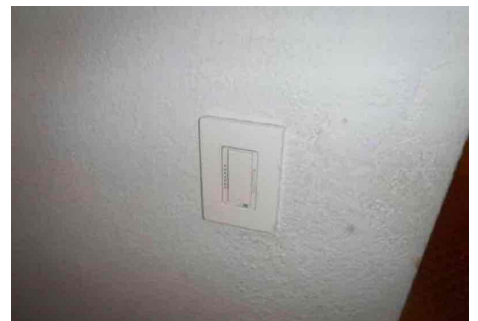
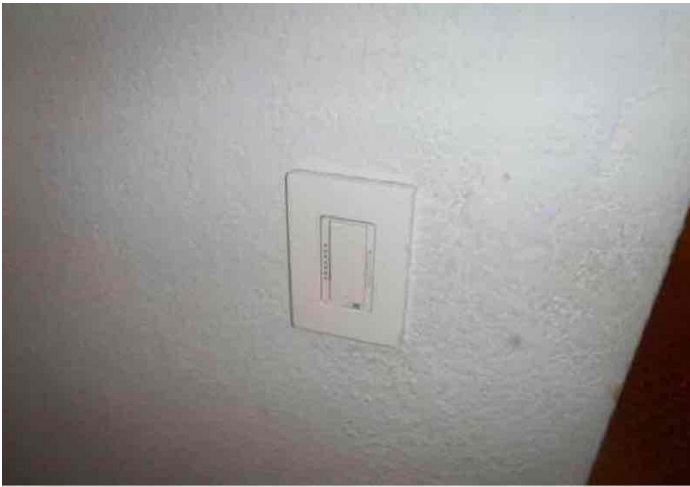
Photo 13

16. A switch at the master bedroom is faulty or damaged. We recommend it be replaced. (See Photo 13)

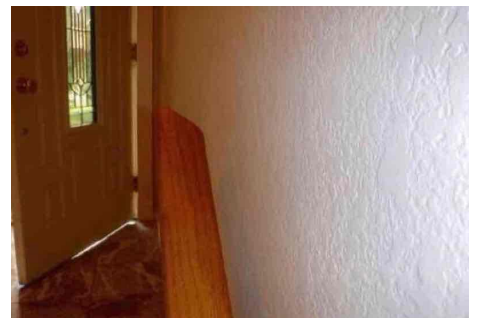
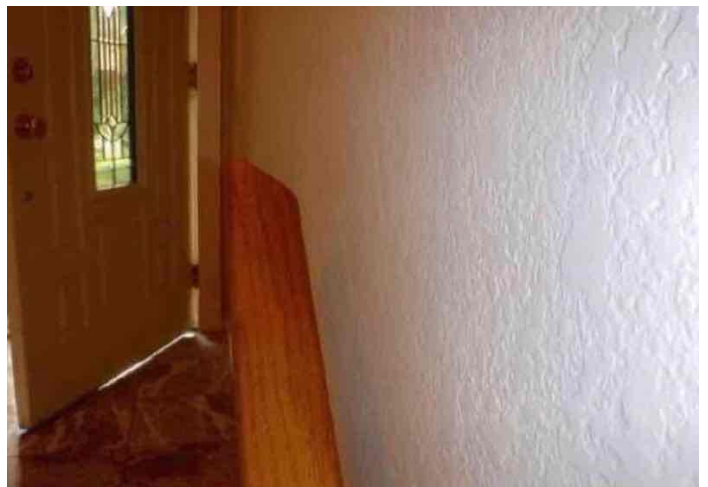
Photo 22

17. The ends of the railing at the interior staircase should return or connect to the wall. This will eliminate any loose clothing or straps from hanging up on the ends of the railing. It is recommended that this condition be corrected for improved safety. (See Photo 22)

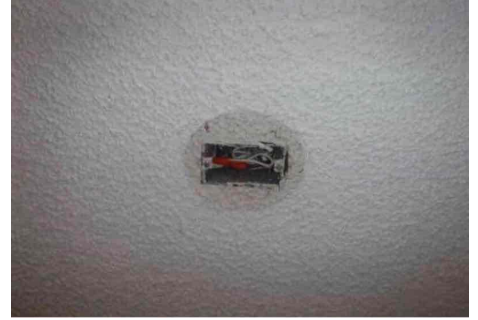
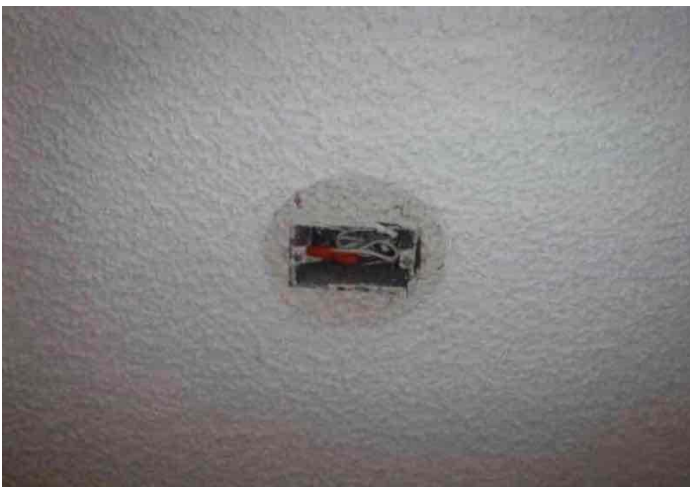
Photo 21

18. The installation of smoke detectors where missing or removed is required for added safety. (See Photo 21)

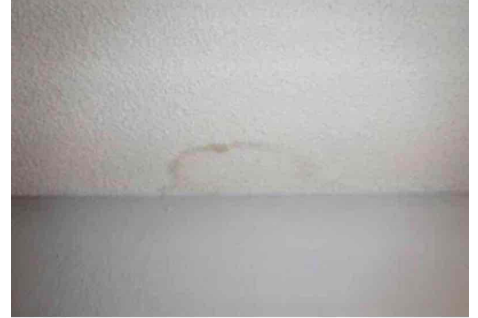
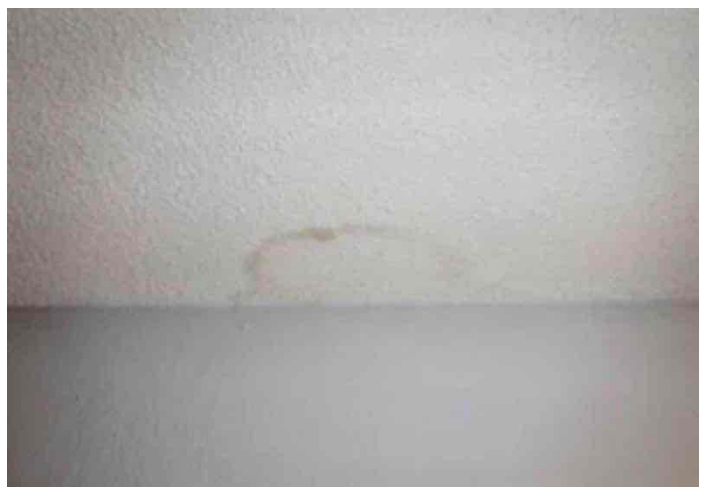
Photo 12

19. The ceiling at the master bedroom shows evidence of water stains. It is recommended that the source of these stains be identified and corrected and the surface be refinished. (See Photo 12)

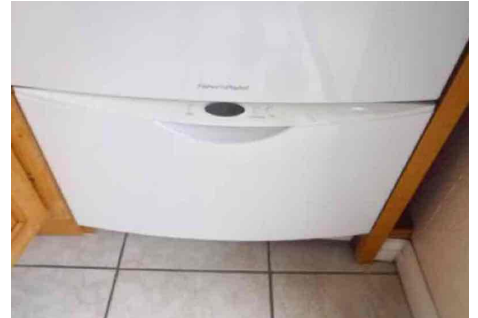
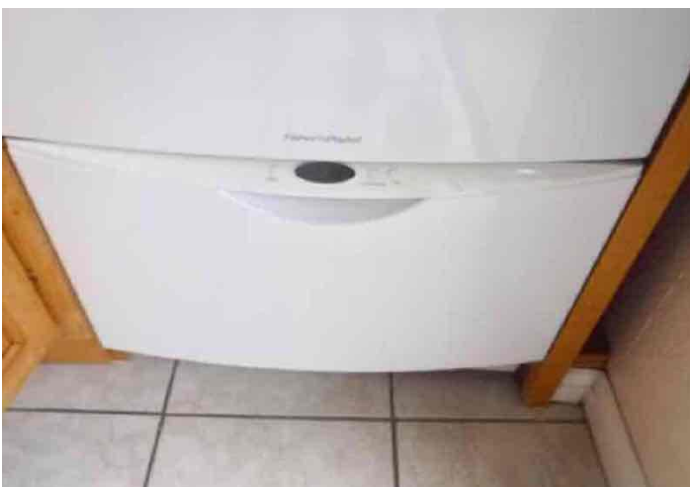
Photo 11

20. At the time of our inspection the lower dishwasher was inoperative or did not respond to normal operating controls. For attention to the conditions noted and/or cost estimates, if necessary, we recommend the advice of a qualified appliance technician. (See Photo 11)

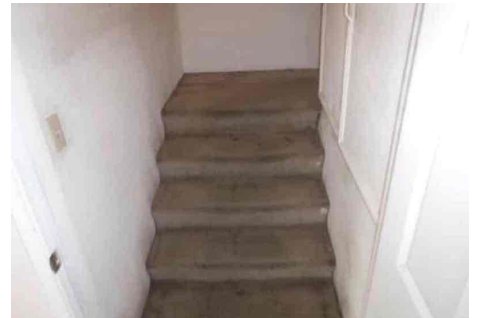
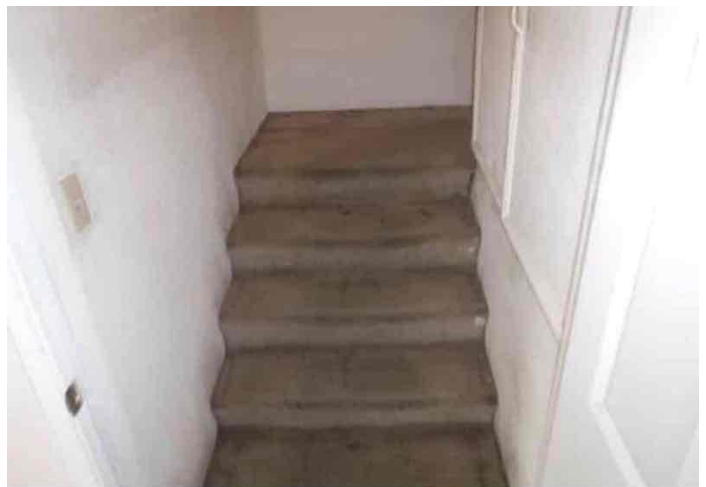
Photo 16

21. There is no hand railing where needed at the garage staircase. For improved safety, it is recommended that appropriate railing be installed. (See Photo 16)

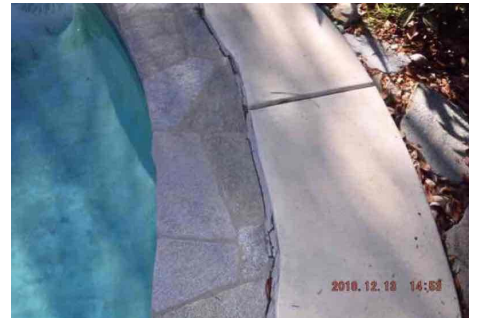
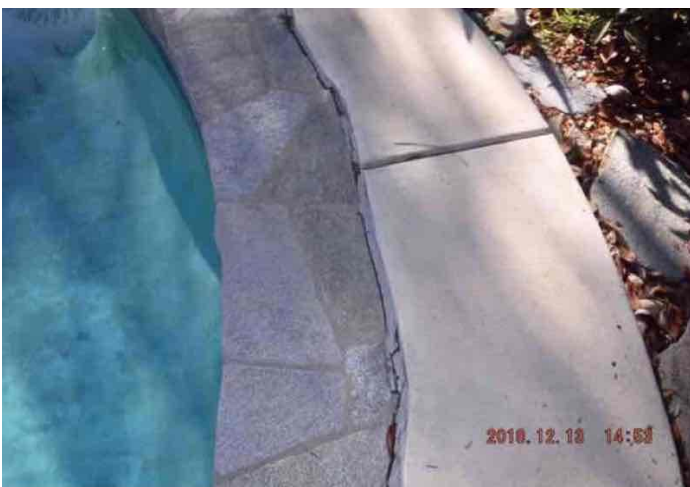
Photo 23

22. Cracked, loose, and/or damaged coping was noted along the pool edge. We recommend the coping be repaired or replaced as needed and sealed to prevent moisture intrusion. A licensed pool contractor should be consulted for repairs. (See Photo 23)

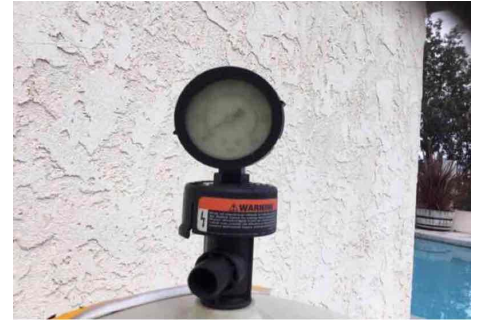
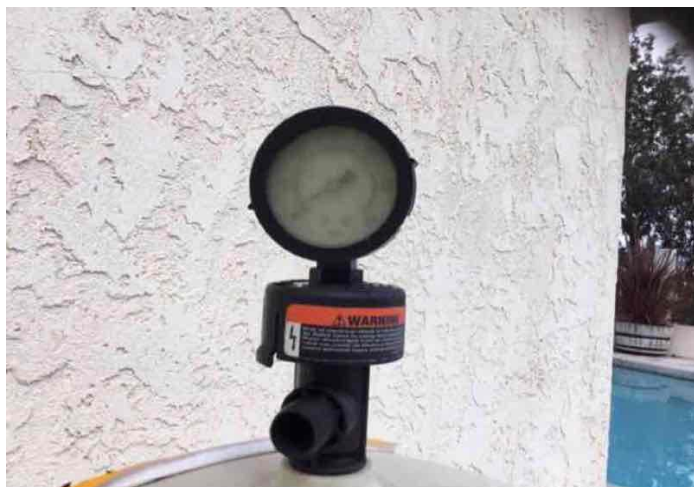
Photo 25

23. The filter pressure gauge was inoperative. We recommend the gauge be repaired or replaced, contact a licensed pool operator for further evaluation. (See Photo 25)

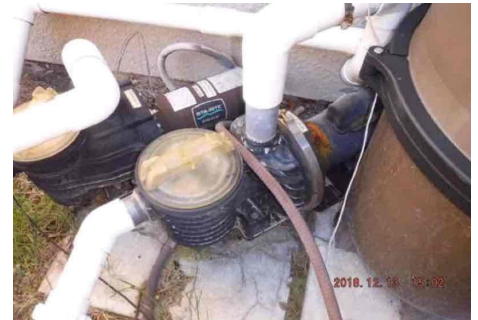
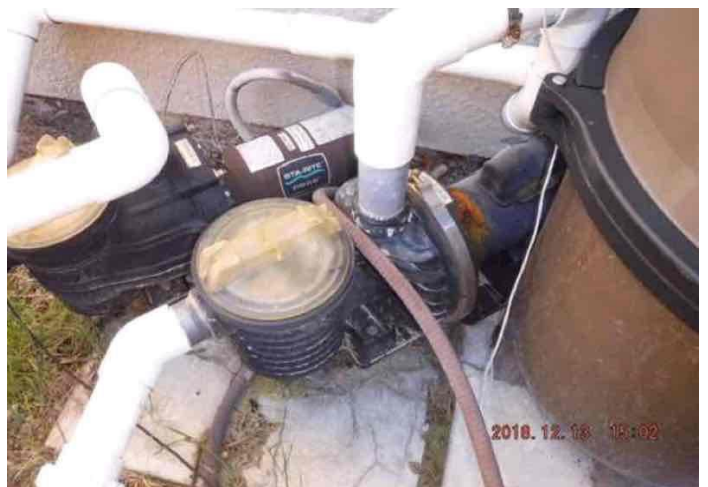
Photo 24

24. The pool/spa pump was found to be inoperative. We recommend the pump be further evaluated by a licensed pool operator and repaired or replaced as needed. (See Photo 24)
