## Home Inspection Report

**2623 Anywhere Street, Hometown**

Travis Palser  
April 5, 2019

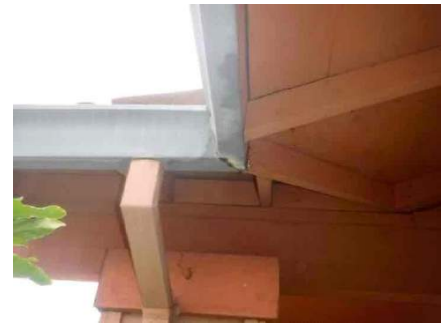
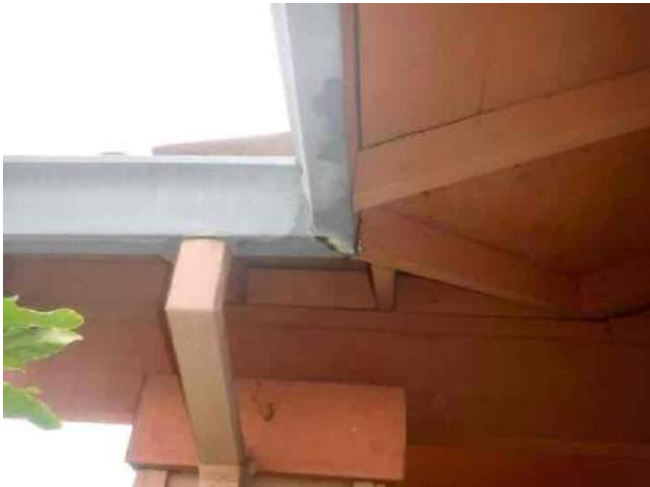
Photo 07

1. Leaks were noted in the downspouts and/or gutters at the front. During wet weather conditions these areas are more obvious and during dry weather conditions they are noted from the stains at the areas where the leaks have occurred. We recommend all leaks be repaired. (See Illustration 2D) (See Photo 7)

- !** 1. Leaks were noted in the downspouts and/or gutters at the front. During wet weather conditions these areas are more obvious and during dry weather conditions they are noted from the stains at the areas where the leaks have occurred. We recommend all leaks be repaired. (See Illustration 2D) (See Photo 7)

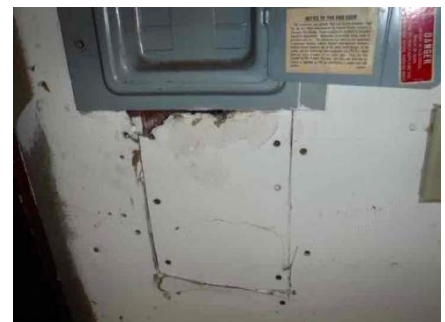
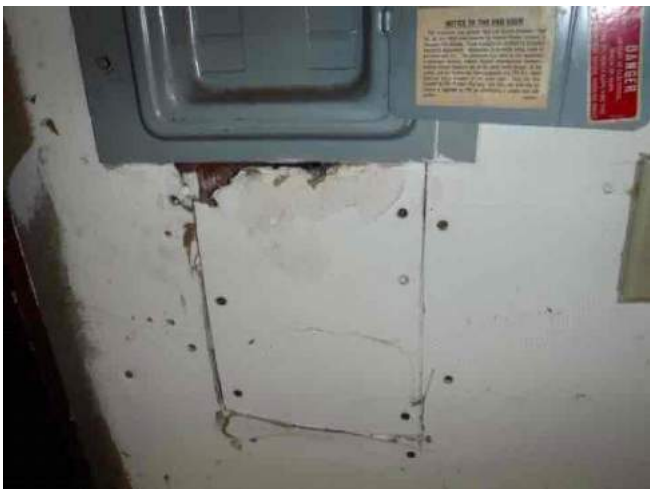
Photo 09

2. Damaged, open or missing wall and/or ceiling finishes of attached garages should be repaired and sealed where they abut the interior of a house. This reduces the potential of toxic automobile gases entering the house and serves as a fire break. Current standards require all walls/ceilings common to the finished living spaces be covered with 5/8" fire resistant sheetrock double taped at all seams. (See Illustration 3A) (See Photo 9)
3. Water stains were noted on the ceiling of the garage. This is usually an indication of past plumbing or roof leaks. This area should be further evaluated by the appropriate trades. (See Photo 15)

- ! 1. Damaged, open or missing wall and/or ceiling finishes of attached garages should be repaired and sealed where they abut the interior of a house. This reduces the potential of toxic automobile gases entering the house and serves as a fire break. Current standards require all walls/ceilings common to the finished living spaces be covered with 5/8" fire resistant sheetrock double taped at all seams. (See Illustration 3A) (See Photo 9)

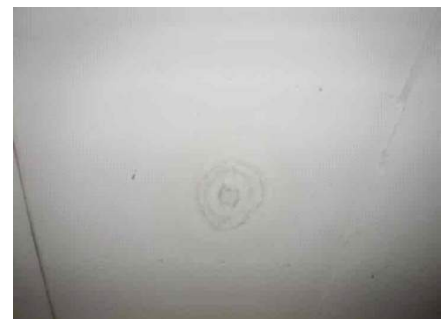
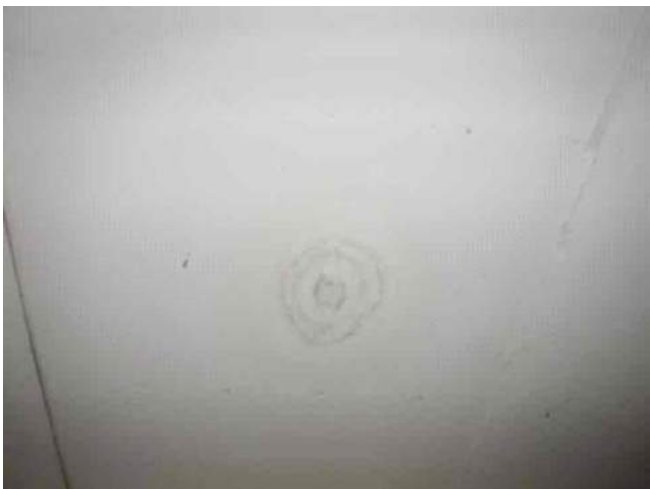
Photo 15

- ! 2. Water stains were noted on the ceiling of the garage. This is usually an indication of past plumbing or roof leaks. This area should be further evaluated by the appropriate trades. (See Photo 15)

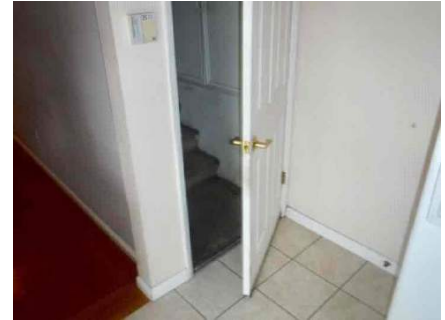
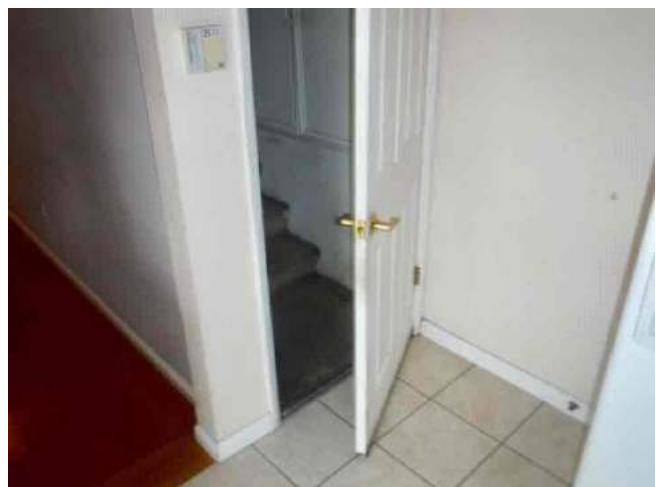
Photo 18

4. The door between the garage and the house did not have an automatic closing mechanism. The door between the garage and the interior of the house should be fitted with an automatic closing mechanism. This will reduce the potential of toxic automobile gases entering the house and serves as a fire break. (See Illustration 3G) (See Photo 18)

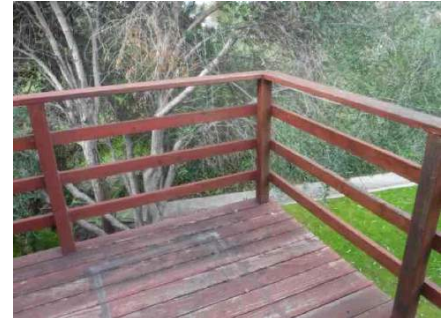
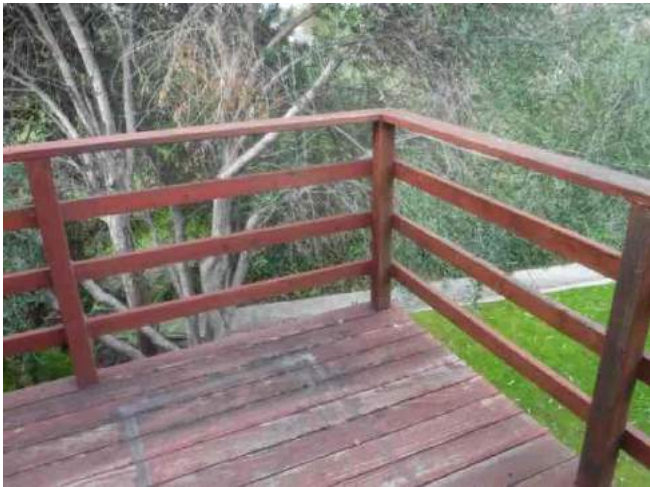
Photo 13

5. The openings in the deck railing(s) are larger than 4" inches and contain horizontal infill. It is recommended that this be corrected for improved safety. (See Illustration 3N) (See Photo 13)

- ! 4. The openings in the deck railing(s) are larger than 4" inches and contain horizontal infill. It is recommended that this be corrected for improved safety. (See Illustration 3N) (See Photo 13)

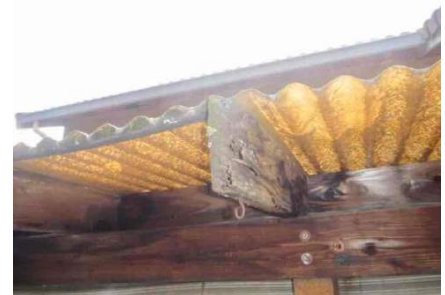
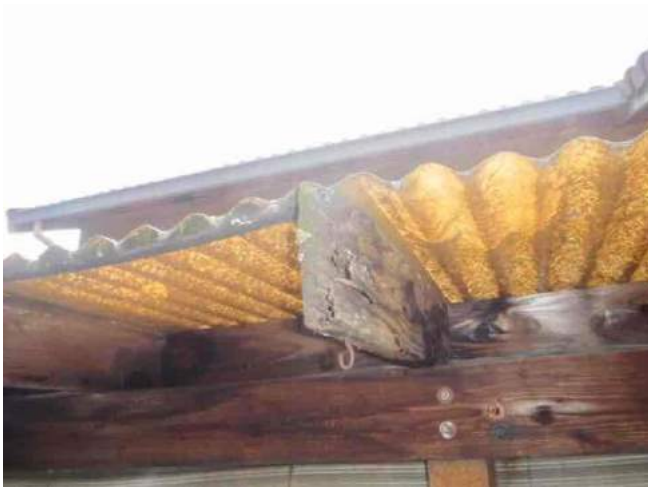
Photo 01

6. Evidence of water damage was noted at the patio cover. Consult a licensed structural pest control company regarding necessary repairs. (See Photo 1)

- ! 5. Evidence of water damage was noted at the patio cover. Consult a licensed structural pest control company regarding necessary repairs. (See Photo 1)

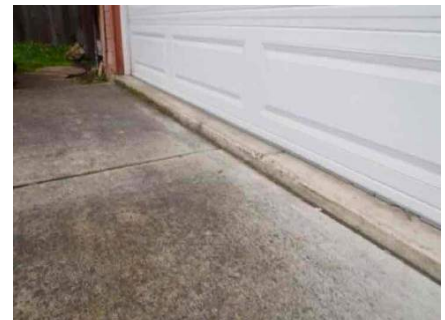
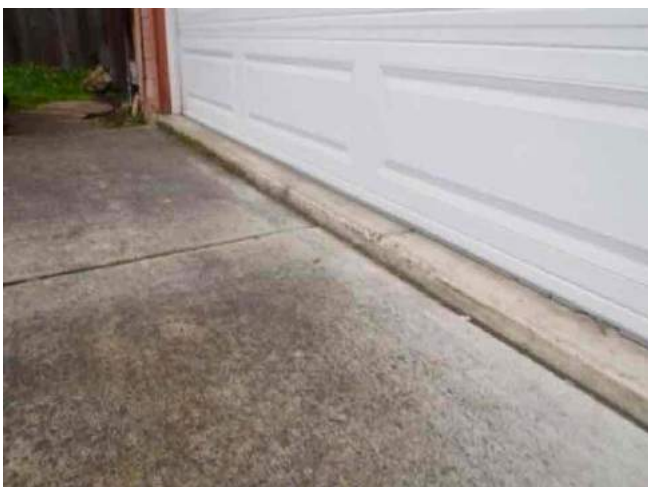
Photo 05

7. The raised sections of the driveway present a trip hazard. This condition should be corrected for improved safety. (See Photo 5)

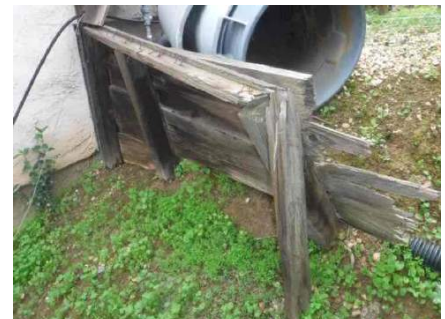
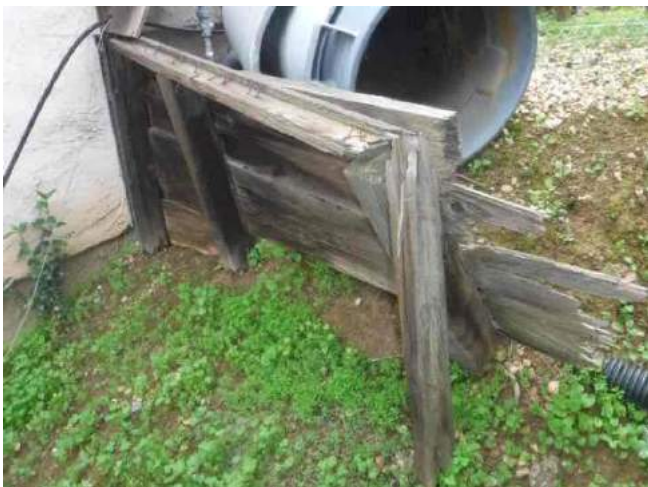
Photo 03

8. The wood retaining wall at the left side shows evidence of substantial water damage. It is difficult to determine when rebuilding will become necessary. Rebuilding may be necessary in the short term. Further evaluation of this condition by the appropriate tradesperson is recommended. (See Illustration 3Y) (See Photo 3)

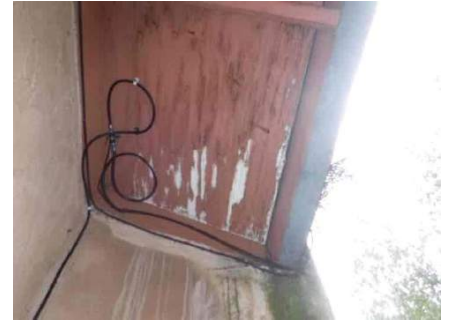
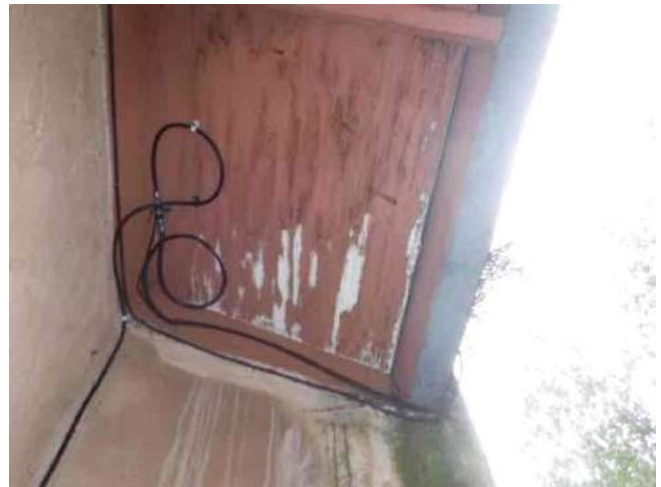
Photo 02

9. Water damage was observed to the roof eaves/sheathing at the rear. We recommend the services of a licensed general contractor and/or structural pest control company. (See Photo 2)

- ! 8. Water damage was observed to the roof eaves/sheathing at the rear. We recommend the services of a licensed general contractor and/or structural pest control company. (See Photo 2)

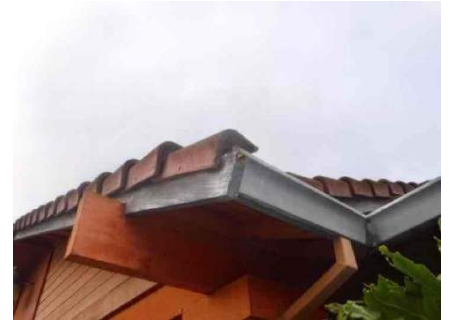
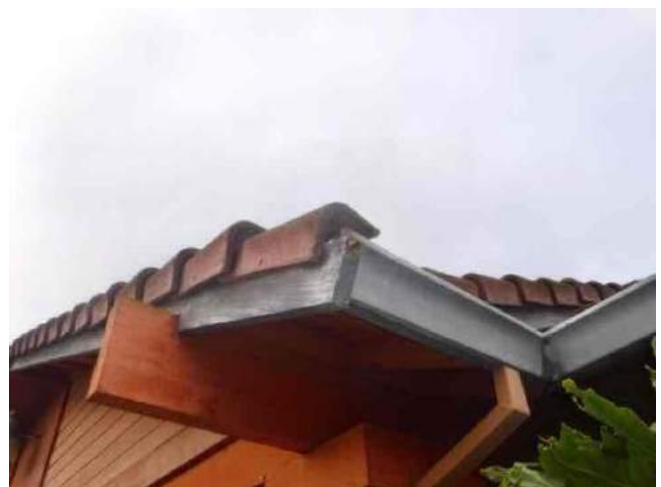
Photo 06

10. Water damage was observed to the rafters at the front and various areas. We recommend the services of a licensed general contractor and/or structural pest control company. (See Photo 6)

- ! 9. Water damage was observed to the rafters at the front and various areas. We recommend the services of a licensed general contractor and/or structural pest control company. (See Photo 6)

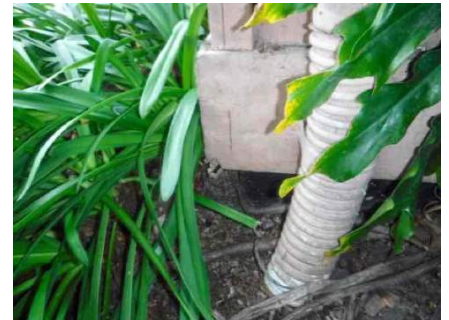
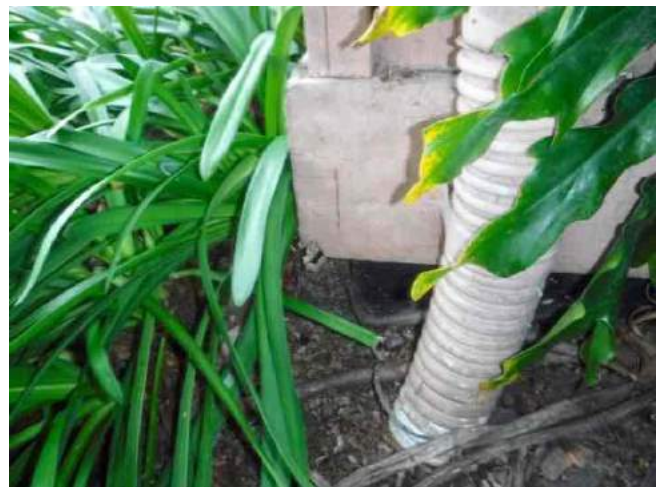
Photo 04

11. Water damage was observed to the exterior trim at the front and various areas. We recommend the services of a licensed general contractor and/or structural pest control company. (See Photo 4)

- ! 10. Water damage was observed to the exterior trim at the front and various areas. We recommend the services of a licensed general contractor and/or structural pest control company. (See Photo 4)

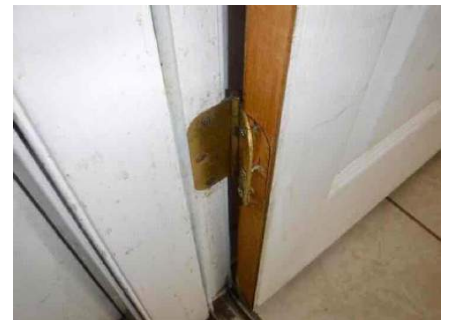
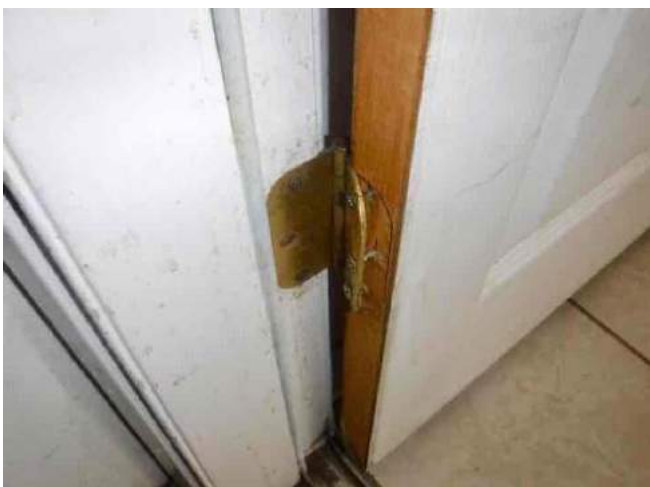
Photo 17

12. The hinges for the garage passage door are loose or broken. We recommend they be repaired or replaced as necessary. (See Photo 17)
13. Less than two drowning prevention safety features were noted. State law requires that during the course of our inspection we observe at least two of seven drowning prevention safety features outlined in the Health and Safety Code.  
They are as follows:

- ! 11. The hinges for the garage passage door are loose or broken. We recommend they be repaired or replaced as necessary. (See Photo 17)

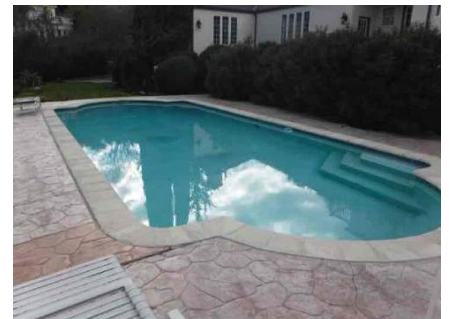
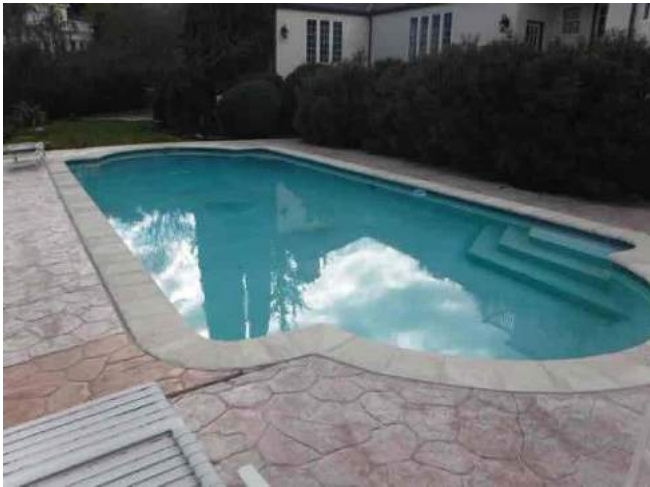
Photo 19

The owner is advised to contact the appropriate trades to rectify this condition.

(See Photo 19)

The owner is advised to contact the appropriate trades to rectify this condition. (See Photo 19)

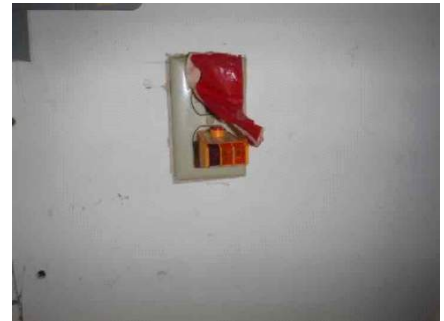
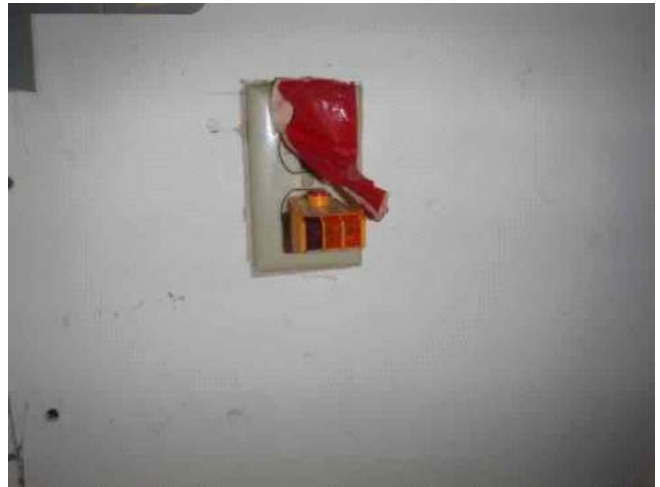
Photo 14

14. One or more outlets at the garage were inoperative at the time of our inspection. Possibly due to turned off switches which were not located during our inspection. These outlets and circuits should be investigated and corrected as necessary. Based upon our inspection of a representative number of outlets, we recommend testing of every outlet at a later date. Repairs or rewiring are recommended at all deficient locations. (See Photo 14)

- ! 1. One or more outlets at the garage were inoperative at the time of our inspection. Possibly due to turned off switches which were not located during our inspection. These outlets and circuits should be investigated and corrected as necessary. Based upon our inspection of a representative number of outlets, we recommend testing of every outlet at a later date. Repairs or rewiring are recommended at all deficient locations. (See Photo 14)

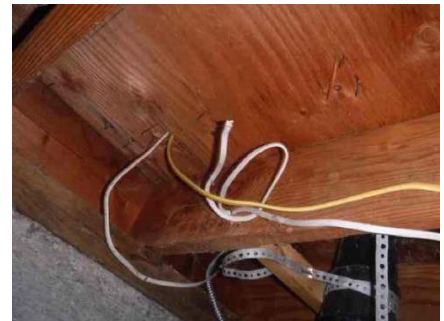
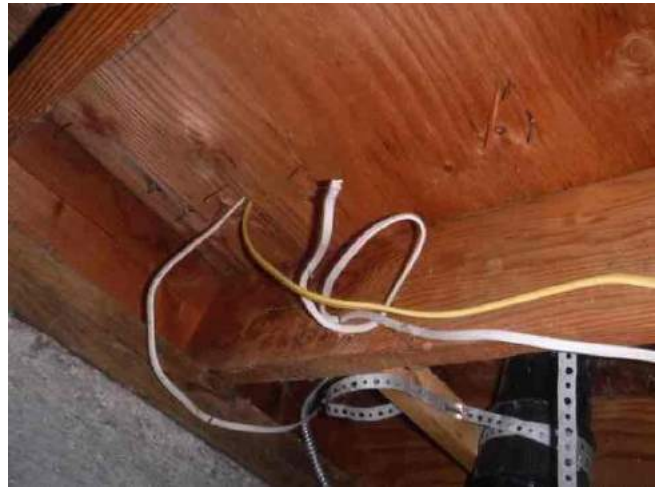
Photo 20

15. Abandoned wiring was noted in the crawlspace under the master bathroom. We recommend the wiring be disconnected at its source or terminated in an approved manner in a covered junction box. (See Photo 20)

- ! 6. Abandoned wiring was noted in the crawlspace under the master bathroom. We recommend the wiring be disconnected at its source or terminated in an approved manner in a covered junction box. (See Photo 20)

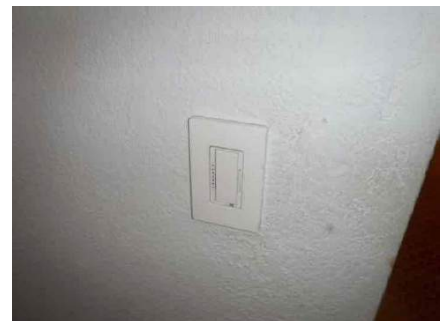
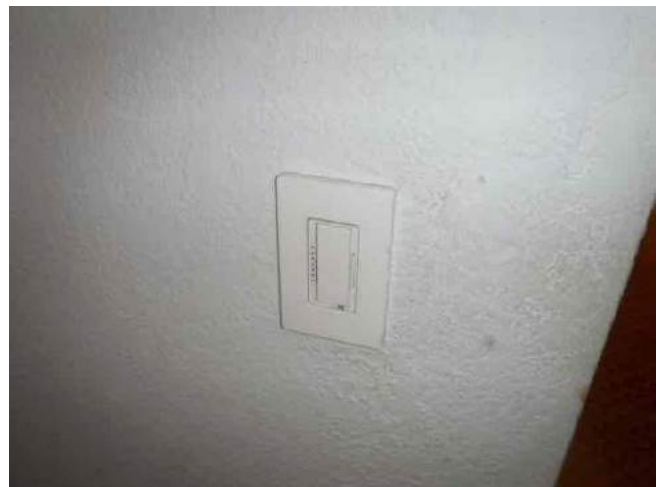
Photo 12

16. A switch at the master bedroom is faulty or damaged. We recommend it be replaced. (See Photo 12)

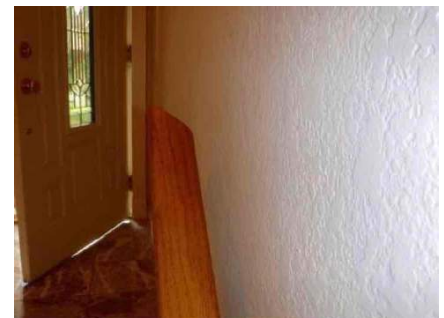
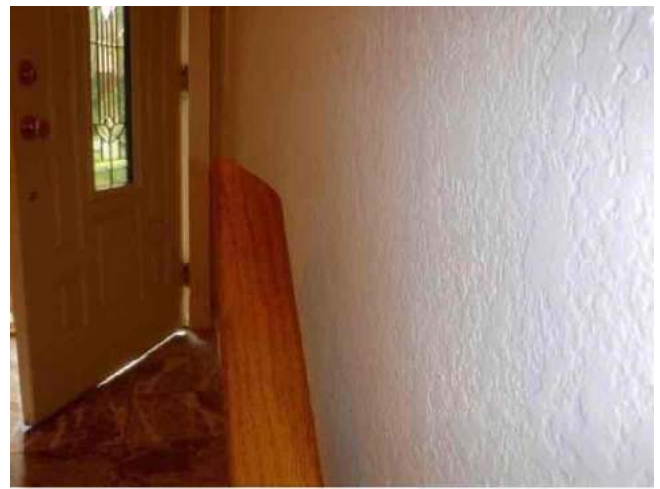
Photo 22

17. The ends of the railing at the interior staircase should return or connect to the wall. This will eliminate any loose clothing or straps from hanging up on the ends of the railing. It is recommended that this condition be corrected for improved safety. (See Photo 22)

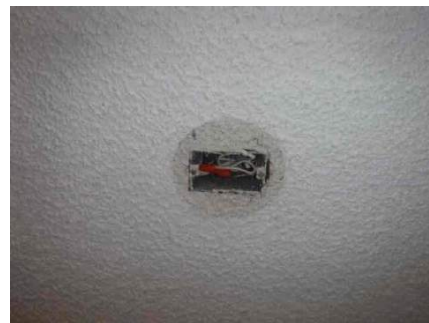
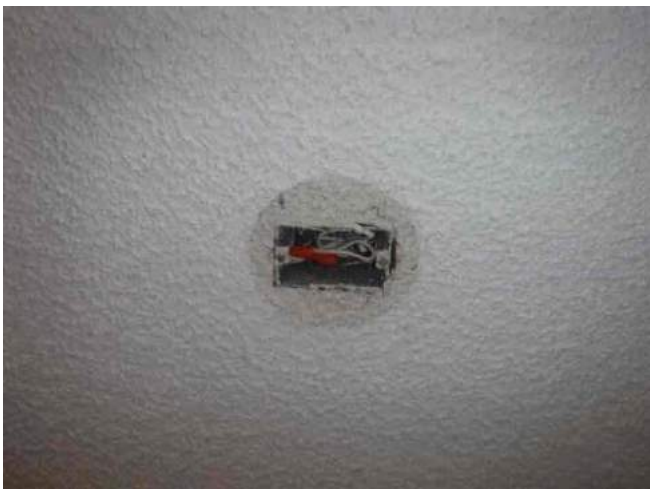
Photo 21

18. The installation of smoke detectors where missing or removed is required for added safety. (See Photo 21)

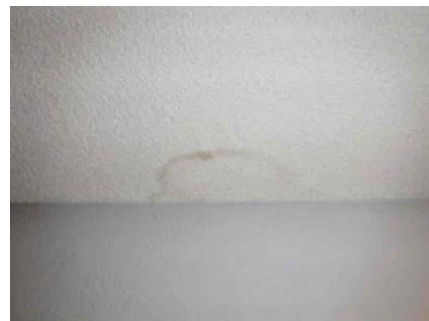
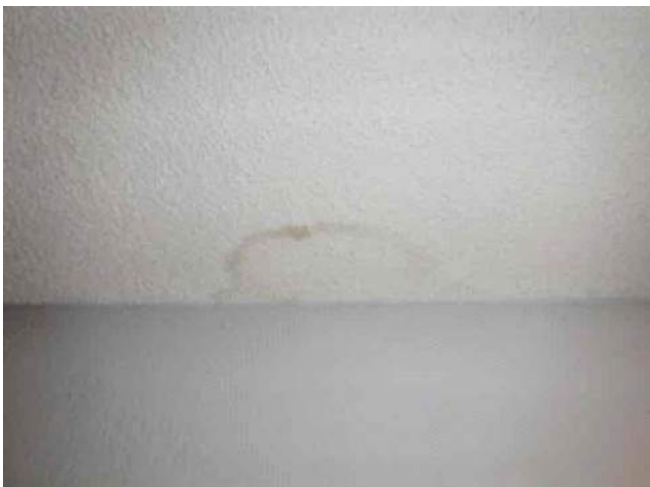
Photo 11

19. The ceiling at the master bedroom shows evidence of water stains. It is recommended that the source of these stains be identified and corrected and the surface be refinished. (See Photo 11)

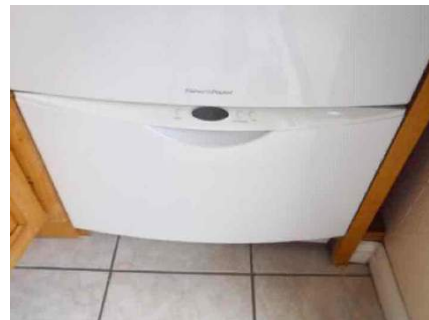
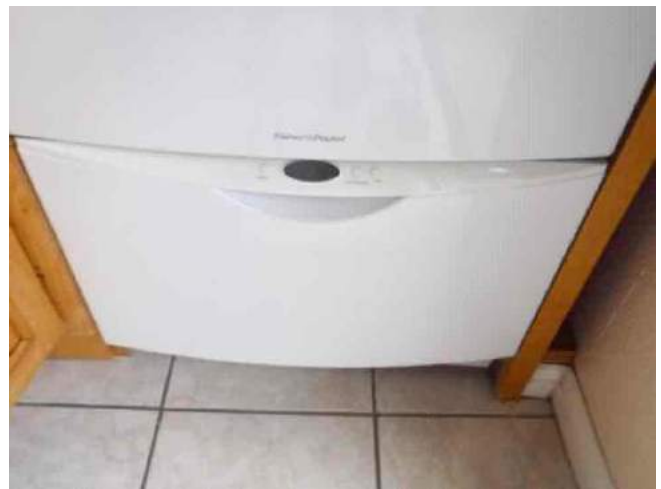
Photo 10

20. At the time of our inspection the lower dishwasher was inoperative or did not respond to normal operating controls. For attention to the conditions noted and/or cost estimates, if necessary, we recommend the advice of a qualified appliance technician. (See Photo 10)

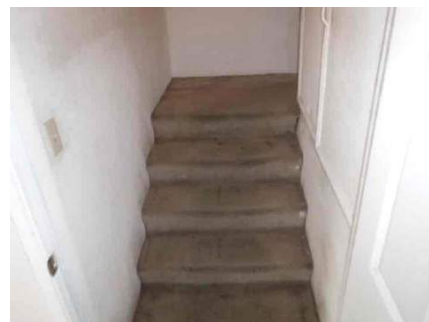
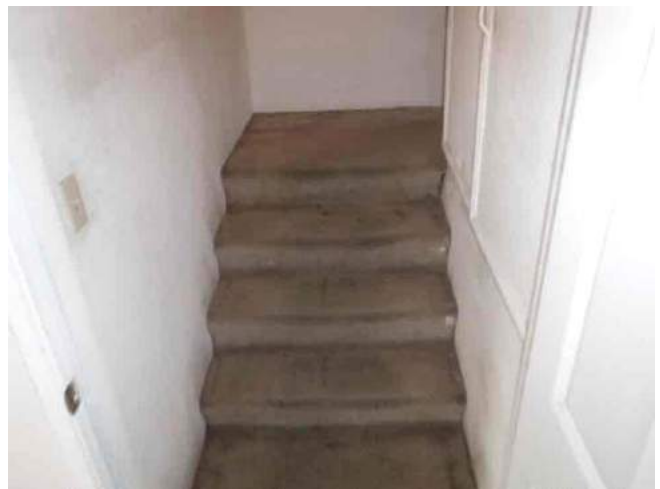
Photo 16

21. There is no hand railing where needed at the garage staircase. For improved safety, it is recommended that appropriate railing be installed. (See Photo 16)

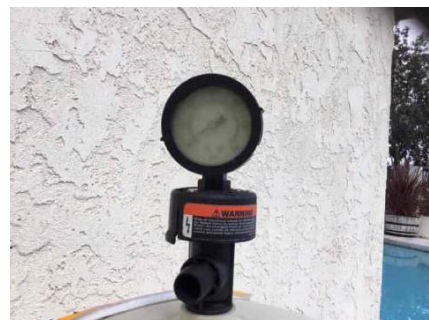
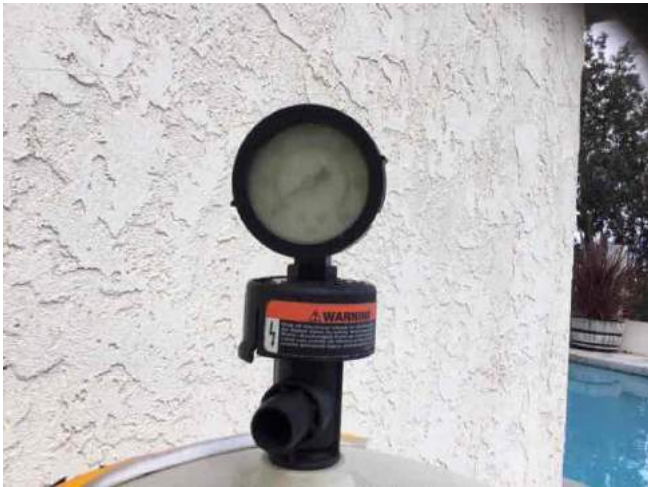
Photo 25

22. The pressure gauge was inoperative at the time of inspection. (See Photo 25)

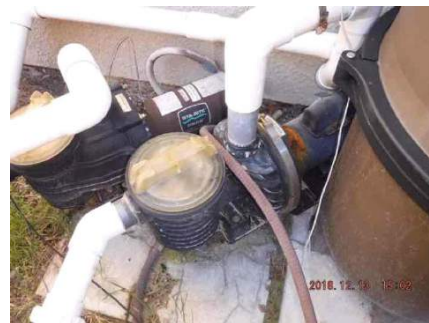
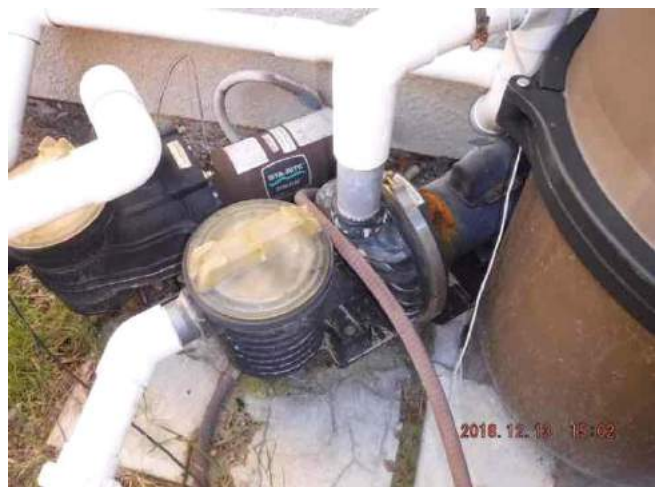
Photo 24

23. The circulation pump was not operational at the time of the inspection. A qualified licensed contractor should be consulted for further evaluation of this condition and the remedies available for correction. (See Photo 24)

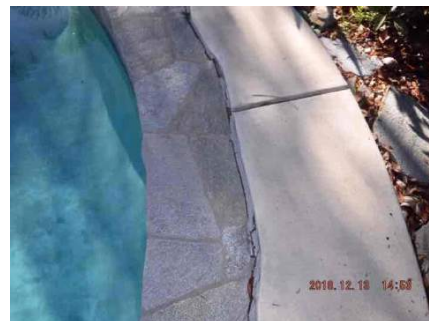
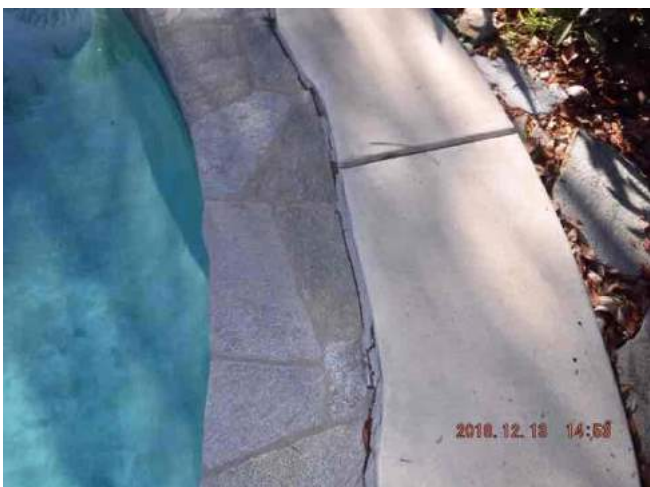
Photo 23

24. Damage was observed at the pool coping or adjacent concrete flatwork. We recommend repair. (See Photo 23)

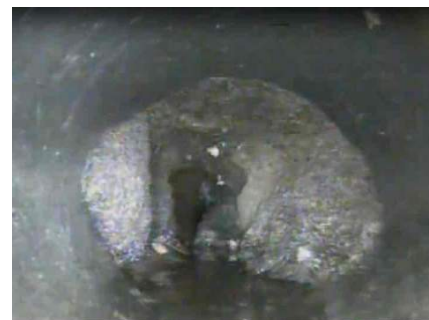
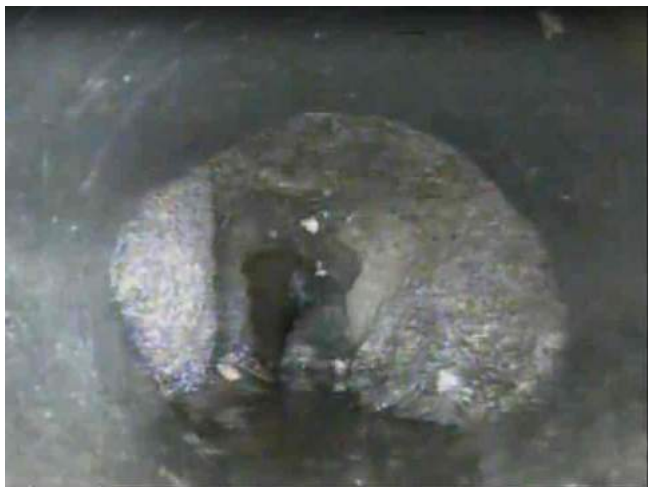
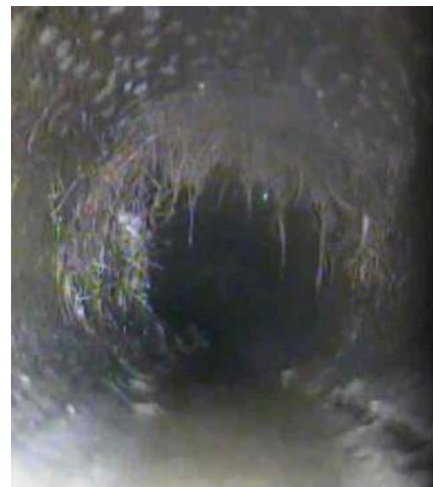
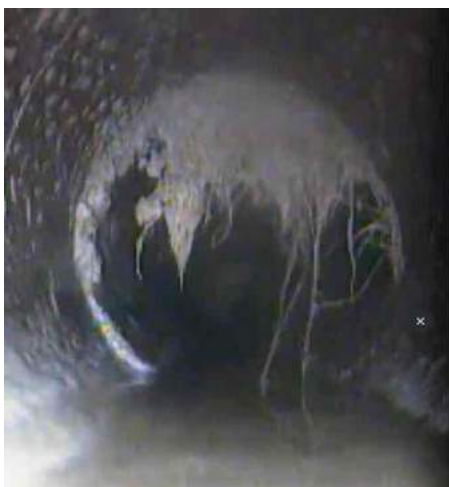
Photo 27

25. Large amounts of tree roots were found entering the sewer line. We recommend these be removed immediately before stoppage in the system occurs. (See Photo 27) (See Photo 28) (See Photo 29)

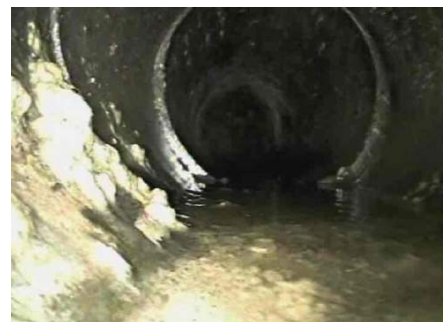
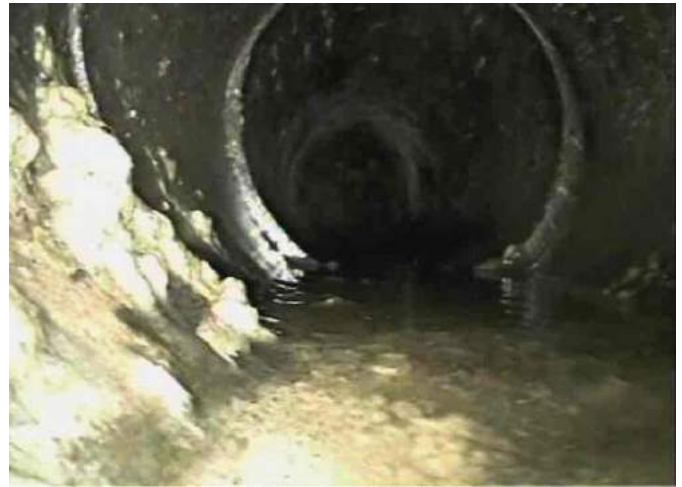
Photo 26

26. There are areas of the piping that have shifted. We recommend repairs be made to these areas to prevent further damage or stoppage from developing in the line. (See Photo 26)
