Home Inspection Report

2623 Anywhere Street, Hometown

Ordered by: John Doe
2623 Anywhere Street
Hometown, CA 99999

Travis Palser
January 1, 2020

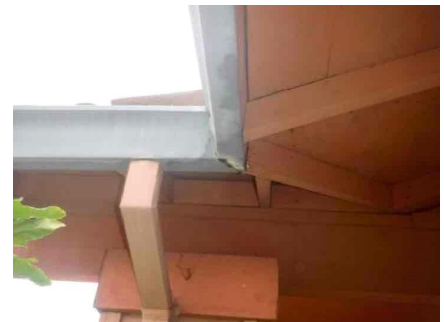
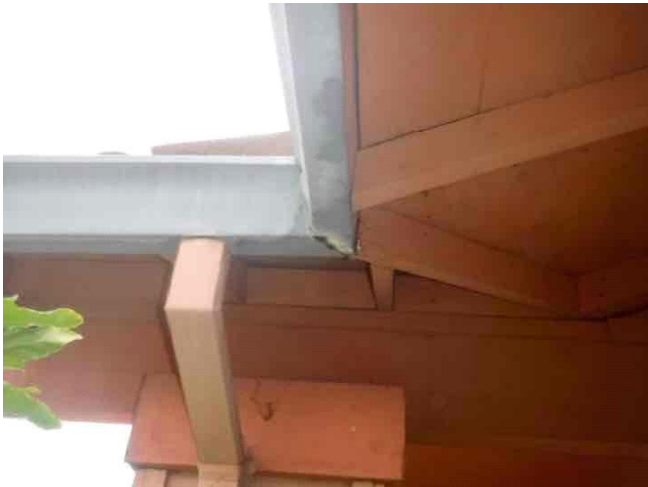
Photo 07

1. Leaks were noted in the downspouts and/or gutters at the front. During wet weather conditions these areas are more obvious and during dry weather conditions they are noted from the stains at the areas where the leaks have occurred. We recommend all leaks be repaired. (See Illustration 2D) (See Photo 7)

- ! 1. Leaks were noted in the downspouts and/or gutters at the front. During wet weather conditions these areas are more obvious and during dry weather conditions they are noted from the stains at the areas where the leaks have occurred. We recommend all leaks be repaired. (See Illustration 2D) (See Photo 7)

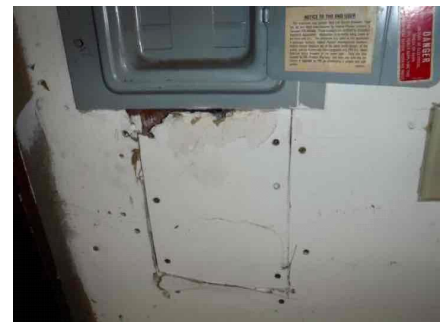
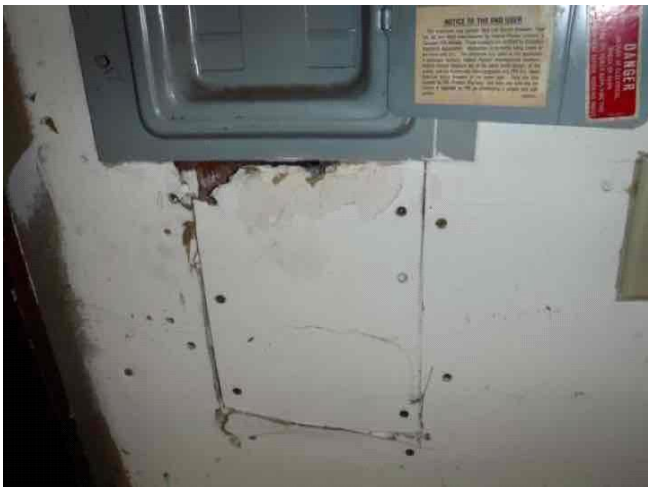
Photo 09

- ! 1. Damaged, open or missing wall and/or ceiling finishes of attached garages should be repaired and sealed where they abut the interior of a house. This reduces the potential of toxic automobile gases entering the house and serves as a fire break. Current standards require all walls/ceilings common to the finished living spaces be covered with 5/8" fire resistant sheetrock double taped at all seams. (See Illustration 3A) (See Photo 9)

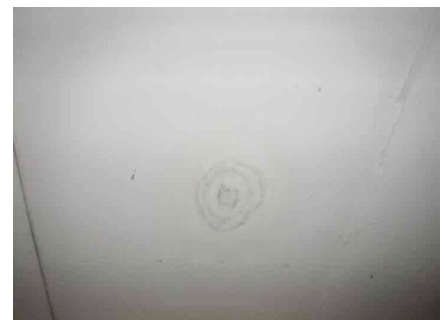
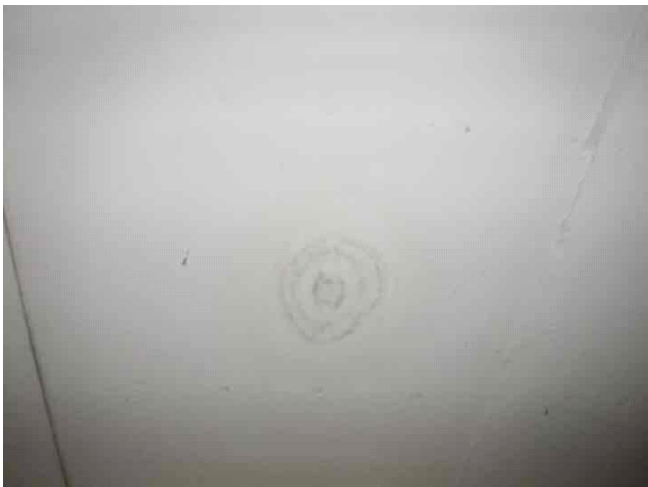
Photo 15

2. Damaged, open or missing wall and/or ceiling finishes of attached garages should be repaired and sealed where they abut the interior of a house. This reduces the potential of toxic automobile gases entering the house and serves as a fire break. Current standards require all walls/ceilings common to the finished living spaces be covered with 5/8" fire resistant sheetrock double taped at all seams. (See Illustration 3A) (See Photo 9)
3. Water stains were noted on the ceiling of the garage. This is usually an indication of past plumbing or roof leaks. This area should be further evaluated by the appropriate trades. (See Photo 15)

- ! 2. Water stains were noted on the ceiling of the garage. This is usually an indication of past plumbing or roof leaks. This area should be further evaluated by the appropriate trades. (See Photo 15)

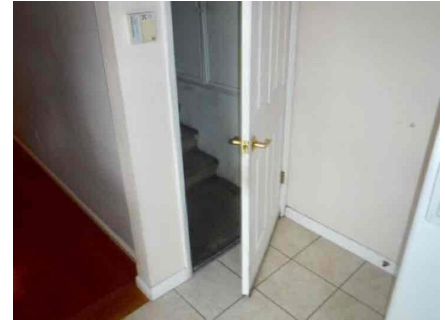
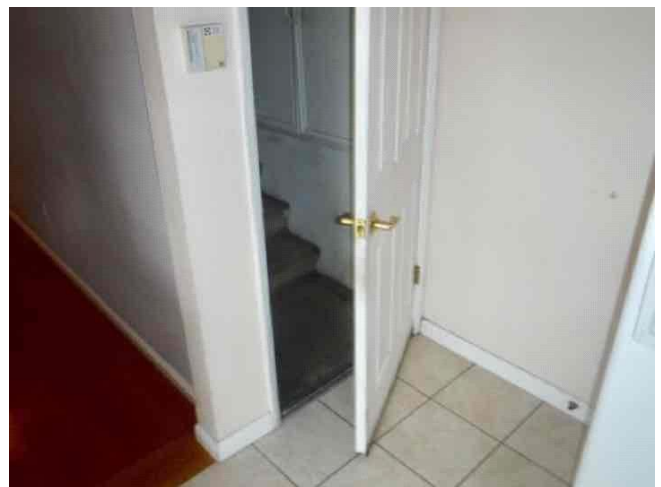
Photo 18

4. The door between the garage and the house did not have an automatic closing mechanism. The door between the garage and the interior of the house should be fitted with an automatic closing mechanism. This will reduce the potential of toxic automobile gases entering the house and serves as a fire break. (See Illustration 3G) (See Photo 18)

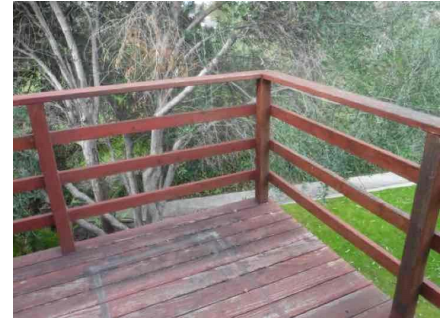
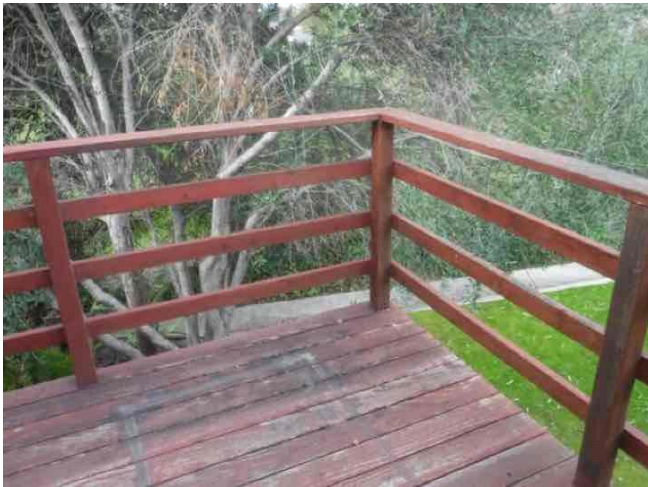
Photo 13

5. The openings in the deck railing(s) are larger than 4" inches and contain horizontal infill. It is recommended that this be corrected for improved safety. (See Illustration 3N) (See Photo 13)

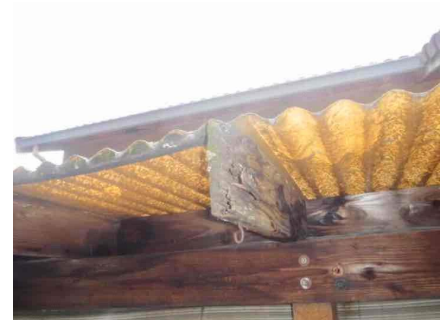
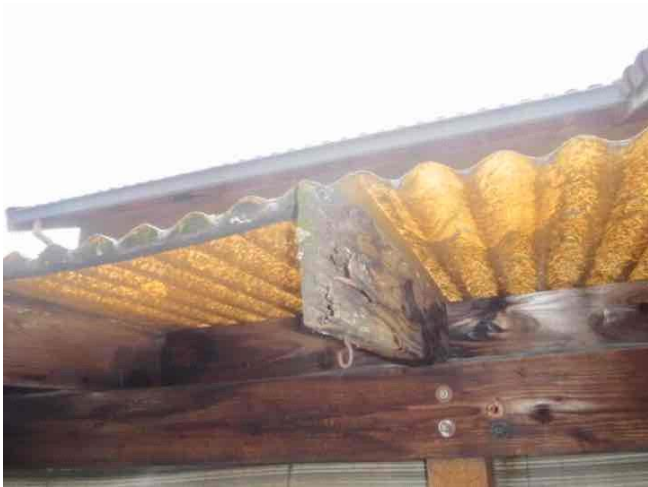
Photo 01

6. Evidence of water damage was noted at the patio cover. Consult a licensed structural pest control company regarding necessary repairs. (See Photo 1)

- ! 6. Evidence of water damage was noted at the patio cover. Consult a licensed structural pest control company regarding necessary repairs. (See Photo 1)

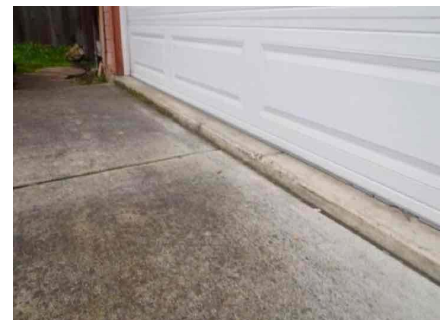
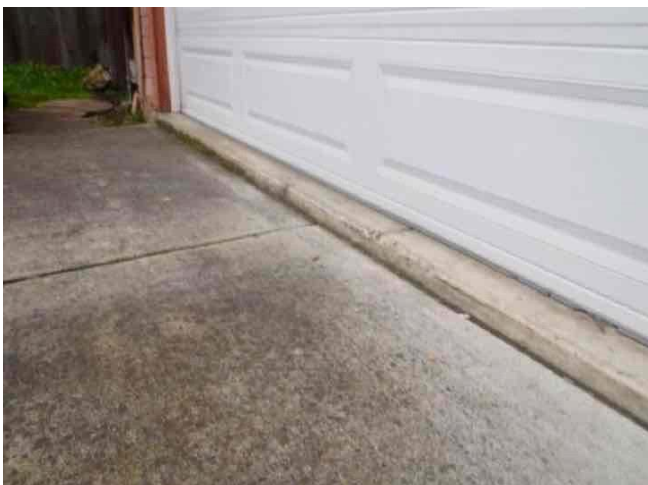
Photo 05

7. The raised sections of the driveway present a trip hazard. This condition should be corrected for improved safety. (See Photo 5)

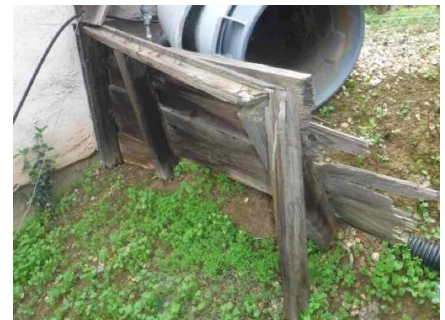
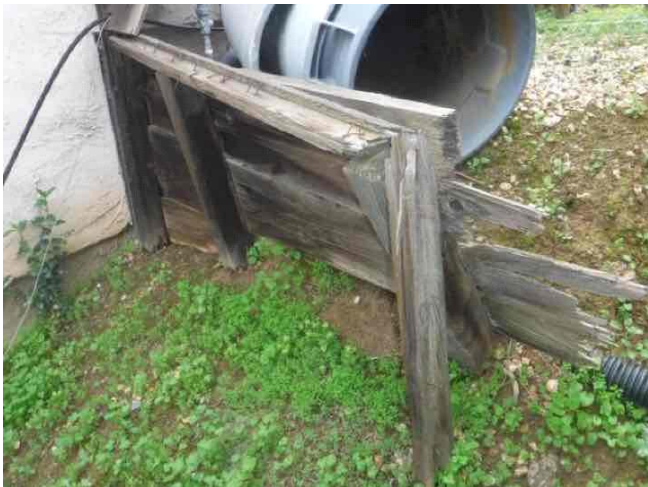
Photo 03

8. The wood retaining wall at the left side shows evidence of substantial water damage. It is difficult to determine when rebuilding will become necessary. Rebuilding may be necessary in the short term. Further evaluation of this condition by the appropriate tradesperson is recommended. (See Illustration 3Y) (See Photo 3)

- ! 7. The raised sections of the driveway present a trip hazard. This condition should be corrected for improved safety. (See Photo 5)
- ! 8. The wood retaining wall at the left side shows evidence of substantial water damage. It is difficult to determine when rebuilding will become necessary. Rebuilding may be necessary in the short term. Further evaluation of this condition by the appropriate tradesperson is recommended. (See Illustration 3Y) (See Photo 3)

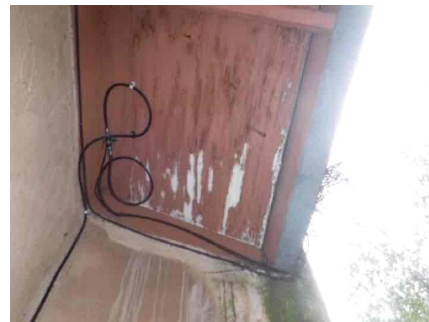
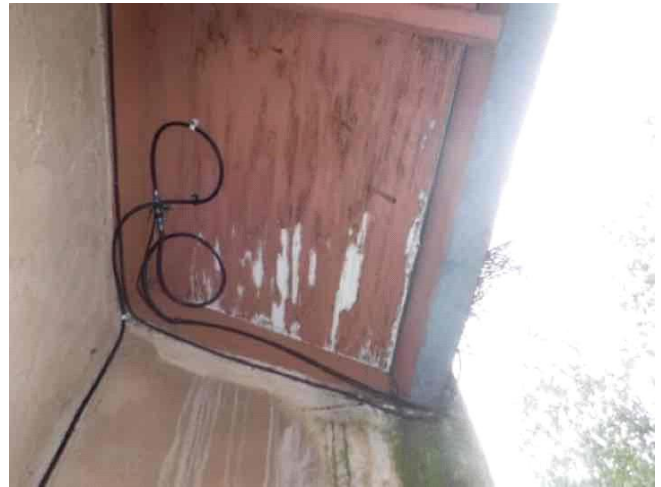
Photo 02

- ! 9. Water damage was observed to the roof eaves/sheathing at the rear. We recommend the services of a licensed general contractor and/or structural pest control company. (See Photo 2)

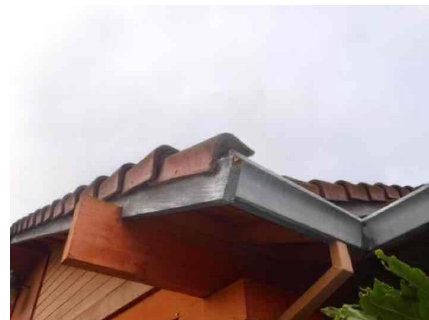
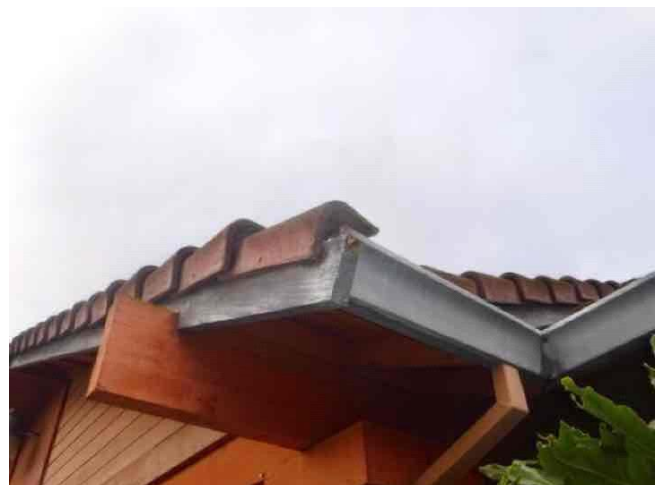
Photo 06

- ! 10. Water damage was observed to the rafters at the front and various areas. We recommend the services of a licensed general contractor and/or structural pest control company. (See Photo 6)

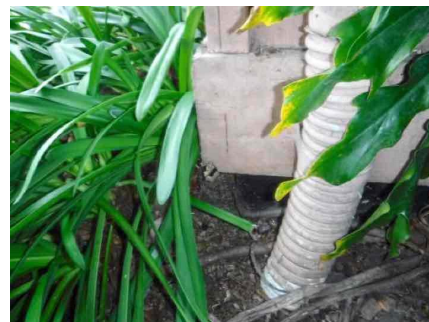
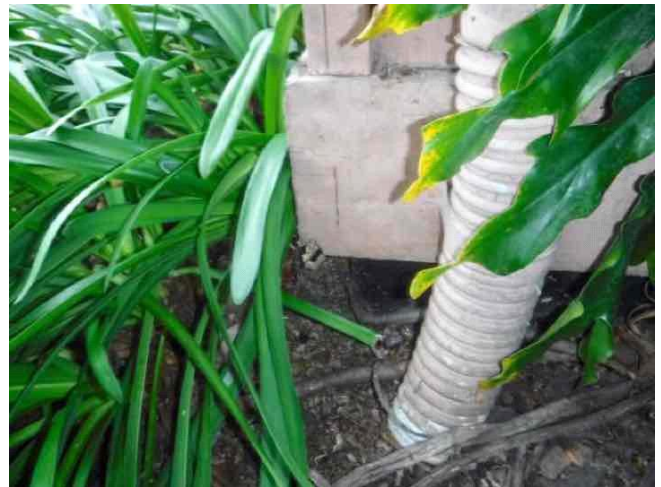
Photo 04

- ! 11. Water damage was observed to the exterior trim at the front and various areas. We recommend the services of a licensed general contractor and/or structural pest control company. (See Photo 4)

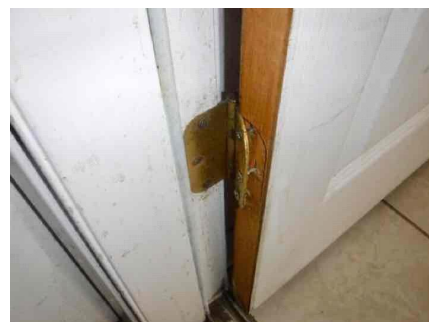
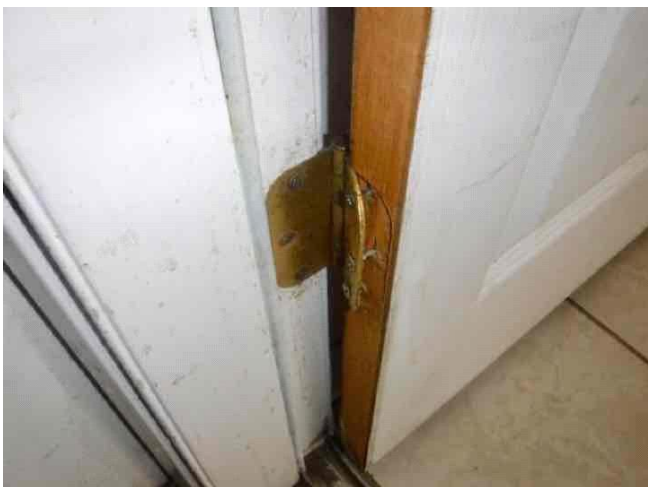
Photo 17

- ! 4. The hinges for the garage passage door are loose or broken. We recommend they be repaired or replaced as necessary. (See Photo 17)
- ! 5. The openings in the deck railing(s) are larger than 4" inches and contain horizontal infill. It is recommended that this be corrected for improved safety. (See Illustration 3N) (See Photo 13)

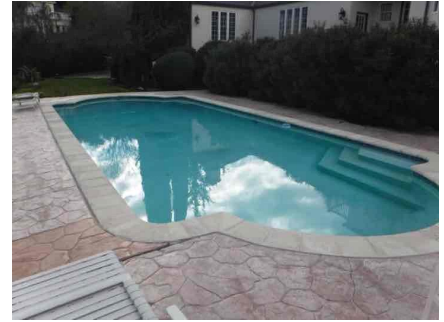
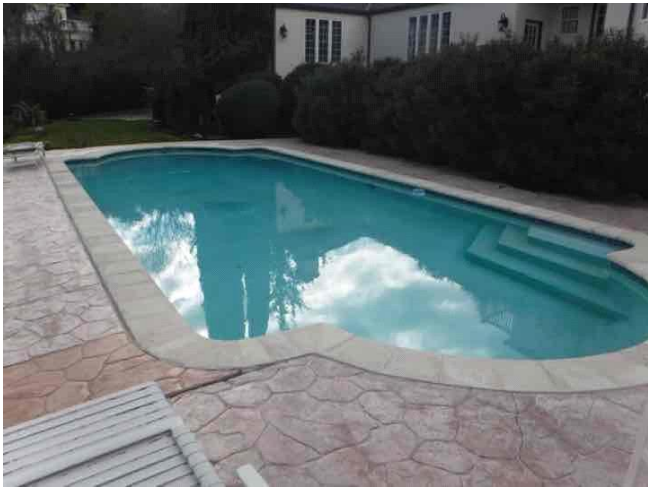
Photo 19

13. Less than two drowning prevention safety features were noted. State law requires that during the course of our inspection we observe at least two of seven drowning prevention safety features outlined in the Health and Safety Code.

The owner is advised to contact the appropriate trades to rectify this condition.

! 12. Less than two drowning prevention safety features were noted. State law requires that during the course of our inspection we observe at least two of seven drowning prevention safety features outlined in the Health and Safety Code.

The owner is advised to contact the appropriate trades to rectify this condition. (See Photo 19)

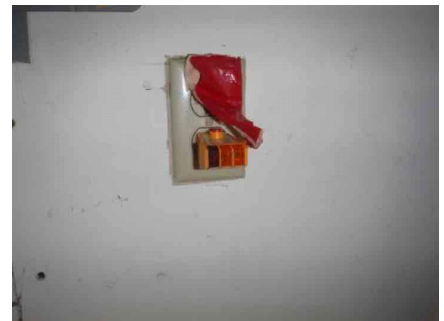
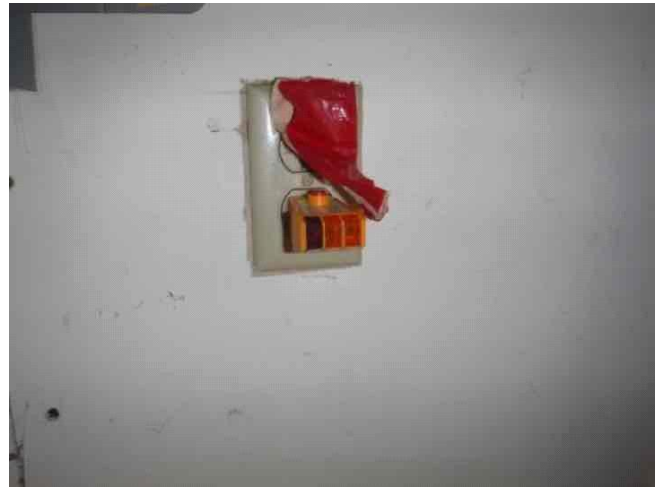
Photo 14

14. One or more outlets at the garage were inoperative at the time of our inspection. Possibly due to turned off switches which were not located during our inspection. These outlets and circuits should be investigated and corrected as necessary. Based upon our inspection of a representative number of outlets, we recommend testing of every outlet at a later date. Repairs or rewiring are recommended at all deficient locations. (See Photo 14)

- ! 1. One or more outlets at the garage were inoperative at the time of our inspection. Possibly due to turned off switches which were not located during our inspection. These outlets and circuits should be investigated and corrected as necessary. Based upon our inspection of a representative number of outlets, we recommend testing of every outlet at a later date. Repairs or rewiring are recommended at all deficient locations. (See Photo 14)

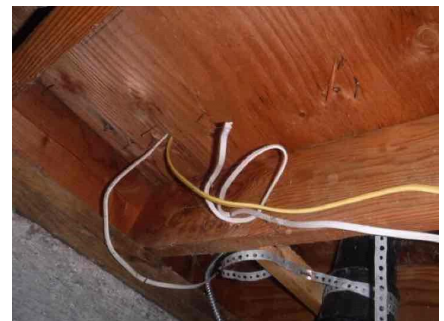
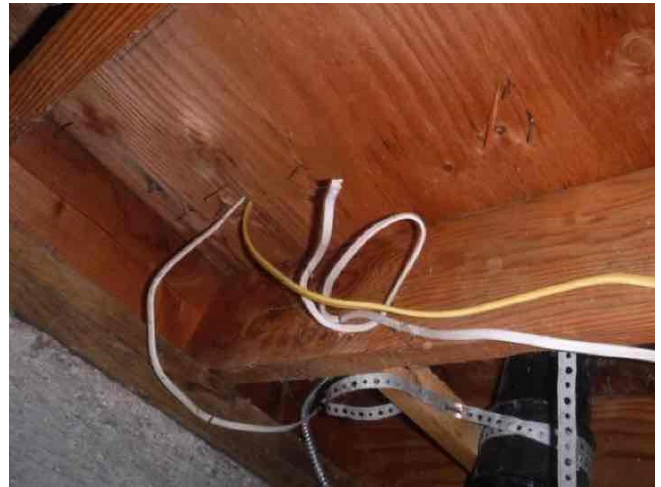
Photo 20

15. Abandoned wiring was noted in the crawlspace under the master bathroom. We recommend the wiring be disconnected at its source or terminated in an approved manner in a covered junction box. (See Photo 20)

- ! 2. Abandoned wiring was noted in the crawlspace under the master bathroom. We recommend the wiring be disconnected at its source or terminated in an approved manner in a covered junction box. (See Photo 20)

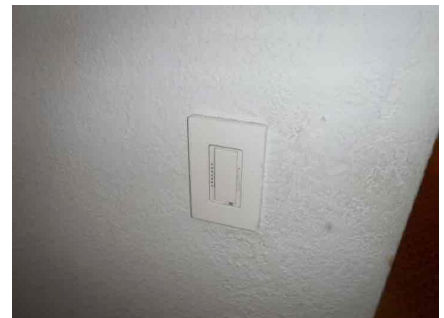
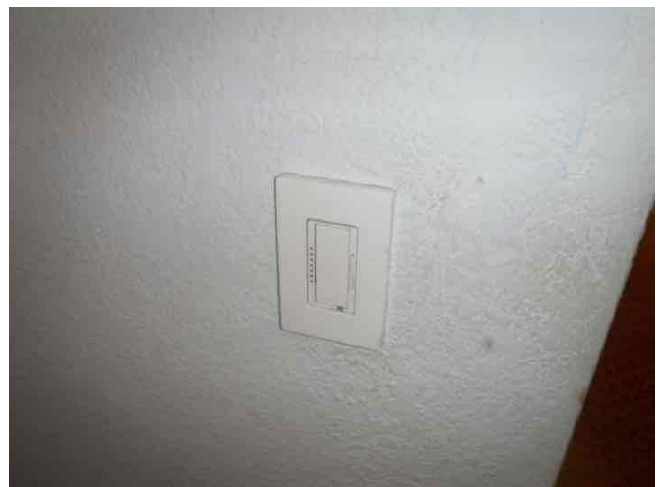
Photo 12

16. A switch at the master bedroom is faulty or damaged. We recommend it be replaced. (See Photo 12)

- ! 3. A switch at the master bedroom is faulty or damaged. We recommend it be replaced. (See Photo 12)
4. The accessible aluminum connectors inside the electrical main and/or branch panel are lacking the application of an anti-oxidant. We recommend that each accessible connection be covered with an anti-oxidant.

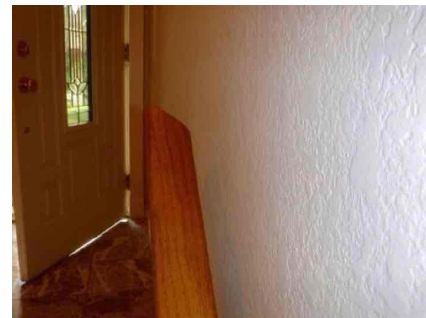
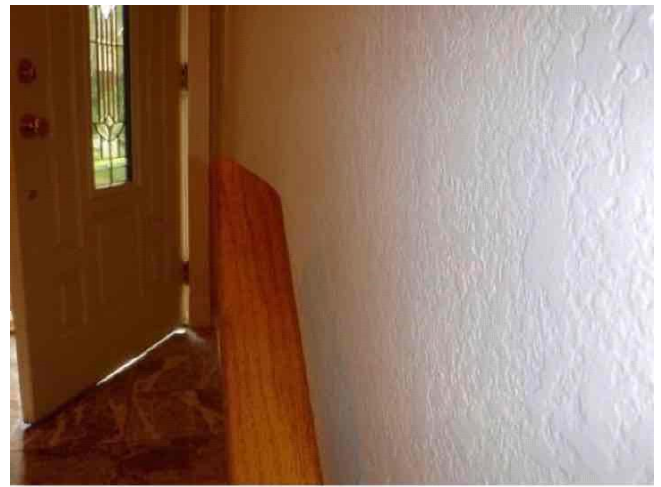
Photo 22

17. The ends of the railing at the interior staircase should return or connect to the wall. This will eliminate any loose clothing or straps from hanging up on the ends of the railing. It is recommended that this condition be corrected for improved safety. (See Photo 22)

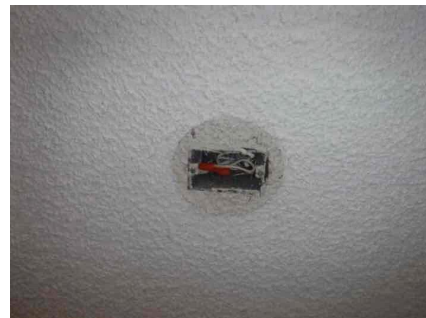
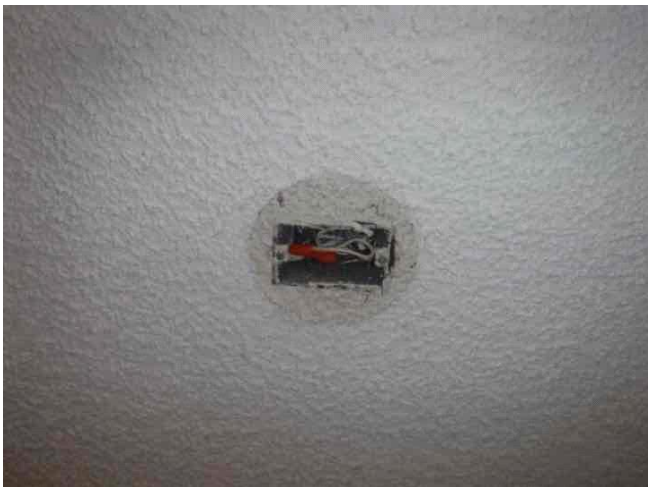
Photo 21

18. The installation of smoke detectors where missing or removed is required for added safety. (See Photo 21)

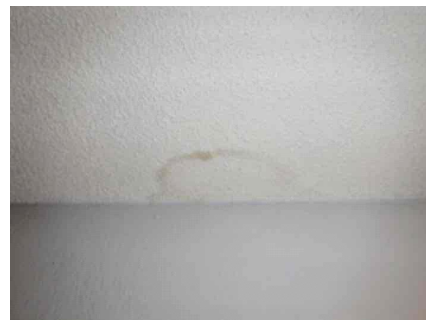
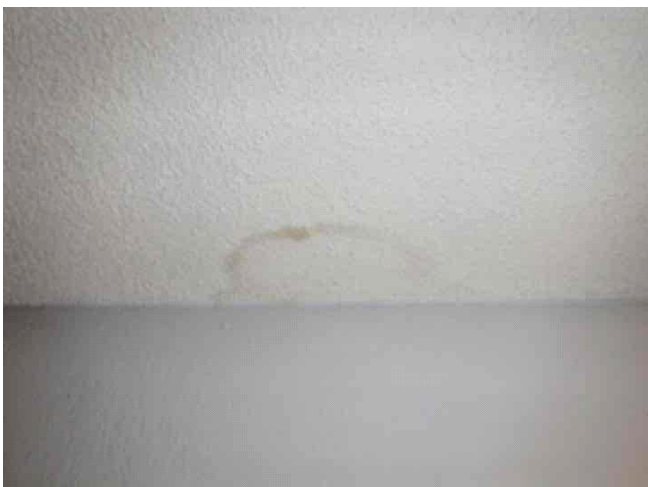
Photo 11

19. The ceiling at the master bedroom shows evidence of water stains. It is recommended that the source of these stains be identified and corrected and the surface be refinished. (See Photo 11)

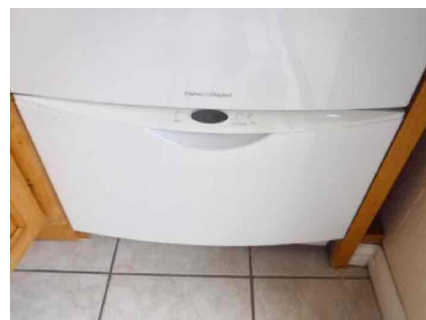
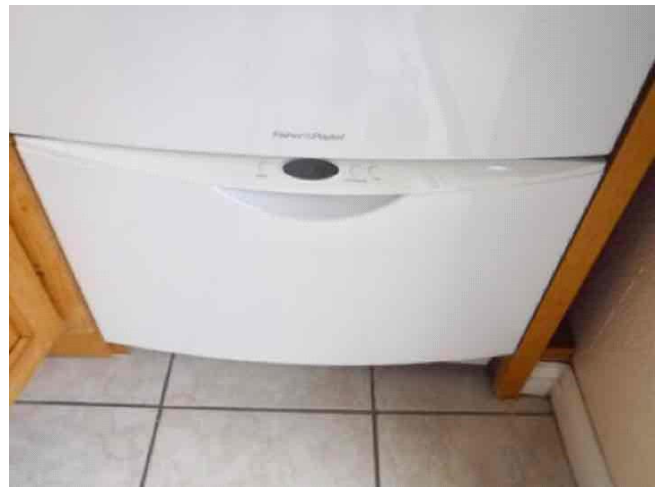
Photo 10

20. At the time of our inspection the lower dishwasher was inoperative or did not respond to normal operating controls. For attention to the conditions noted and/or cost estimates, if necessary, we recommend the advice of a qualified appliance technician. (See Photo 10)

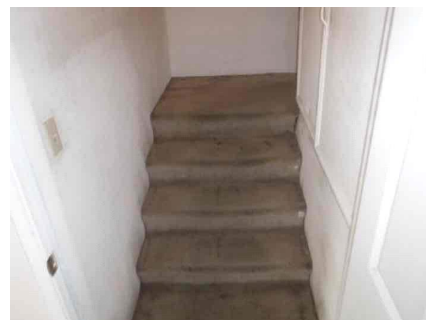
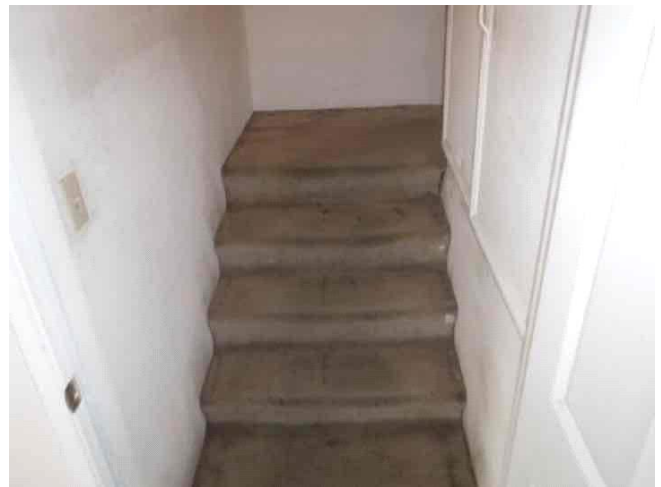
Photo 16

21. There is no hand railing where needed at the garage staircase. For improved safety, it is recommended that appropriate railing be installed. (See Photo 16)

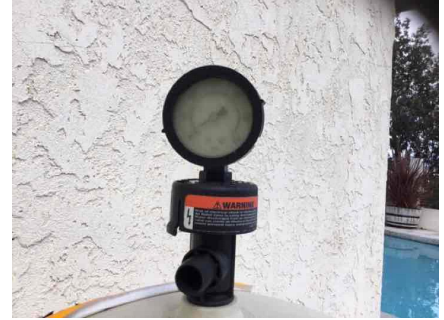
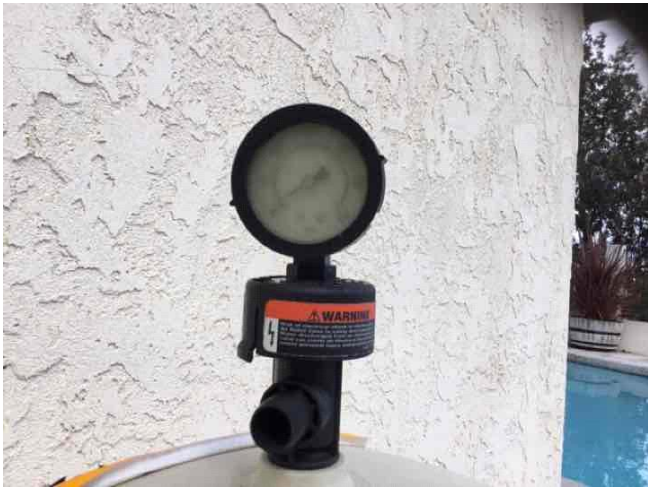
Photo 25

22. The pressure gauge was inoperative at the time of inspection. (See Photo 25)

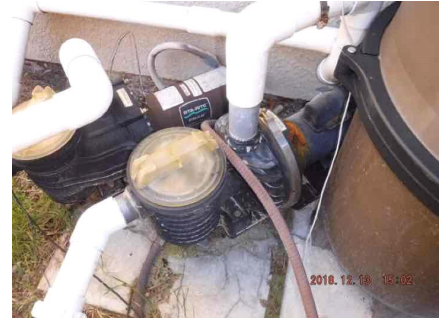
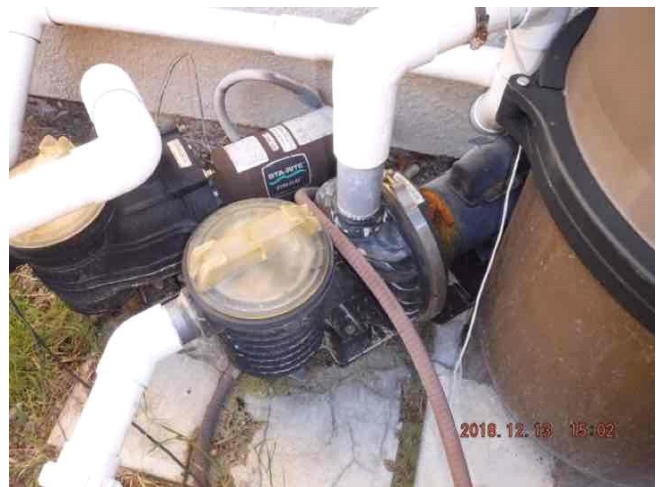
Photo 24

23. The circulation pump was not operational at the time of the inspection. A qualified licensed contractor should be consulted for further evaluation of this condition and the remedies available for correction. (See Photo 24)

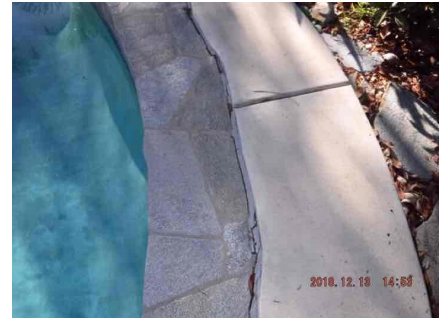
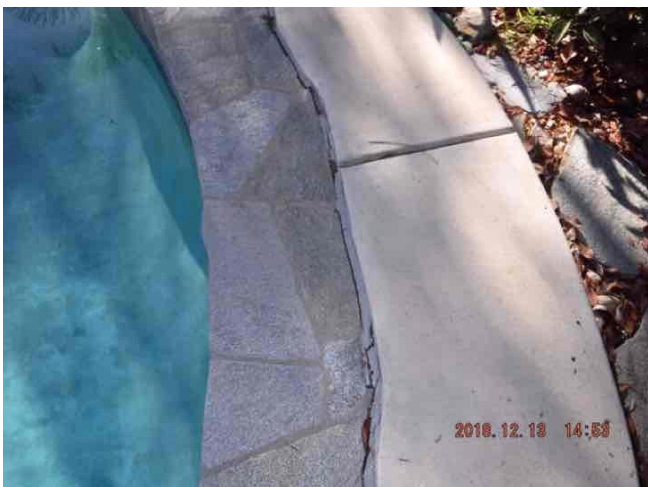
Photo 23

24. Damage was observed at the pool coping or adjacent concrete flatwork. We recommend repair. (See Photo 23)

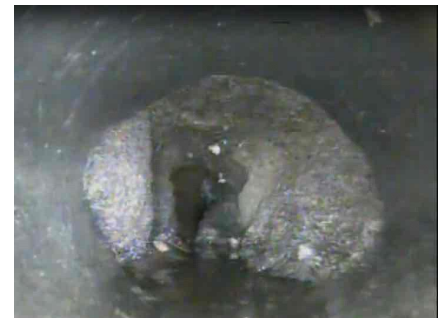
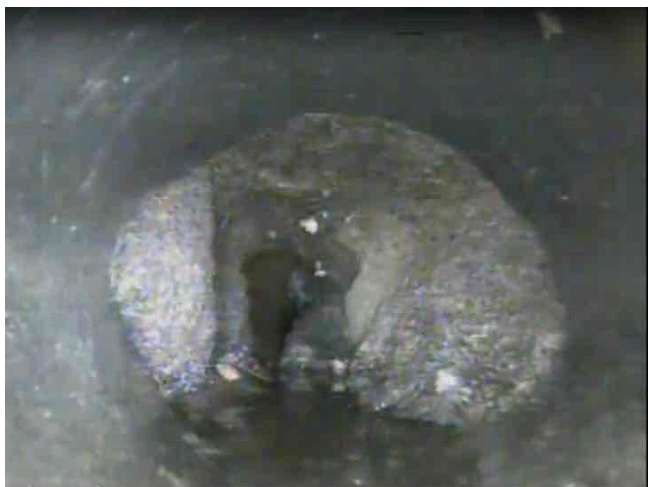
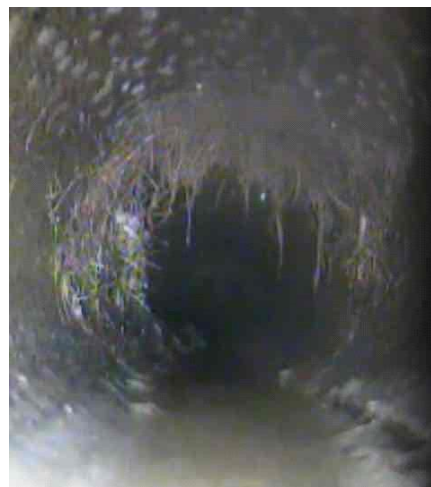
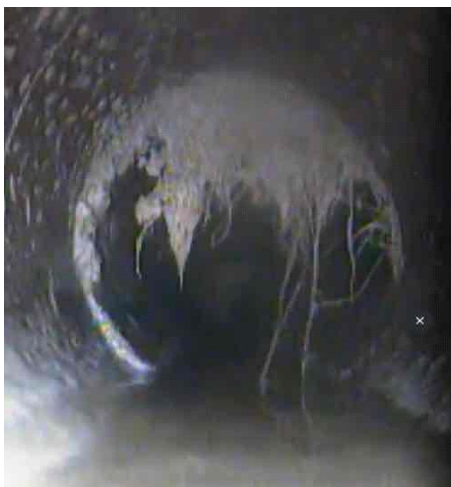
Photo 27

25. Large amounts of tree roots were found entering the sewer line. We recommend these be removed immediately before stoppage in the system occurs. (See Photo 27) (See Photo 28) (See Photo 29)

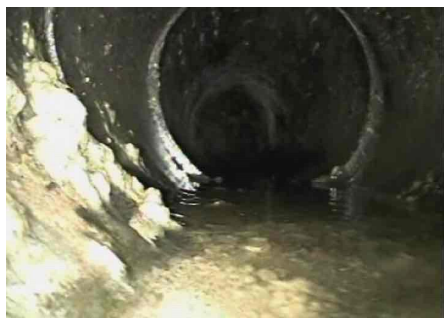
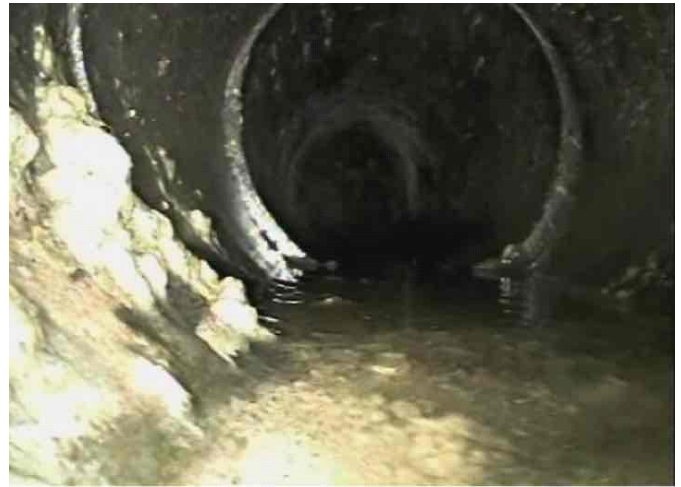
Photo 26

26. There are areas of the piping that have shifted. We recommend repairs be made to these areas to prevent further damage or stoppage from developing in the line. (See Photo 26)
