WOOD DESTROYING PESTS AND ORGANISM INSPECTION REPORT

Building No. 2623	Street Anywhere Street	City Hometown	ZIP 99999	Date of Inspection 1/11/2022	Number of Pages Page 1 of 14
<div style="display: flex; align-items: center;"><div style="flex: 1;">

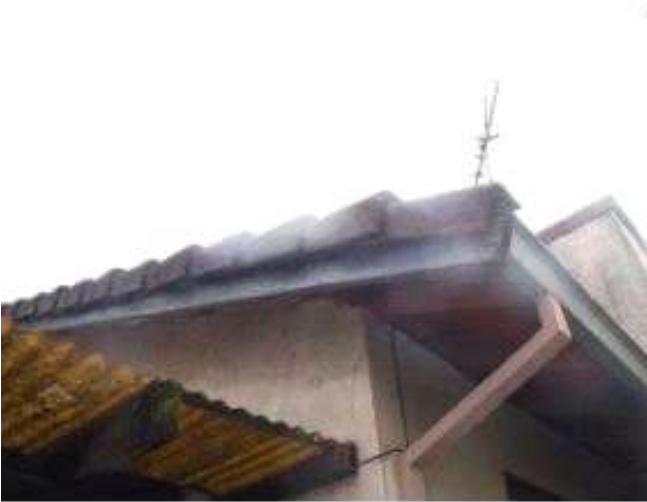
Picture 1

- 1A.** FINDING: The barge rafter(s) as indicated on the diagram are damaged by fungus. The contributing moisture source appears to be exposure to the weather. (See Picture 1)

RECOMMENDATION: Remove and replace a section of the damaged barge rafter(s) to correct this condition. This bid includes repair of the roof covering if disturbed by our repairs. If existing gutters need to be removed to perform the repairs then our bid also includes reinstallation of original gutters. If it becomes necessary or desirable to install new gutters this will be done only if authorized and at an additional cost. The guarantees on the roof covering are limited to the areas where the work was performed. Owner to open the wall, repair the plumbing leak and remove and replace the damaged wood members. Before installing
***** (SECTION 1 ITEM) *****

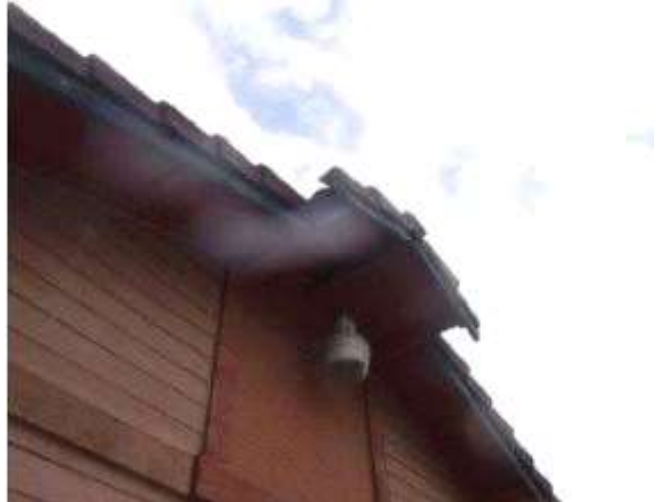
Picture 2

- 1F.** FINDING: The rafter tail ends at the area indicated on the diagram are damaged by fungus. The contributing moisture source appears to be exposure to the weather. (See Picture 2) (See Picture 3) (See Picture 12) (See Picture 23) (See Picture 25)

RECOMMENDATION: Cut off and omit approximately 2 to 3 inches from all of the rafter tail ends in this area, and dispose of same. Paint end of rafters with one coat of primer.

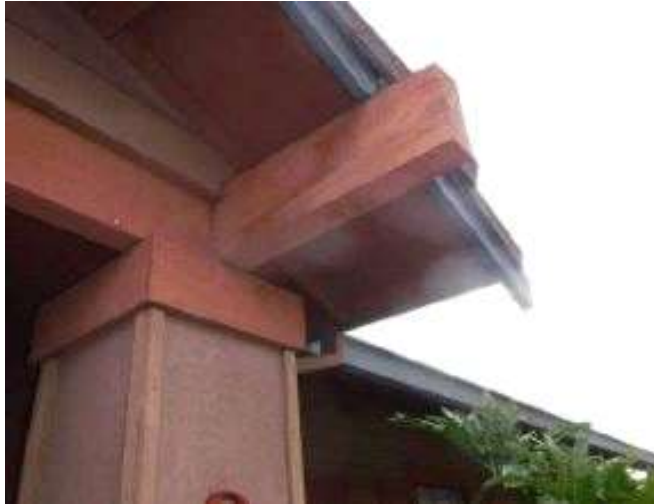
Picture 4

- 1H.** FINDING: The decorative beam end(s) at the area indicated on the diagram are damaged by fungus. (See Picture 4)

RECOMMENDATION: Cut back and remove approximately 10 to 12 inches from the end of the beams to correct this condition. Paint end of beam with one coat of primer. The contributing moisture source appears to be exposure to the weather.

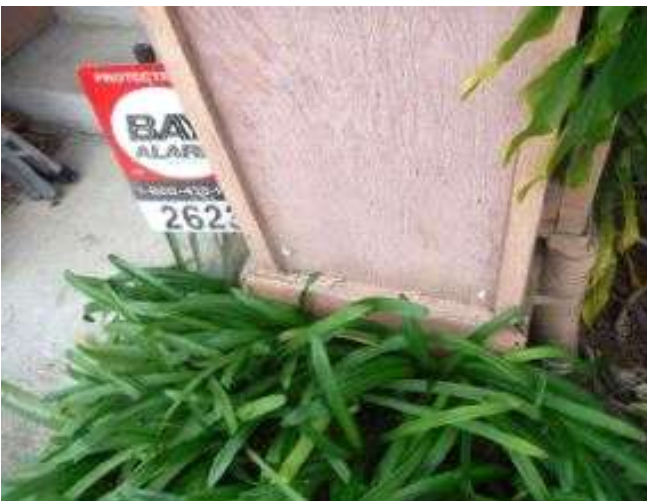
Picture 5

1N. FINDING: Infestation by Drywood Termites was noted at the exterior and subarea. (See Picture 5) (See Picture 16) (See Picture 17) (See Picture 23) (See Picture 26)

10. FINDING: Drywood termite pellets were evident as noted in the above recommendation. (See Picture 5) (See Picture 16) (See Picture 17) (See Picture 23) (See Picture 26)

RECOMMENDATION: Due to the nature of these infestations, it will be necessary to seal the entire structure and fumigate it with Vikane (sulfuryl fluoride), using Chloropicrin as a warning agent. The entire structure must be vacant for this process. It is the owners responsibility to make any preparations required by the fumigators or to have someone to do so at a separate expense and to have the gas turned back on when the fumigation is complete. "NOTICE: The charge for service that this company subcontracts to another registered company may include the company's charges for arranging and administering such services that are in addition to the direct costs associated with paying the subcontractor. You may accept HomeGuard Incorporated's bid or you may contract directly with another registered company licensed to perform the work.

RECOMMENDATION: Remove and/or mask over all accessible termite pellets. It is possible for the drywood termite pellets to sift down or reappear in these areas where they have been masked over.

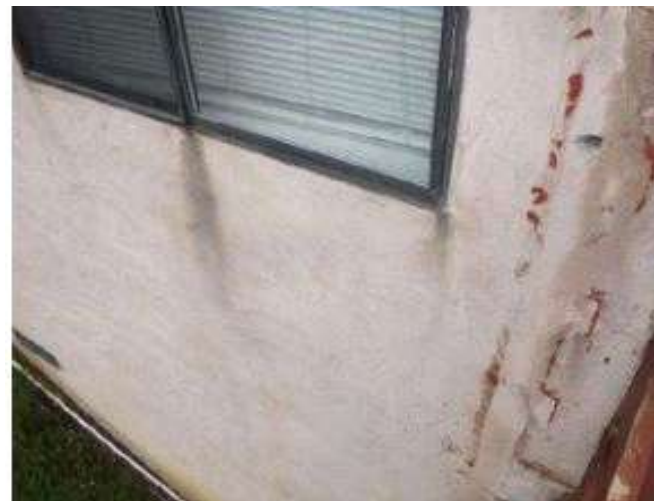
Picture 6

3A. FINDING: The exterior stucco wall at the area indicated on the diagram was noted to be bulging or is uneven (See Picture 6)

RECOMMENDATION: Install test holes in the stucco to allow for further inspection. All findings recommendations and bids will be issued in a supplemental report. The above bid does not include any damage that may be found after the further inspection has been performed however this bid does include patching the stucco holes matching as close as possible the existing texture. HomeGuard will apply one coat of primer paint to the repaired area .

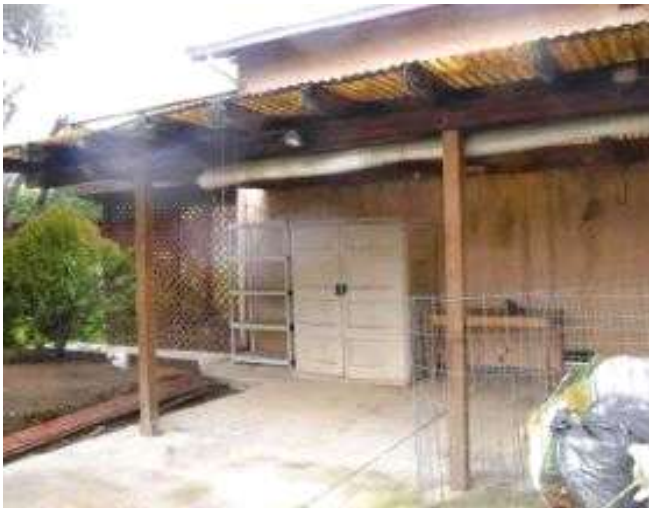
Picture 7

- 1I.** FINDING: The overhang has been damaged by fungus at the area indicated on the diagram. (See Picture 7)

RECOMMENDATION: Remove and omit the entire overhang. If damage is found to extend into any enclosed areas we will issue a supplemental report and bid.

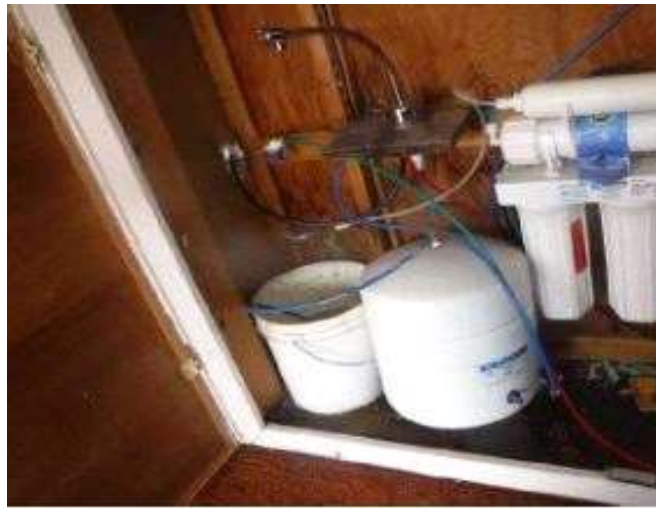
Picture 8

- 1J.** FINDING: There is a plumbing leak at the water filtration system. (See Picture 8)

RECOMMENDATION: The owner should have a licensed plumber repair the leakage. All guarantees desired should be secured from the persons or firm that performed the repairs.

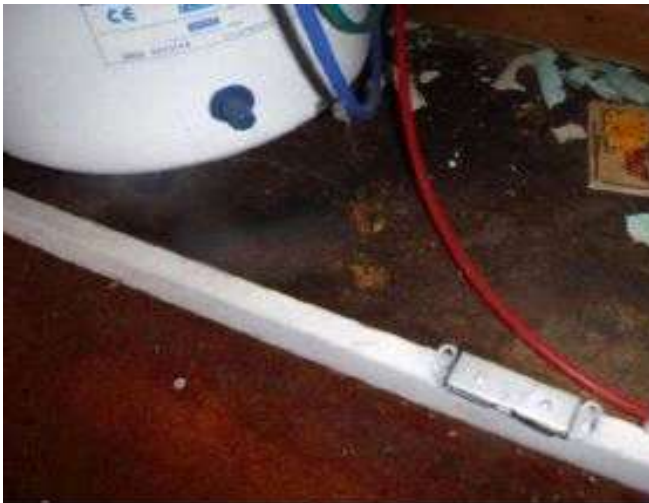
Picture 9

- 1K.** FINDING: The shelving has been damaged by fungus at the garage water filtration stand. The contributing moisture source appears to be exposure to the weather. (See Picture 9) (See Picture 10)

RECOMMENDATION: Remove and replace all the damaged wood members. If any damage is found to extend into any enclosed areas a supplemental report and bid will be issued.

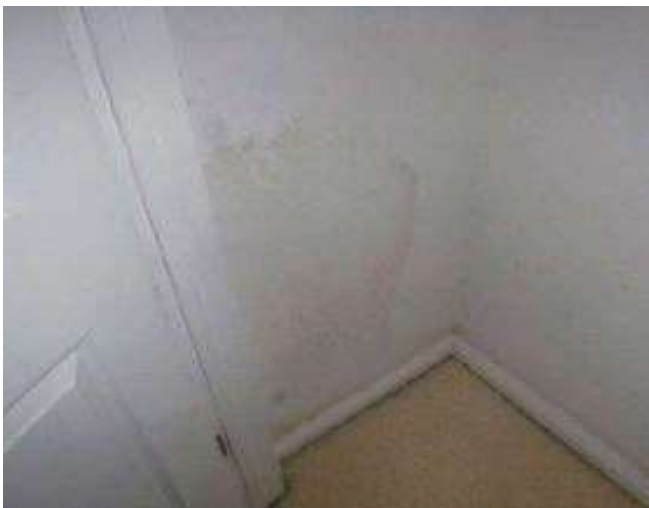
Picture 11

3B. FINDING: The sheetrock at the interior closet was found to be damaged by excessive moisture. (See Picture 11)

RECOMMENDATION: Remove the sheetrock in this area to allow for further inspection. Issue a supplemental report with all findings and bids. Note: If no additional findings are made HomeGuard will reinstall sheetrock in this area. Note this bid includes one coat of primer.

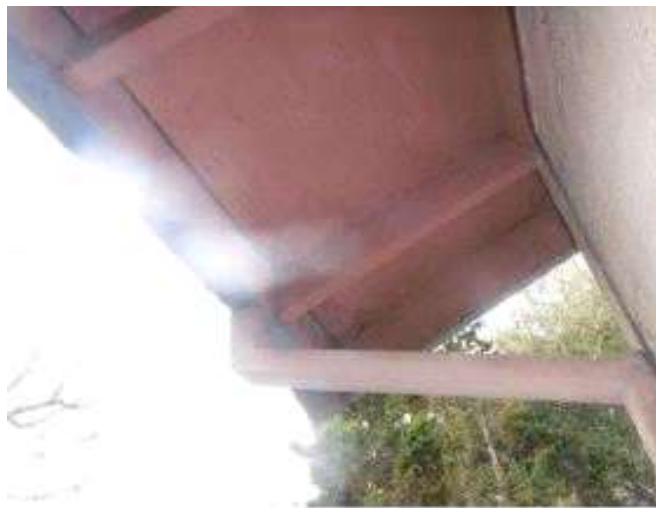
Picture 12

- 1B.** FINDING: The roof sheathing as indicated on the diagram is damaged by fungus. The contributing moisture source appears to have been caused by a failure of the roof covering. (See Picture 12) (See Picture 20)

RECOMMENDATION: Remove and replace the damaged wood members to correct this condition. This bid includes repair of the roof covering if disturbed by our repairs. If existing gutters need to be removed to perform the repairs then our bid also includes reinstallation of original gutters. If it becomes necessary or desirable to install new gutters this will be done only if authorized and at an additional cost. The guarantees on the roof covering are limited to the areas where the repairs were performed.
***** (SECTION 1 ITEM) *****

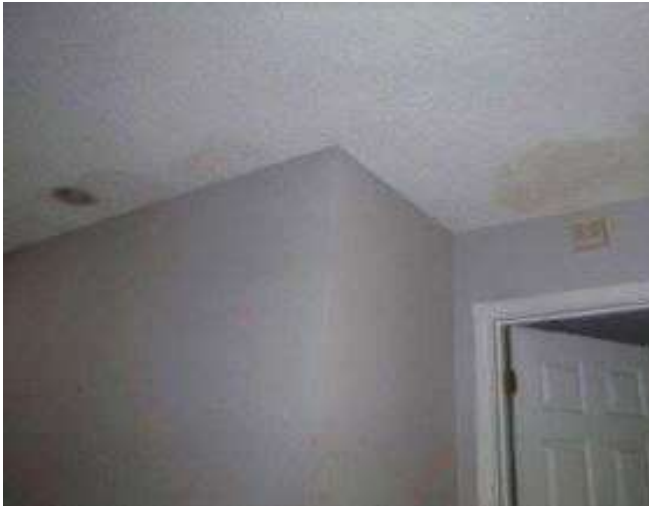
Picture 13

3C. FINDING: Water stains were noted on the acoustic ceiling in the areas indicated on the diagram. (See Picture 13) (See Picture 14)

RECOMMENDATION: The owner is to open this area. When requested HomeGuard Incorporated will return to perform a further inspection to determine the source of these stains and if damage exists. All findings, recommendations, and bids will be issued in a supplemental report.

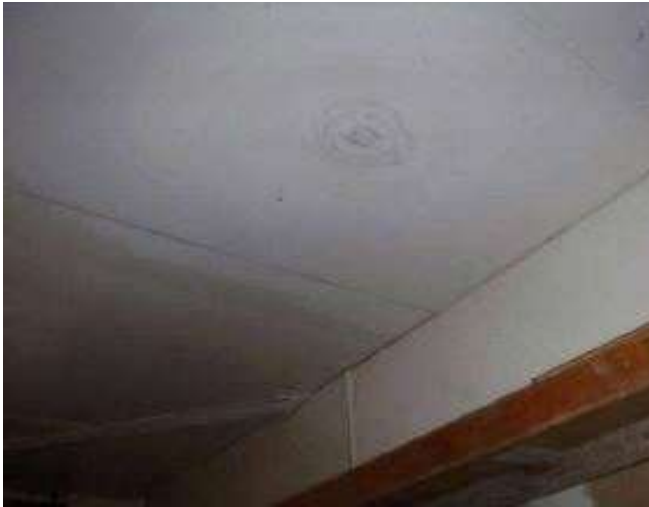
Picture 15

3D. FINDING: The sheetrock on the ceiling in the garage was found to be stained. (See Picture 15)

RECOMMENDATION: Remove sheetrock in this area to allow for further inspection. All findings, *Estimated Cost* recommendations, and bids will be issued in a supplemental report. If no additional findings are made HomeGuard will reinstall sheetrock in this area.

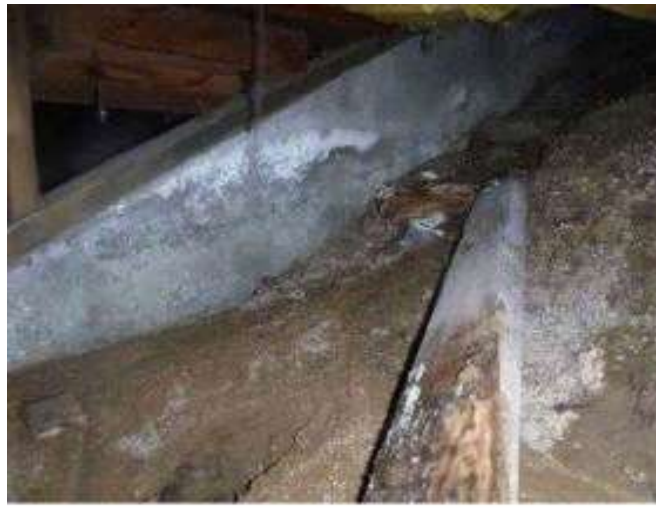
Picture 18

- 1L.** FINDING: There is evidence of a subterranean termite infestation in the substructure area soil. (See Picture 18) (See Picture 19)

1M. FINDING: There is fungus infected and subterranean termite infested cellulose debris in earth contact in the substructure area. (See Picture 18)

RECOMMENDATION: Treat the affected areas with Termidor HE (Fipronil: 5-amino-1-(2,6-dichloro-4-(trifluoromethyl) phenyl)-4-((1R,S)-trifluoromethyl)sulfinyl)-1H-pyrazole-3-carbonitrile and break down and brush away all subterranean termite migratory tubes.. NOTE: In order to perform this treatment the property must be vacated during the treatment and three hours after the treatment is performed.

RECOMMENDATION: Remove cellulose debris of a size that can be raked from the substructure area.

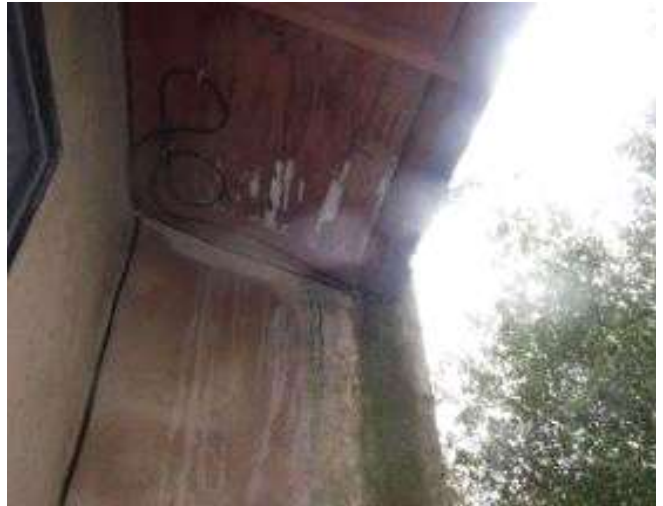
Picture 20

- 1C.** FINDING: The rafter tail(s) as indicated on the diagram are damaged by fungus. The contributing moisture source appears to be exposure to the weather. (See Picture 20)

RECOMMENDATION: Remove and replace the end of the damaged rafter tail(s) and install a new sister section alongside for support.
***** (SECTION 1 ITEM) *****

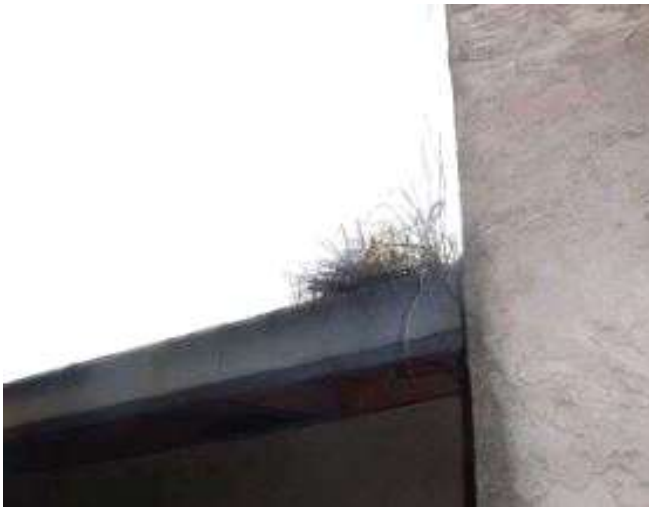
Picture 21

- 1D.** FINDING: The rain gutters and downspouts appear to be leaking and/or clogged where indicated on the diagram (See Picture 21)

RECOMMENDATION: Clean and/or repair the gutters or downspouts as needed.
***** (SECTION 1 ITEM) *****

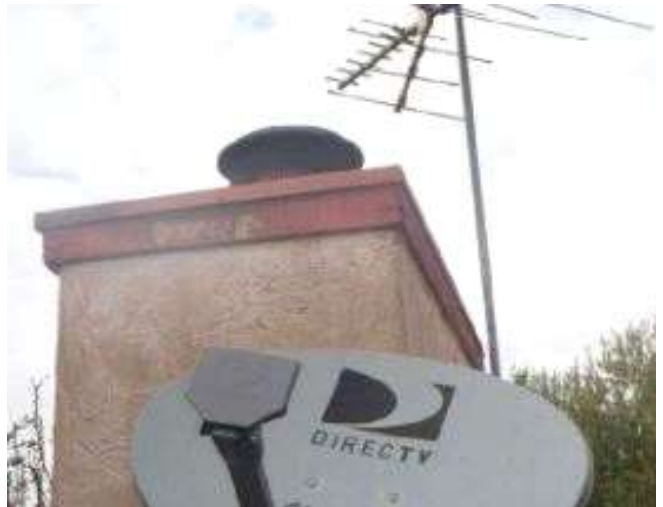
Picture 22

- 1E.** FINDING: The trim has been damaged by fungus and drywood termites at the area indicated on the diagram. The contributing moisture source appears to be exposure to the weather. (See Picture 22) (See Picture 26)

RECOMMENDATION: Remove and replace all the damaged wood members. If any damage is found to extend into any enclosed areas a supplemental report and bid will be issued.

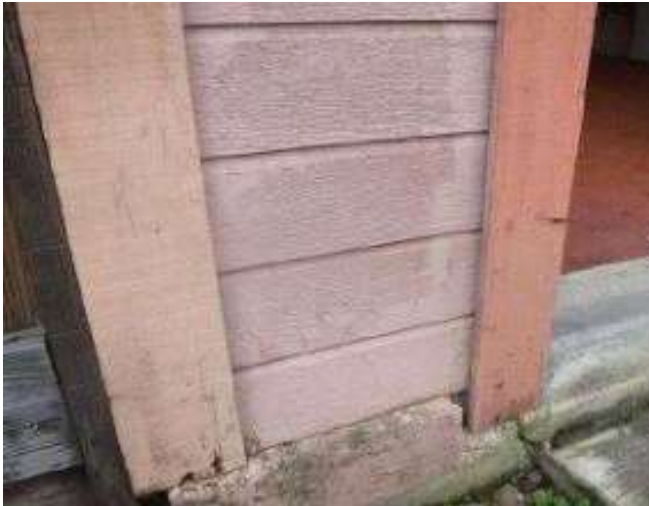
Picture 26

- 1G.** FINDING: The siding has been damaged by fungus at the area indicated on the diagram. The contributing moisture source appears to be exposure to the weather. (See Picture 26)

RECOMMENDATION: Remove and replace all the damaged wood members. If any damage is found to extend into any enclosed areas a supplemental report and bid will be issued.
