HealthyHome Maintenance Checkup Inspection Report

2623 Anywhere Street, Hometown

Travis Palsler
May 23, 2024

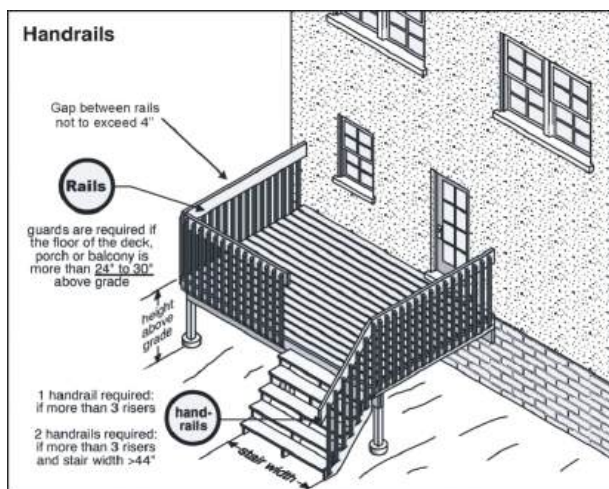
Illustration 3N

- ! 2. The openings in the exterior staircase railing(s) are larger than 4" inches. It is recommended that this be corrected for improved safety. Estimated costs for similar repairs range from \$400 - \$800. Actual repair costs may vary based on specific conditions. (See Illustration 3N) (See Photo 1)

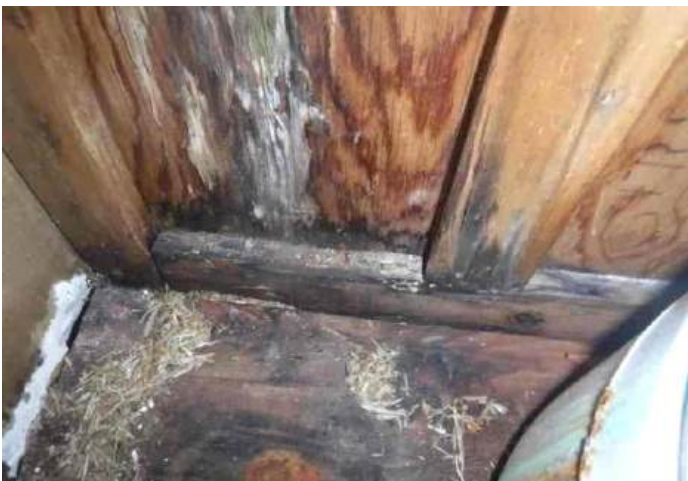
Photo 05

- ! 4. The base and/or side of the water filtration cabinet sink shelf is water damaged. Please refer to WDO Report #637502. (See Photo 5)

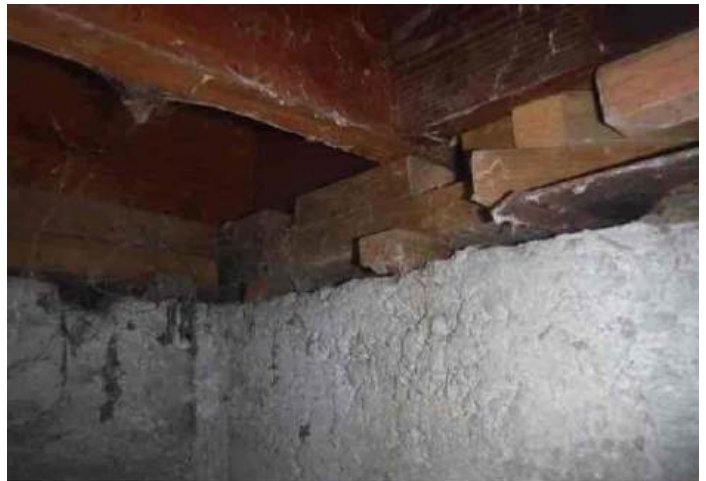
Photo 06

1. Portions of the structure have been leveled by shimming the mudsill. This is an indication of past movement in the foundation but, in this case, the shimming is minor. If further information is desired in regards to this condition the appropriate tradesperson should be contacted. (See Photo 6)

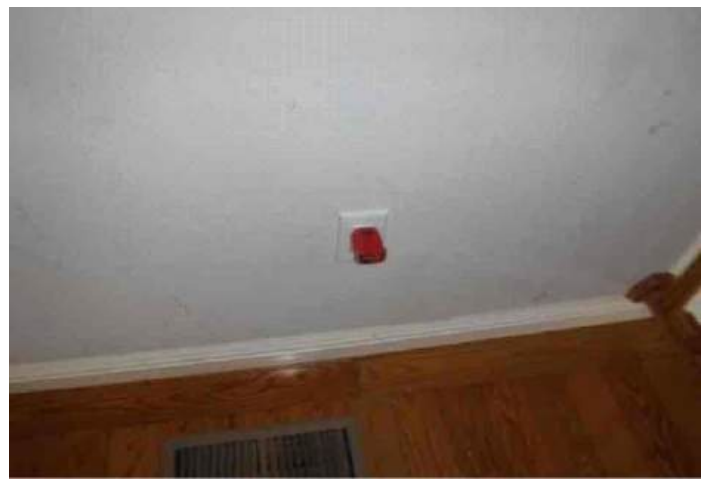
Photo 08

- ! 1. One or more outlets at the left bedroom were inoperative at the time of our inspection. Possibly due to turned off switches which were not located during our inspection. These outlets and circuits should be investigated and corrected as necessary. Based upon our inspection of a representative number of outlets, we recommend testing of every outlet at a later date. Repairs or rewiring are recommended at all deficient locations. Estimated costs for similar repairs range from \$200 - \$400. Actual repair costs may vary based on specific conditions. (See Photo 8)

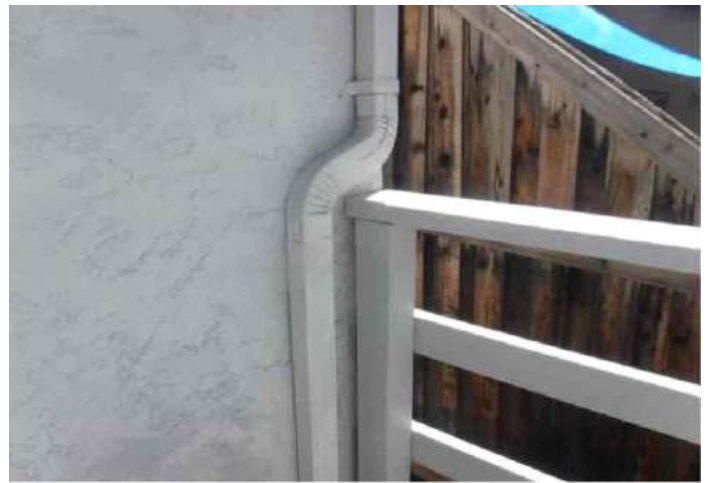
Photo 10

- ! 1. The railing is loose at the balcony. It is recommended that this be repaired for improved safety. Estimated costs for similar repairs range from \$300 - \$600. Actual repair costs may vary based on specific conditions. (See Photo 10)

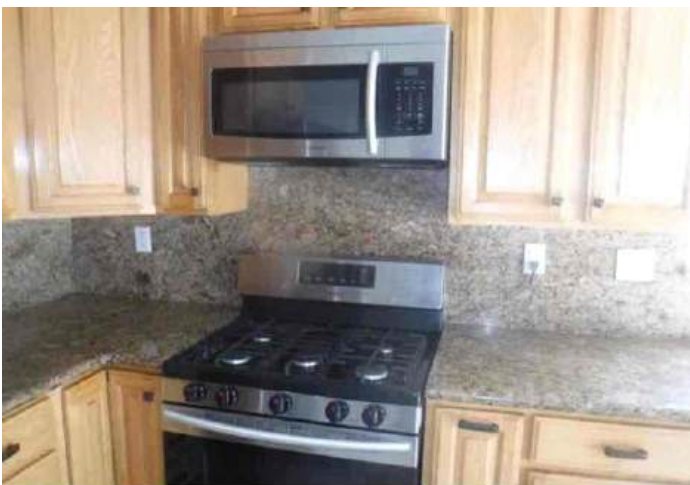
Photo 11

- ! 7. There is no "exterior vented" exhaust fan for the gas appliances installed in the kitchen. It is recommended that all gas appliances be vented to the exterior. (See Photo 11)
