WOOD DESTROYING PESTS AND ORGANISM INSPECTION REPORT

Building No. 2623	Street Anywhere Street	City Hometown	ZIP 99999	Date of Inspection 1/11/2022	Number of Pages Page 1 of 14

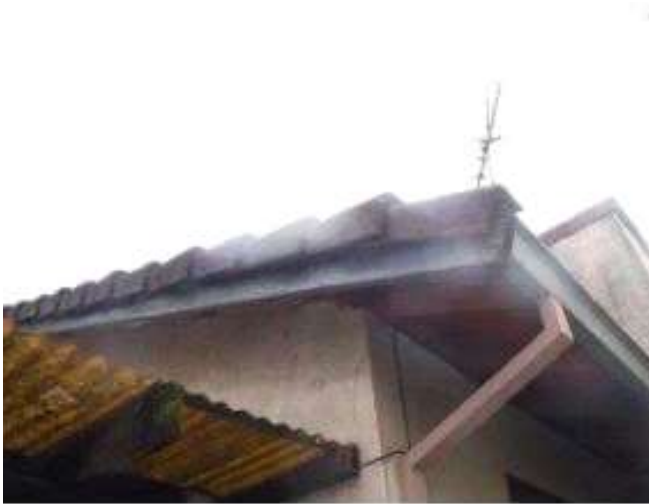
Picture 1

1A. FINDING: The barge rafter(s) as indicated on the diagram are damaged by fungus. The contributing moisture source appears to be exposure to the weather. (See Picture 1)

RECOMMENDATION: Remove and replace a section of the damaged barge rafter(s) to correct this condition. This bid includes repair of the roof covering if disturbed by our repairs. If existing gutters need to be removed to perform the repairs then our bid also includes reinstallation of original gutters. If it becomes necessary or desirable to install new gutters this will be done only if authorized and at an additional cost. The guarantees on the roof covering are limited to the areas where the work was performed. Owner to open the wall, repair the plumbing leak and remove and replace the damaged wood members. Before installing
***** (SECTION 1 ITEM) *****

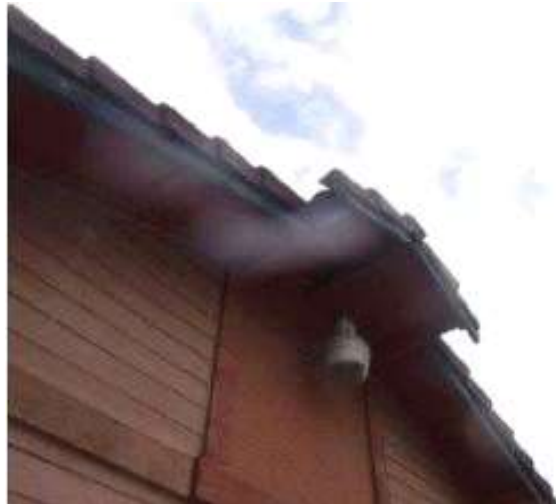
Picture 2

1F. FINDING: The rafter tail ends at the area indicated on the diagram are damaged by fungus. The contributing moisture source appears to be exposure to the weather. (See Picture 2) (See Picture 3) (See Picture 12) (See Picture 23) (See Picture 25)

RECOMMENDATION: Cut off and omit approximately 2 to 3 inches from all of the rafter tail ends in this area, and dispose of same. Paint end of rafters with one coat of primer.

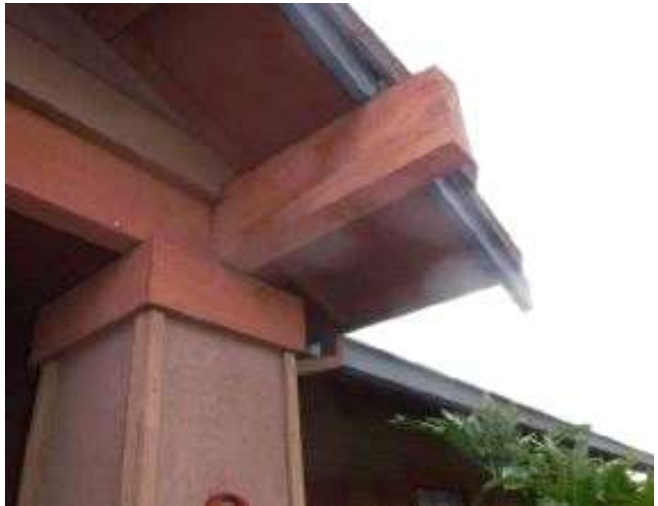
Picture 4

1H. FINDING: The decorative beam end(s) at the area indicated on the diagram are damaged by fungus. (See Picture 4)

RECOMMENDATION: Cut back and remove approximately 10 to 12 inches from the end of the beams to correct this condition. Paint end of beam with one coat of primer. The contributing moisture source appears to be exposure to the weather.

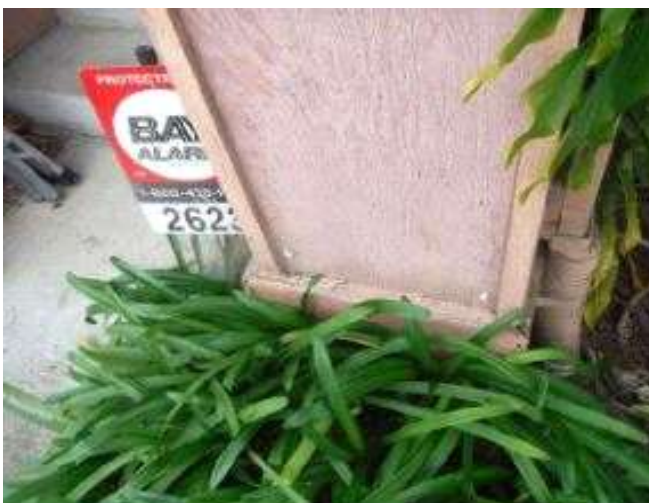
Picture 5

1N. FINDING: Infestation by Drywood Termites was noted at the exterior and subarea. (See Picture 5) (See Picture 16) (See Picture 17) (See Picture 23) (See Picture 26)

10. FINDING: Drywood termite pellets were evident as noted in the above recommendation. (See Picture 5) (See Picture 16) (See Picture 17) (See Picture 23) (See Picture 26)

RECOMMENDATION: Due to the nature of these infestations, it will be necessary to seal the entire structure and fumigate it with Vikane (sulfuryl fluoride), using Chloropicrin as a warning agent. The entire structure must be vacant for this process. It is the owners responsibility to make any preparations required by the fumigators or to have someone to do so at a separate expense and to have the gas turned back on when the fumigation is complete. "NOTICE: The charge for service that this company subcontracts to another registered company may include the company's charges for arranging and administering such services that are in addition to the direct costs associated with paying the subcontractor. You may accept HomeGuard Incorporated's bid or you may contract directly with another registered company licensed to perform the work.

RECOMMENDATION: Remove and/or mask over all accessible termite pellets. It is possible for the drywood termite pellets to sift down or reappear in these areas where they have been masked over.

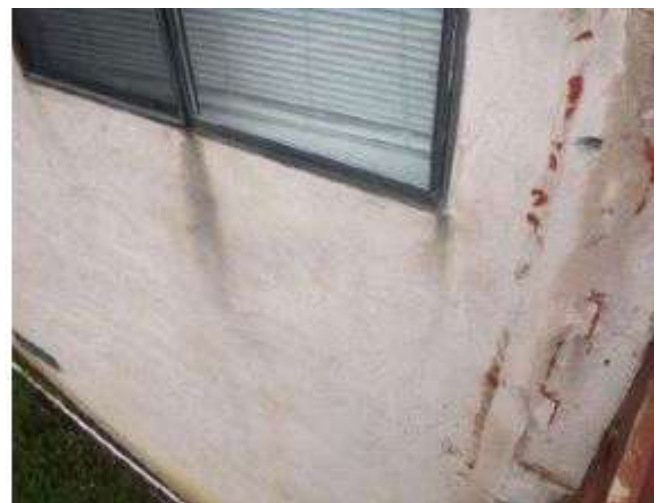
Picture 6

3A. FINDING: The exterior stucco wall at the area indicated on the diagram was noted to be bulging or is uneven ([See Picture 6](#))

RECOMMENDATION: Install test holes in the stucco to allow for further inspection. All findings recommendations and bids will be issued in a supplemental report. The above bid does not include any damage that may be found after the further inspection has been performed however this bid does include patching the stucco holes matching as close as possible the existing texture. HomeGuard will apply one coat of primer paint to the repaired area .

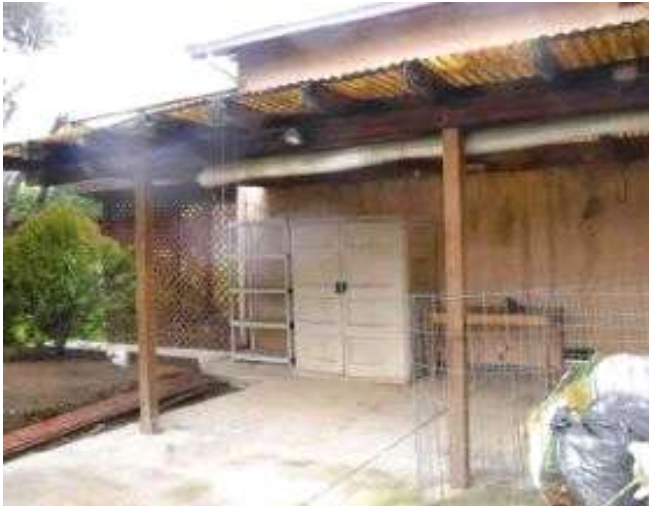
Picture 7

1I. FINDING: The overhang has been damaged by fungus at the area indicated on the diagram. (See Picture 7)

RECOMMENDATION: Remove and omit the entire overhang. If damage is found to extend into any enclosed areas we will issue a supplemental report and bid.

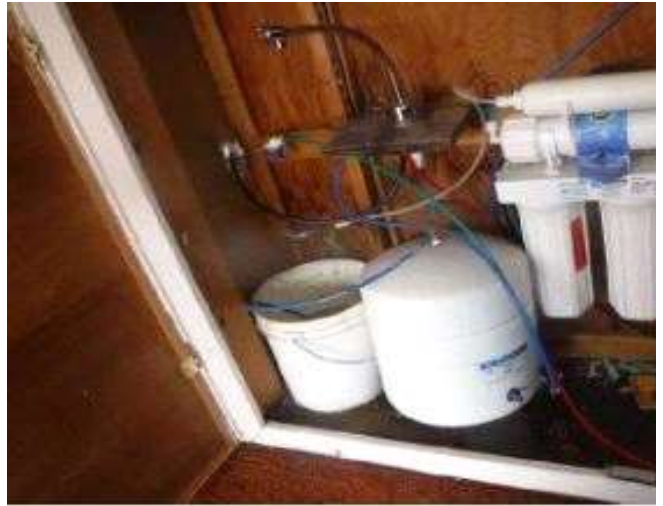
Picture 8

1J. FINDING: There is a plumbing leak at the water filtration system. (See Picture 8)

RECOMMENDATION: The owner should have a licensed plumber repair the leakage. All guarantees desired should be secured from the persons or firm that performed the repairs.

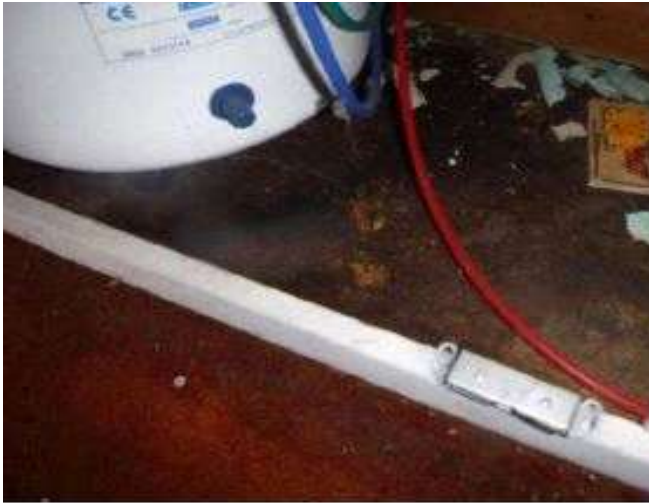
Picture 9

1K. FINDING: The shelving has been damaged by fungus at the garage water filtration stand. The contributing moisture source appears to be exposure to the weather. (See Picture 9) (See Picture 10)

RECOMMENDATION: Remove and replace all the damaged wood members. If any damage is found to extend into any enclosed areas a supplemental report and bid will be issued.

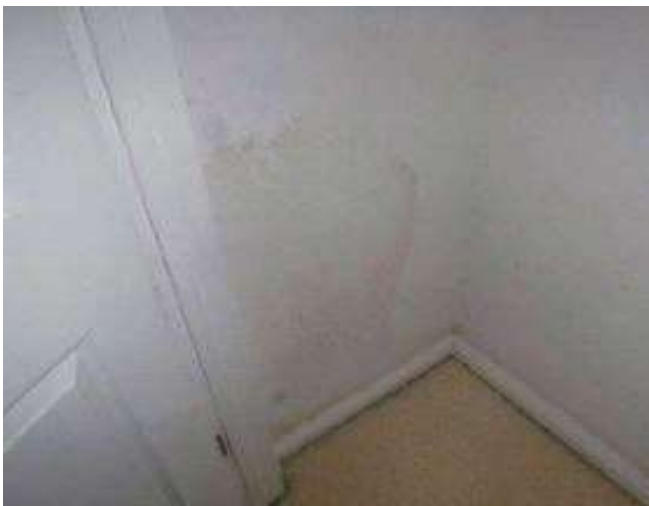
Picture 11

3B. FINDING: The sheetrock at the interior closet was found to be damaged by excessive moisture. ([See Picture 11](#))

RECOMMENDATION: Remove the sheetrock in this area to allow for further inspection. Issue a supplemental report with all findings and bids. Note: If no additional findings are made HomeGuard will reinstall sheetrock in this area. Note this bid includes one coat of primer.

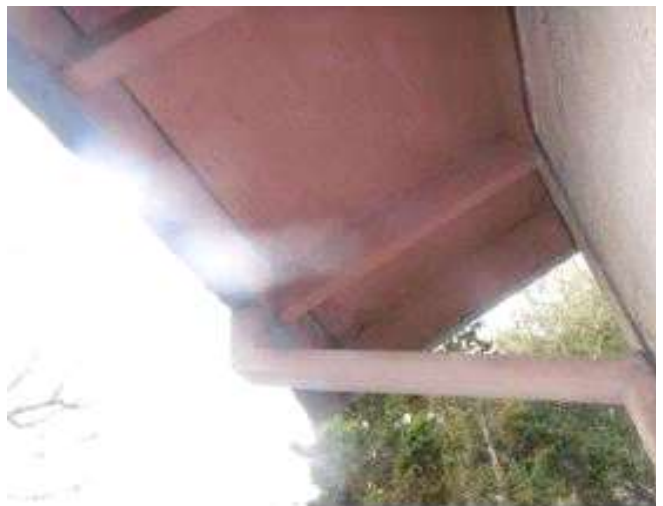
Picture 12

1B. FINDING: The roof sheathing as indicated on the diagram is damaged by fungus. The contributing moisture source appears to have been caused by a failure of the roof covering. (See Picture 12) (See Picture 20)

RECOMMENDATION: Remove and replace the damaged wood members to correct this condition. This bid includes repair of the roof covering if disturbed by our repairs. If existing gutters need to be removed to perform the repairs then our bid also includes reinstallation of original gutters. If it becomes necessary or desirable to install new gutters this will be done only if authorized and at an additional cost. The guarantees on the roof covering are limited to the areas where the repairs were performed.
***** (SECTION 1 ITEM) *****

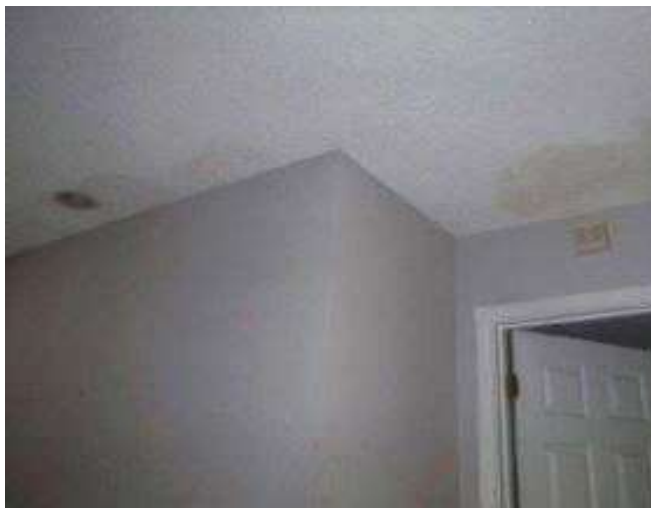
Picture 13

3C. FINDING: Water stains were noted on the acoustic ceiling in the areas indicated on the diagram. ([See Picture 13](#)) ([See Picture 14](#))

RECOMMENDATION: The owner is to open this area. When requested HomeGuard Incorporated will return to perform a further inspection to determine the source of these stains and if damage exists. All findings, recommendations, and bids will be issued in a supplemental report.

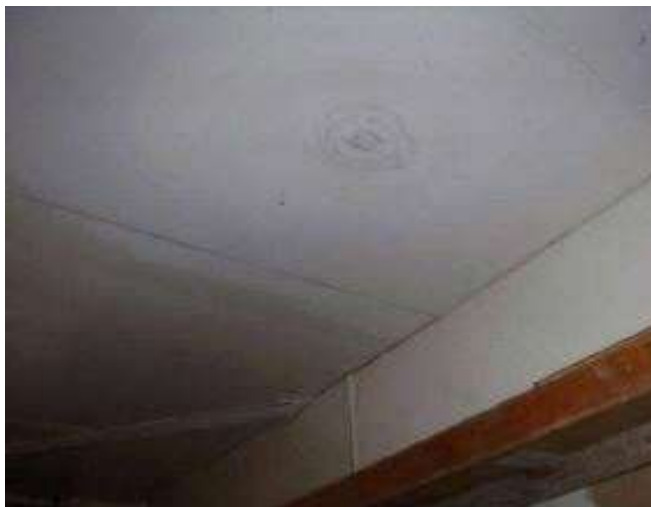
Picture 15

3D. FINDING: The sheetrock on the ceiling in the garage was found to be stained. (See Picture 15)

RECOMMENDATION: Remove sheetrock in this area to allow for further inspection. All findings, *Estimated Cost* recommendations, and bids will be issued in a supplemental report. If no additional findings are made HomeGuard will reinstall sheetrock in this area.

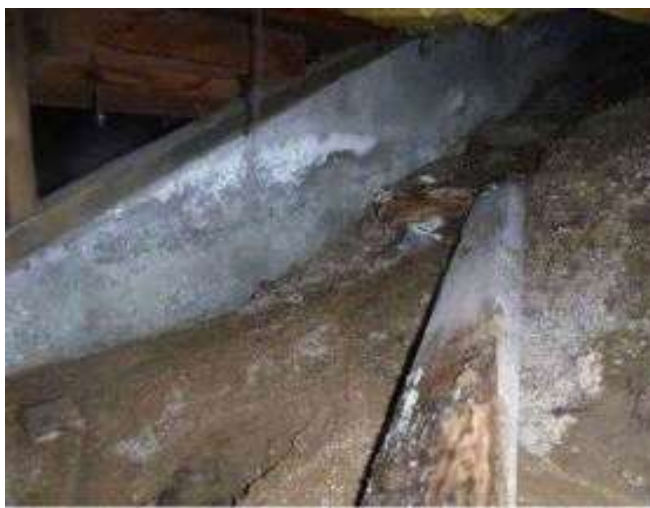
Picture 18

1L. FINDING: There is evidence of a subterranean termite infestation in the substructure area soil. (See Picture 18) (See Picture 19)

1M. FINDING: There is fungus infected and subterranean termite infested cellulose debris in earth contact in the substructure area. (See Picture 18)

RECOMMENDATION: Treat the affected areas with Termidor HE (Fipronil:5-amino-1-(2,6-dichloro-4-(trifluoromethyl) phey)-4-((1,R,S)-trifluoromethyl)sulfinyl)-1-H-pyrazole-3-carbonitrile and break down and brush away all subterranean termite migratory tubes. NOTE: In order to perform this treatment the property must be vacated during the treatment and three hours after the treatment is performed.

RECOMMENDATION: Remove cellulose debris of a size that can be raked from the substructure area.

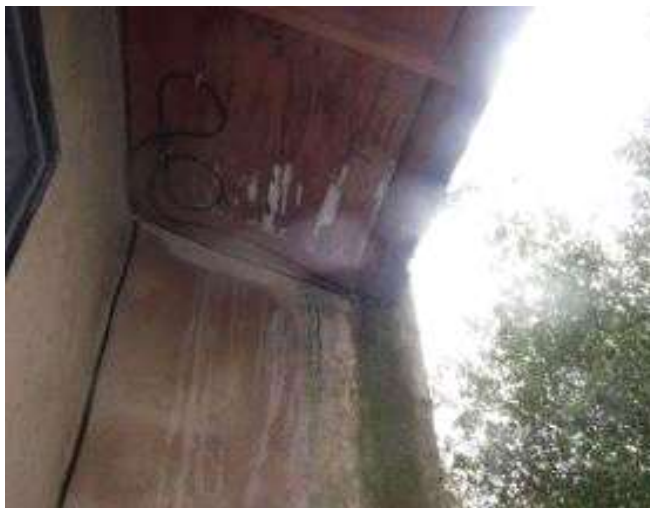
Picture 20

1C. FINDING: The rafter tail(s) as indicated on the diagram are damaged by fungus. The contributing moisture source appears to be exposure to the weather. (See Picture 20)

RECOMMENDATION: Remove and replace the end of the damaged rafter tail(s) and install a new sister section alongside for support.
***** (SECTION 1 ITEM) *****

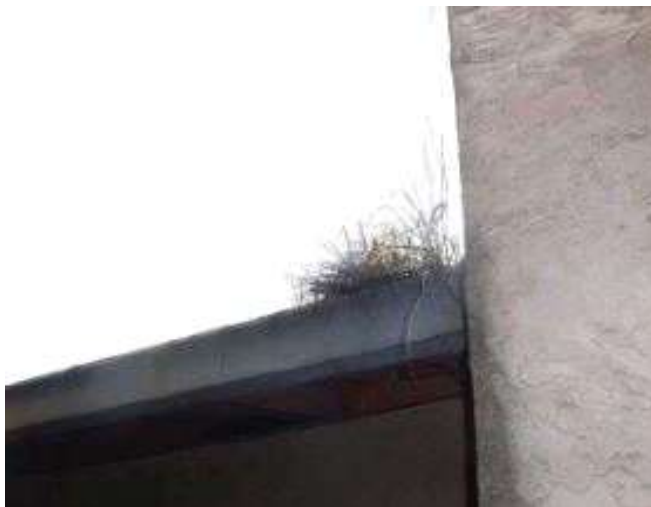
Picture 21

1D. FINDING: The rain gutters and downspouts appear to be leaking and/or clogged where indicated on the diagram (See Picture 21)

RECOMMENDATION: Clean and/or repair the gutters or downspouts as needed.
***** (SECTION 1 ITEM) *****

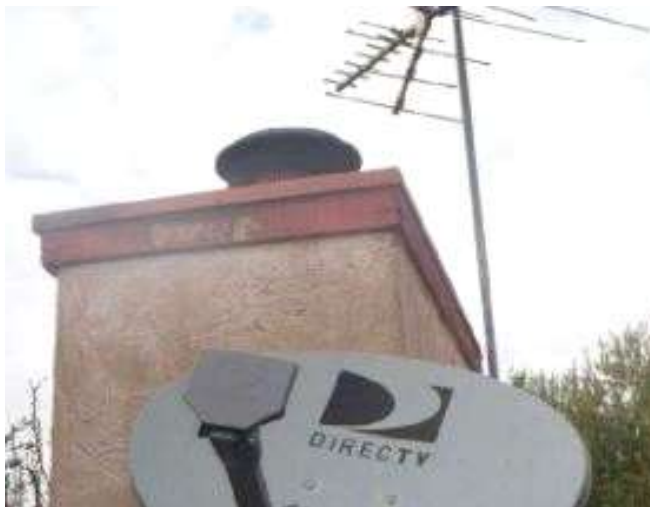
Picture 22

1E. FINDING: The trim has been damaged by fungus and drywood termites at the area indicated on the diagram. The contributing moisture source appears to be exposure to the weather. (See Picture 22) (See Picture 26)

RECOMMENDATION: Remove and replace all the damaged wood members. If any damage is found to extend into any enclosed areas a supplemental report and bid will be issued.

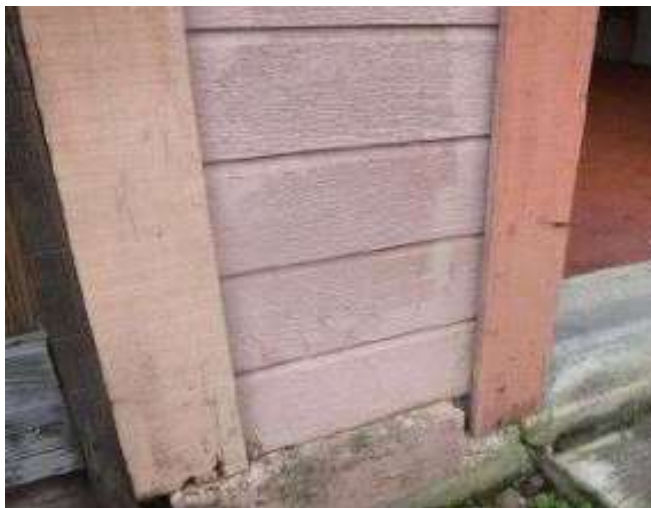
Picture 26

1G. FINDING: The siding has been damaged by fungus at the area indicated on the diagram. The contributing moisture source appears to be exposure to the weather. (See Picture 26)

RECOMMENDATION: Remove and replace all the damaged wood members. If any damage is found to extend into any enclosed areas a supplemental report and bid will be issued.
