## HealthyHome Maintenance Checkup Inspection Report

**2623 Anywhere Street, Hometown**

Ordered by: John Doe  
2623 Anywhere Street  
Hometown, CA 99999

Travis Palser  
May 23, 2024

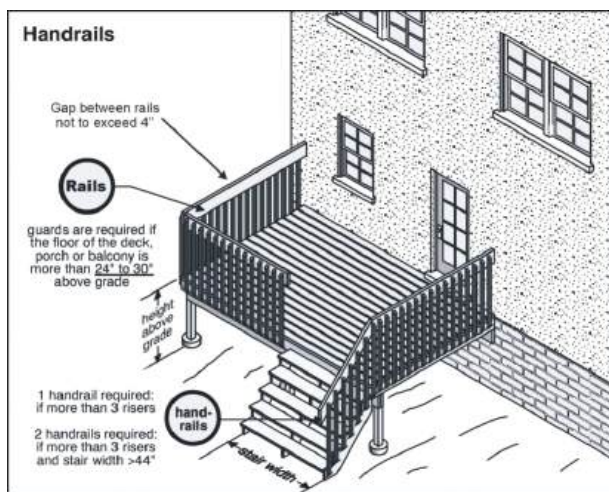
Illustration 3N

- ! 2. The openings in the exterior staircase railing(s) are larger than 4" inches. It is recommended that this be corrected for improved safety. Estimated costs for similar repairs range from \$400 - \$800. Actual repair costs may vary based on specific conditions. (See Illustration 3N) (See Photo 1)

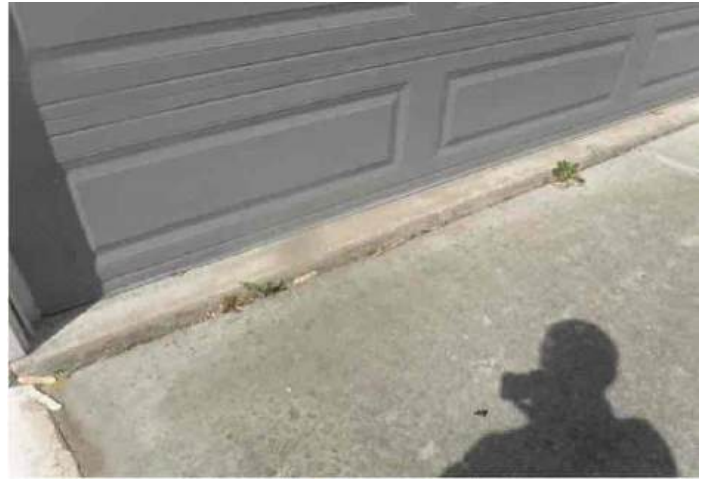
Photo 02

- ! 3. The cracked and heaved sections of the driveway present a trip hazard. This condition should be corrected for improved safety. Estimated costs for similar repairs range from \$750 - \$1,500. Actual repair costs may vary based on specific conditions. (See Photo 2)

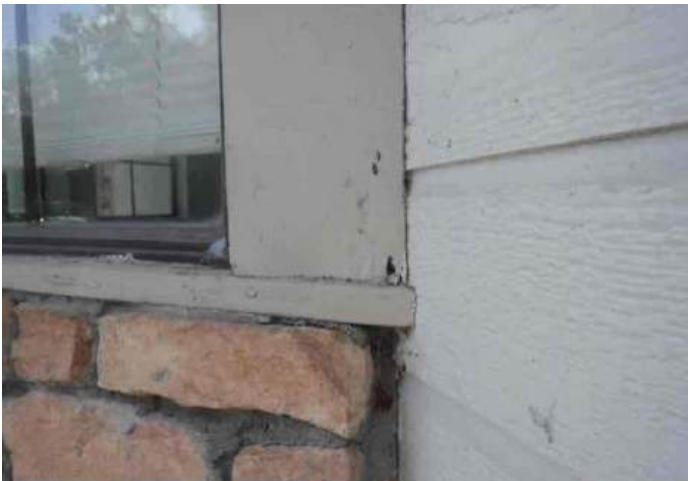
Photo 03

- ! 4. Water damage was observed to the exterior trim at the right side window. Please refer to WDO Report #637502. (See Photo 3)
- 5. Vegetation growing on or within 6" of exterior walls should be kept trimmed away from siding, window trims and the eaves.

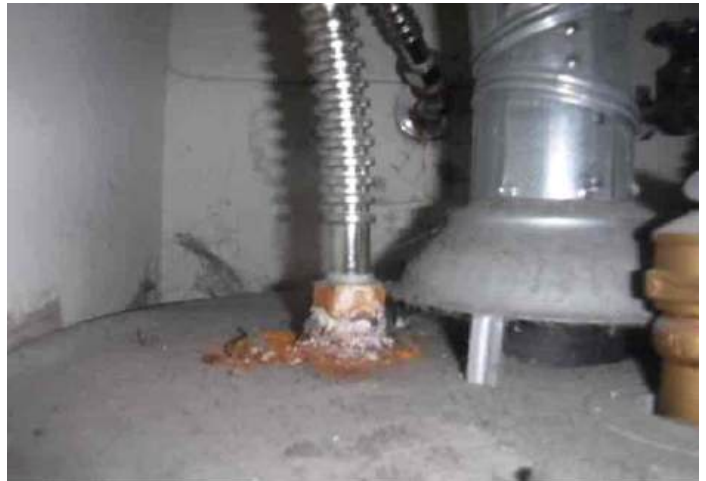
Photo 04

1. The sink was observed to drain slowly at the primary bathroom, suggesting that an obstruction may exist. We recommend the drain line be further evaluated by appropriate trades and improved for full use of this area. Estimated costs for similar repairs range from \$150 - \$300. Actual repair costs may vary based on specific conditions.
- ! 2. Heavy corrosion and possible leakage was noted at the water heater water supply lines. We recommend the lines and/or connections be replaced. Estimated costs for similar repairs range from \$250 - \$500. Actual repair costs may vary based on specific conditions. (See Photo 4)

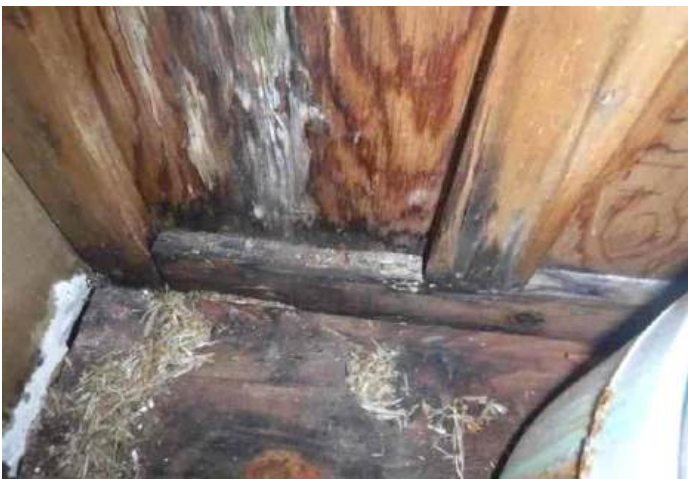
Photo 05

- ! 4. The base and/or side of the water filtration cabinet sink shelf is water damaged. Please refer to WDO Report #637502. (See Photo 5)

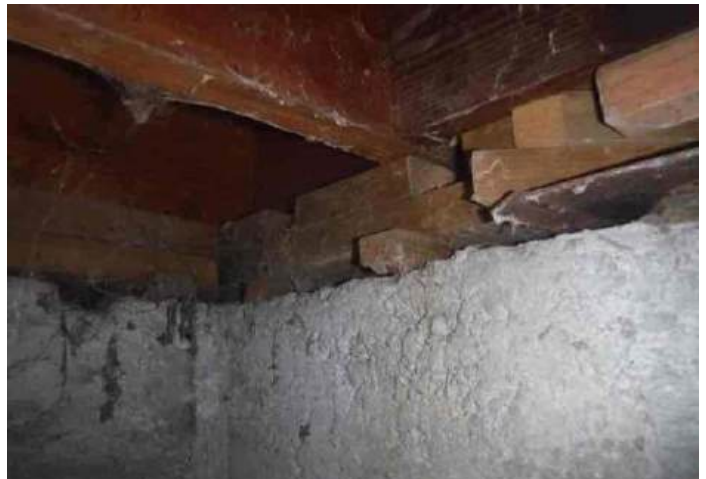
Photo 06

1. Portions of the structure have been leveled by shimming the mudsill. This is an indication of past movement in the foundation but, in this case, the shimming is minor. If further information is desired in regards to this condition the appropriate tradesperson should be contacted. (See Photo 6)

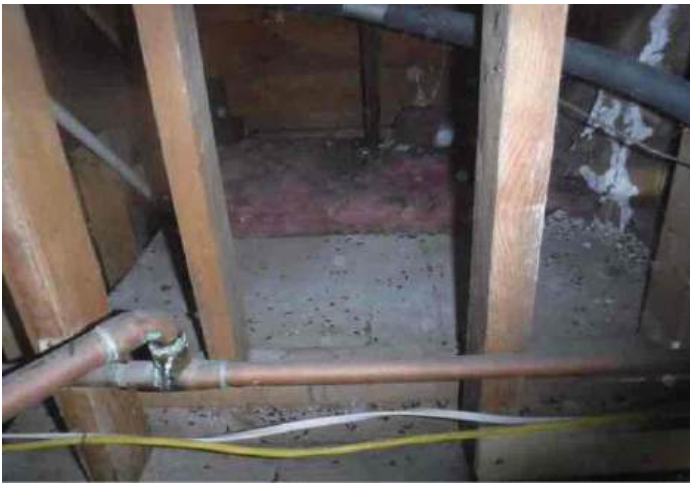
Photo 07

- ! 1. Evidence of vermin activity was observed within the crawlspace. It is likely this evidence will extend into inaccessible areas. The owner is advised to contact the appropriate trade for further evaluation and remedial measures if necessary. (See Photo 7)

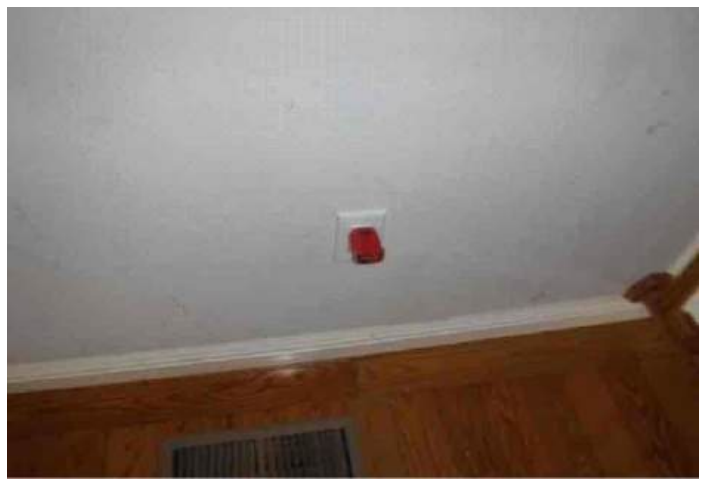
Photo 08

- ! 1. One or more outlets at the left bedroom were inoperative at the time of our inspection. Possibly due to turned off switches which were not located during our inspection. These outlets and circuits should be investigated and corrected as necessary. Based upon our inspection of a representative number of outlets, we recommend testing of every outlet at a later date. Repairs or rewiring are recommended at all deficient locations. Estimated costs for similar repairs range from \$200 - \$400. Actual repair costs may vary based on specific conditions. (See Photo 8)

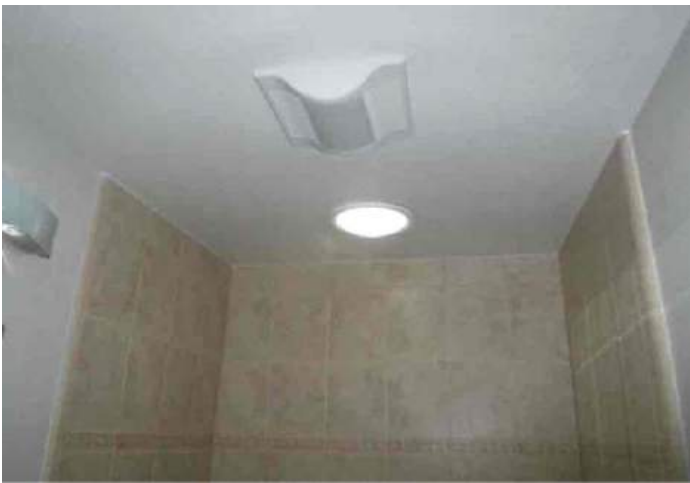
Photo 09

- ! 1. The fan for the hall bathroom exhaust vent is not working or has been disconnected. We recommend this condition be corrected. (See Photo 9)**

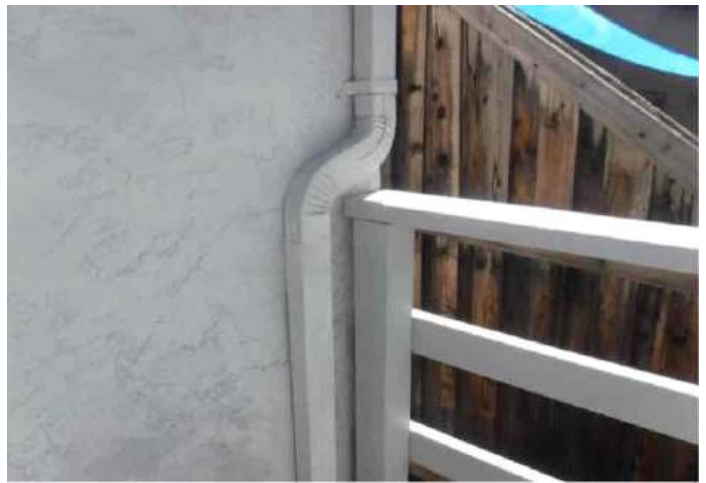
Photo 10

- ! 1. The railing is loose at the balcony. It is recommended that this be repaired for improved safety. Estimated costs for similar repairs range from \$300 - \$600. Actual repair costs may vary based on specific conditions. (See Photo 10)

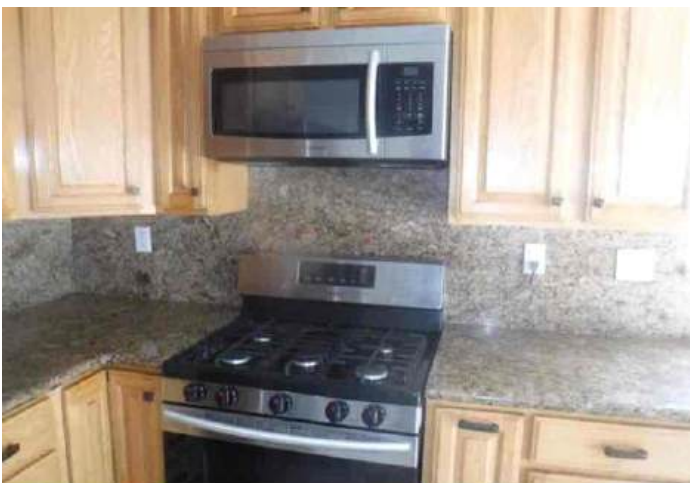
Photo 11

- ! 7. There is no "exterior vented" exhaust fan for the gas appliances installed in the kitchen. It is recommended that all gas appliances be vented to the exterior. (See Photo 11)
