HOME INSPECTION REPORT

2623 Anywhere Street, Hometown

672013

February 26, 2026

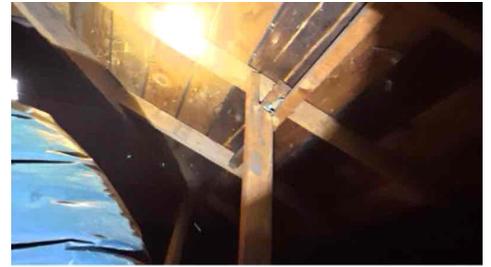
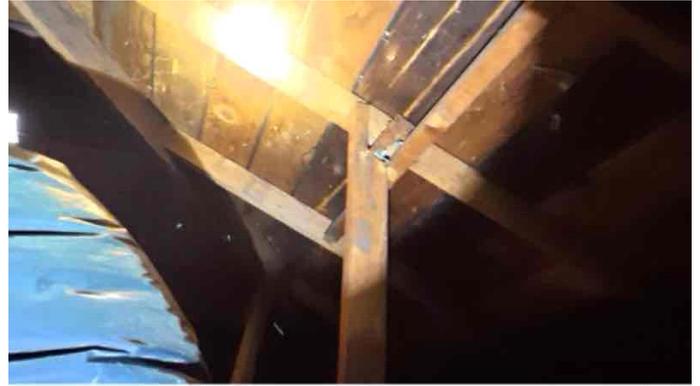
Photo 08

4. One or more roof supports, rafters or joists adjacent to the attic access are disconnected, cracked, and/or damaged. This may affect the integrity of the roof. We recommend this area be investigated and improved by a qualified licensed contractor. (See Photo 8)

- ! 4. One or more roof supports, rafters or joists adjacent to the attic access are disconnected, cracked, and/or damaged. This may affect the integrity of the roof. We recommend this area be investigated and improved by a qualified licensed contractor. (See Photo 8)

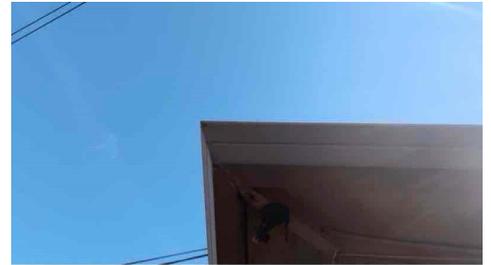
Photo 37

5. Leaks were noted in the downspouts and/or gutters at the rear. During wet weather conditions these areas are more obvious and during dry weather conditions they are noted from the stains at the areas where the leaks have occurred. We recommend all leaks be repaired. (See Illustration 2D) (See Photo 37)

- ! 2. Leaks were noted in the downspouts and/or gutters at the rear. During wet weather conditions these areas are more obvious and during dry weather conditions they are noted from the stains at the areas where the leaks have occurred. We recommend all leaks be repaired. (See Illustration 2D) (See Photo 37)

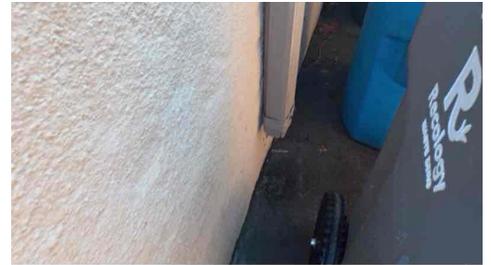
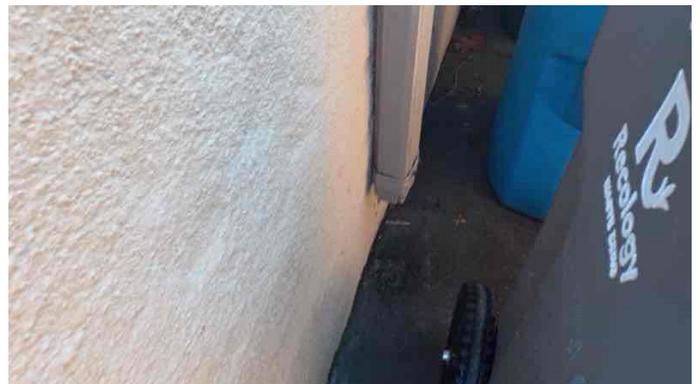
Photo 38

6. A missing downspout leader at the right side gutters should be replaced to direct the flow of water away from the structure. (See Photo 38)

- ! 3. A missing downspout leader at the right side gutters should be replaced to direct the flow of water away from the structure. (See Photo 38)
4. A gap was observed at the top of the rear jack flashing. Gaps around all jack (cone) flashing should be sealed to prevent moisture entry.

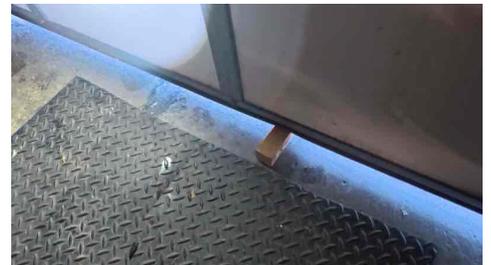
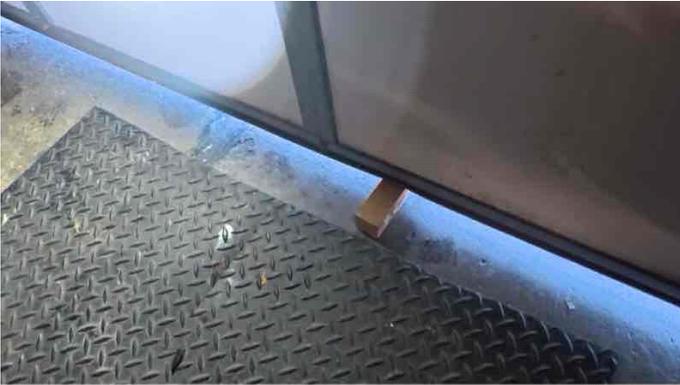
Photo 19

7. The automatic reverse safety feature of the garage door opener did not activate when the door made contact with a 2x2-inch block placed under the center of the door during testing. This feature is an important safety requirement designed to prevent injury or damage if an obstruction is present. The photo-eye sensors were tested separately and found to be operational. We recommend that the garage door opener be adjusted, repaired, or replaced as necessary to restore proper function of the automatic reverse mechanism. A qualified garage door service technician should evaluate and correct this condition for improved safety. (See Photo 19)

- ! 1. The automatic reverse safety feature of the garage door opener did not activate when the door made contact with a 2x2-inch block placed under the center of the door during testing. This feature is an important safety requirement designed to prevent injury or damage if an obstruction is present. The photo-eye sensors were tested separately and found to be operational. We recommend that the garage door opener be adjusted, repaired, or replaced as necessary to restore proper function of the automatic reverse mechanism. A qualified garage door service technician should evaluate and correct this condition for improved safety. (See Photo 19)

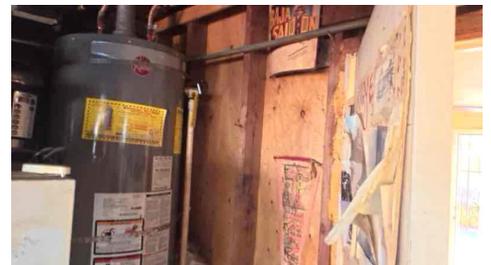
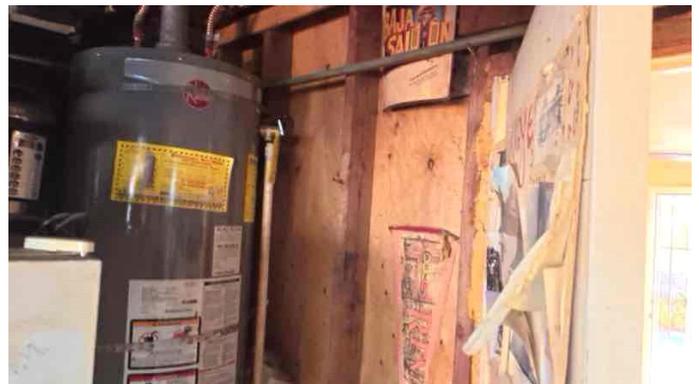
Photo 30

8. Damaged, open or missing wall and/or ceiling finishes of attached garages should be repaired and sealed where they abut the interior of a house. This reduces the potential of toxic automobile gases entering the house and serves as a fire break. Current standards require all walls/ceilings common to the finished living spaces be covered with 5/8" fire resistant sheetrock double taped at all seams. (See Illustration 3A) (See Photo 30)

- ! 2. Damaged, open or missing wall and/or ceiling finishes of attached garages should be repaired and sealed where they abut the interior of a house. This reduces the potential of toxic automobile gases entering the house and serves as a fire break. Current standards require all walls/ceilings common to the finished living spaces be covered with 5/8" fire resistant sheetrock double taped at all seams. (See Illustration 3A) (See Photo 30)

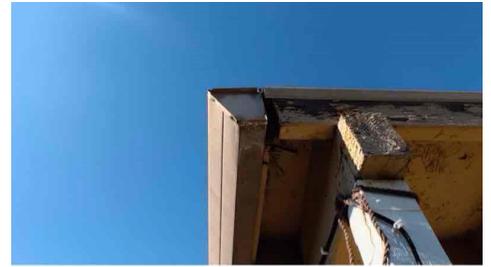
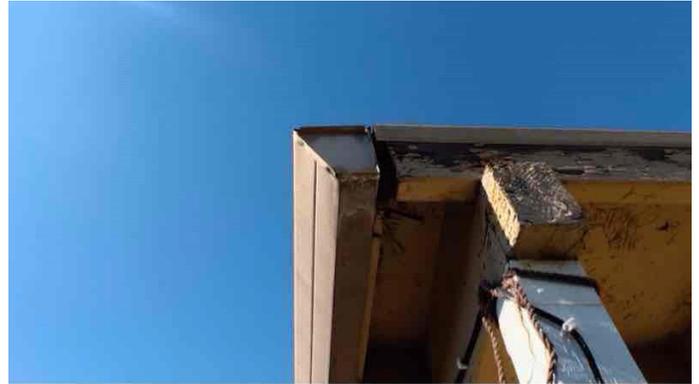
Photo 26

9. Evidence of water damage was noted at the patio cover. Consult a licensed structural pest control company regarding necessary repairs. (See Photo 26)

- ! 3. Evidence of water damage was noted at the patio cover. Consult a licensed structural pest control company regarding necessary repairs. (See Photo 26)

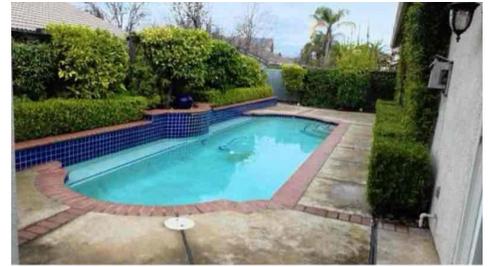
Photo 39

15. The home has fewer than two drowning prevention safety features that are in good repair, fully operable as designed, and, if applicable, appropriately labeled, as required by Section 115922 of the California Health and Safety Code.

The owner is advised to contact the appropriate trades to rectify this condition. (See Photo 39)

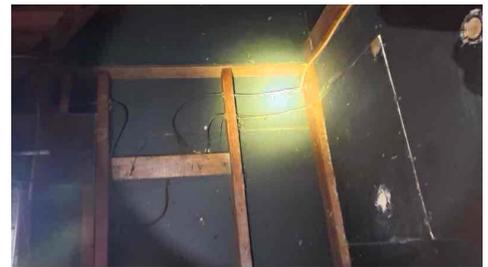
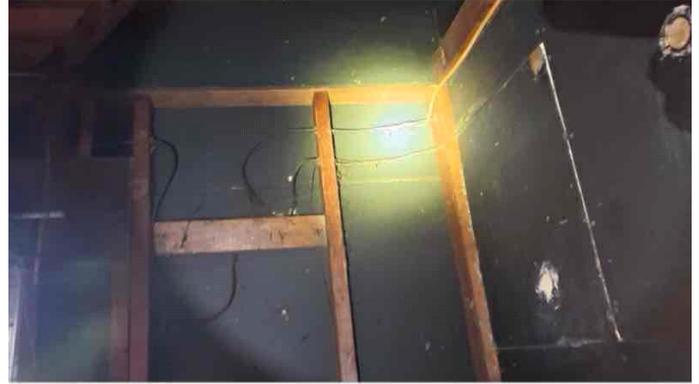
Photo 18

16. Running splices, which are improper connections outside of a junction box, were observed in the garage. We recommend connections be joined with approved connectors inside a junction box to prevent accidental contacts or mechanical damage. (See Photo 18) (See Photo 13)

- ! 1. Running splices, which are improper connections outside of a junction box, were observed in the garage. We recommend connections be joined with approved connectors inside a junction box to prevent accidental contacts or mechanical damage. (See Photo 18) (See Photo 13)

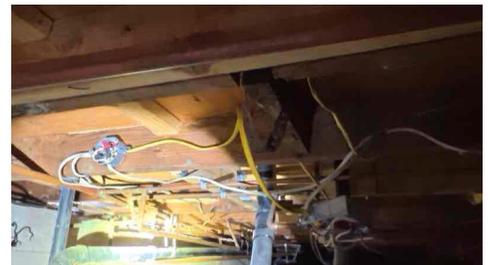
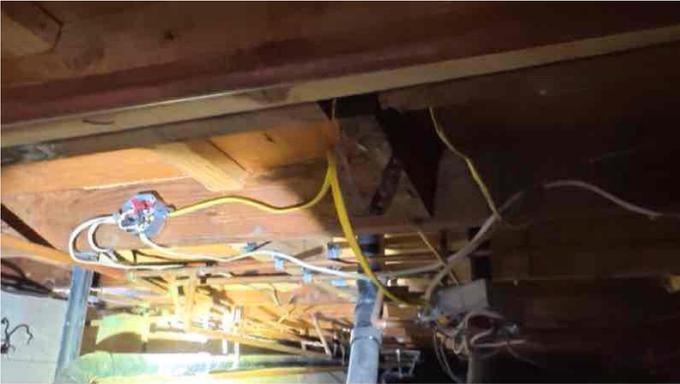
Photo 09

17. Exposed electric connections or open junction boxes at the crawlspace adjacent to the hall bathroom should be corrected. All electric connections should be made inside approved junction boxes fitted with proper cover plates. (See Photo 9)

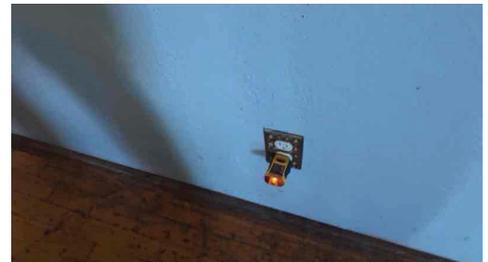
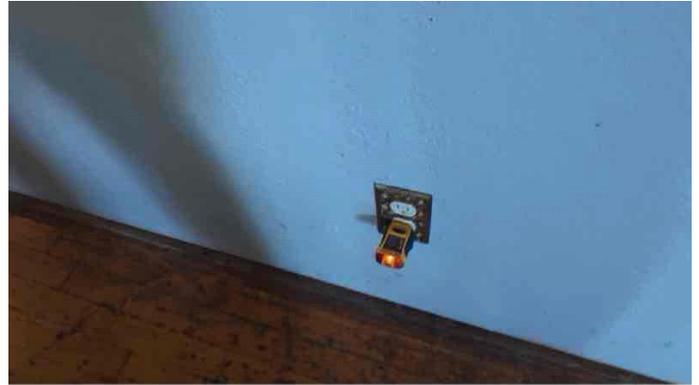
Photo 20

18. Ungrounded "3-prong" outlets at the interior should be improved. A grounded cable or ground wire could be installed at these outlets, the outlet labeled as ungrounded or the original "2-prong" receptacle could be reinstalled. Based upon our inspection of a representative number of outlets, we recommend testing of every outlet. Repairs or rewiring are recommended at all deficient locations. For additional information we recommend a licensed electrician be consulted. (See Illustration 40) (See Photo 20)

- ! 2. Ungrounded "3-prong" outlets at the interior should be improved. A grounded cable or ground wire could be installed at these outlets, the outlet labeled as ungrounded or the original "2-prong" receptacle could be reinstalled. Based upon our inspection of a representative number of outlets, we recommend testing of every outlet. Repairs or rewiring are recommended at all deficient locations. For additional information we recommend a licensed electrician be consulted. (See Illustration 4O) (See Photo 20)

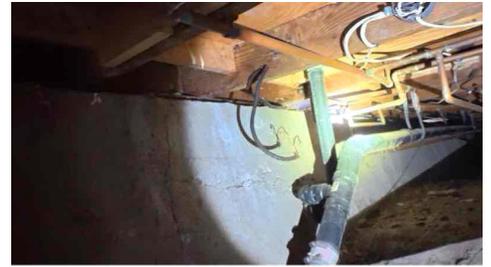
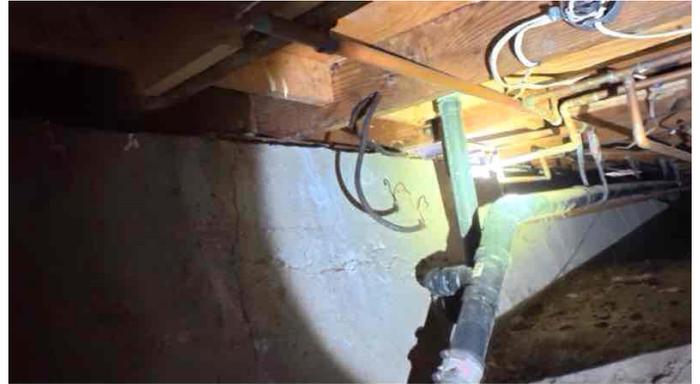
Photo 10

19. Abandoned wiring was noted in the crawlspace adjacent to the hall bathroom. We recommend the wiring be disconnected at its source or terminated in an approved manner in a covered junction box. (See Photo 10) (See Photo 13)

- ! 7. Abandoned wiring was noted in the crawlspace adjacent to the hall bathroom. We recommend the wiring be disconnected at its source or terminated in an approved manner in a covered junction box. (See Photo 10) (See Photo 13)

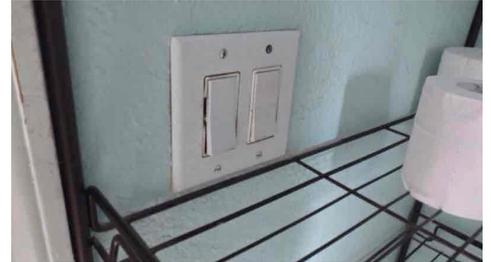
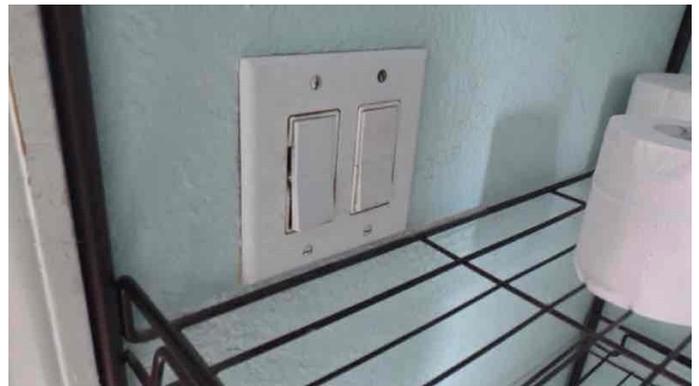
Photo 06

20. A switch at the hall bathroom is faulty or damaged. We recommend it be replaced. (See Photo 6)

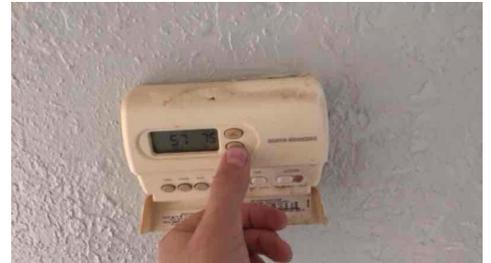
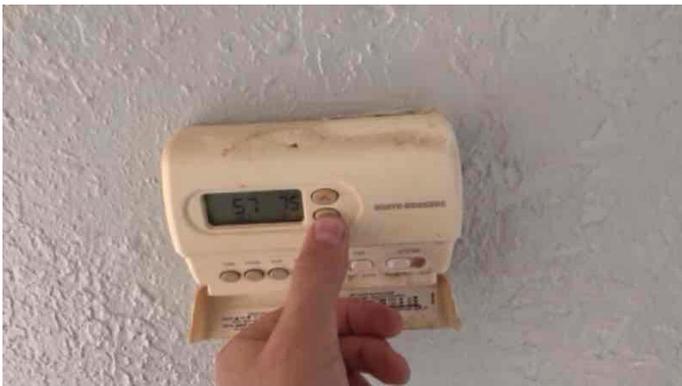
Photo 05

21. The heater thermostat was observed to be damaged at the time of inspection. Some of the controls were not functioning as intended, which may prevent proper operation and temperature regulation. We recommend repair or replacement by a qualified HVAC contractor as needed. (See Photo 5)

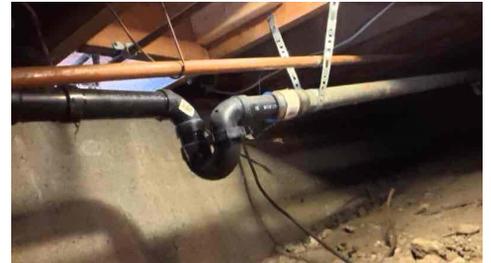
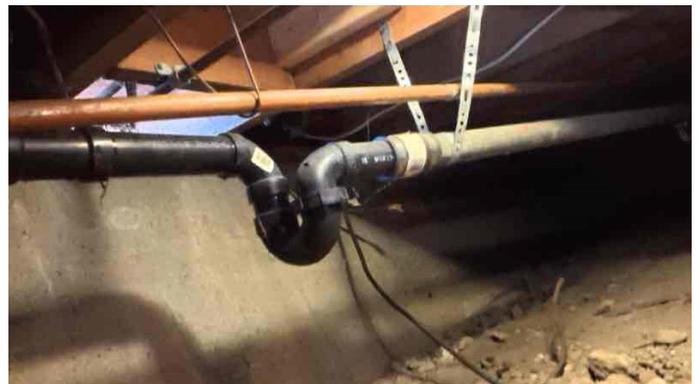
Photo 14

22. The drain piping at the rear right side of the crawlspace does not have sufficient slope for proper drainage. We recommend this condition be corrected. (See Photo 14)

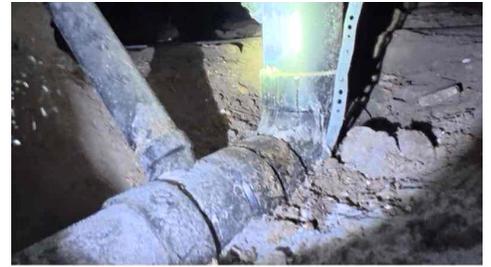
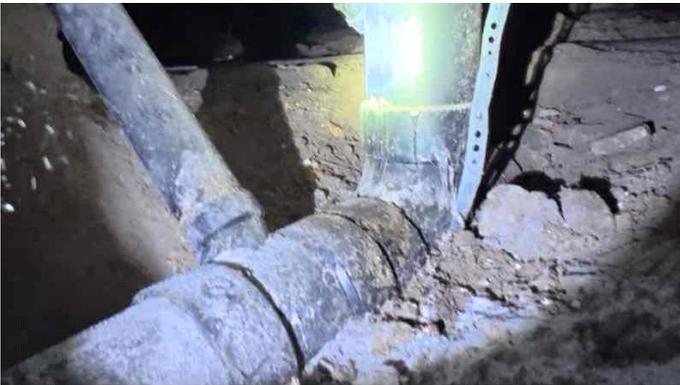
Photo 11

24. There is a cracked and leaking plastic drain pipe at the crawlspace under the hall bathroom. This is a potential health hazard. We recommend the piping in question be repaired or replaced. (See Photo 11) (See Photo 12)

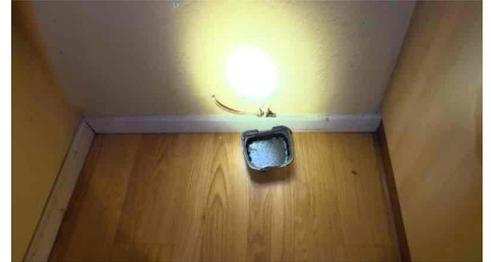
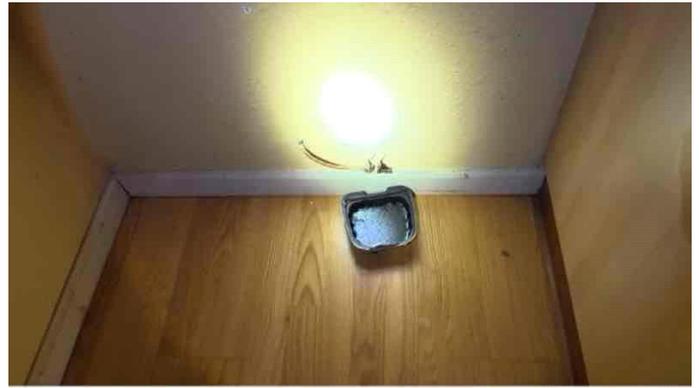
Photo 24

25. The angle stop valve or supply line at the kitchen wall is leaking. We recommend all leaks be repaired. (See Photo 24)

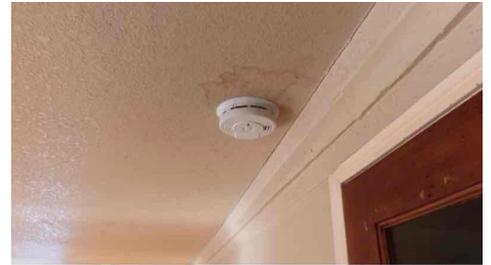
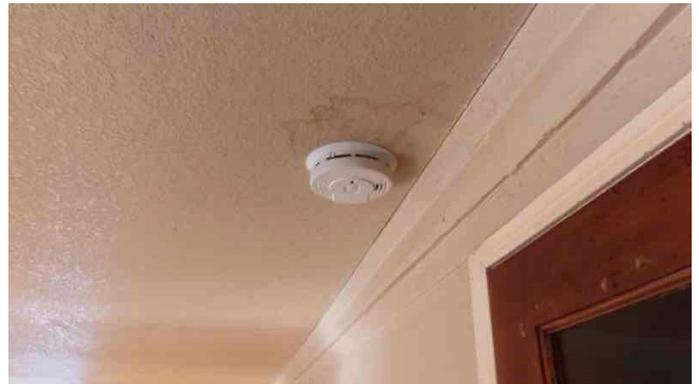
Photo 22

26. The ceiling at the rear bedroom shows evidence of water stains. It is recommended that the source of these stains be identified and corrected and the surface be refinished. (See Photo 22)

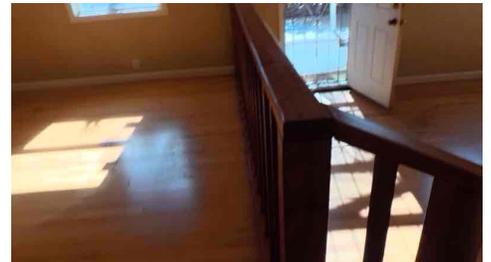
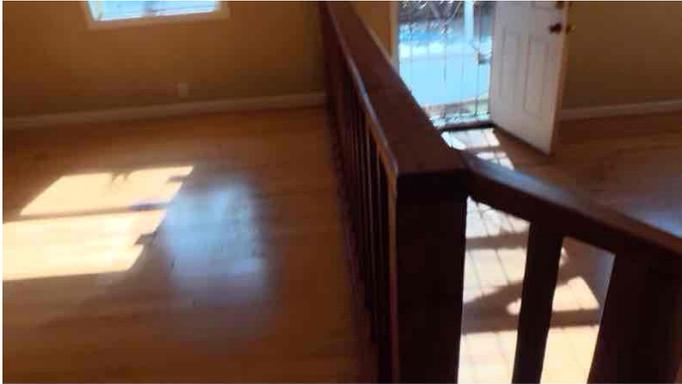
Photo 25

27. The railing at the rear addition is loose. We recommend it be repaired or replaced. (See Photo 25)

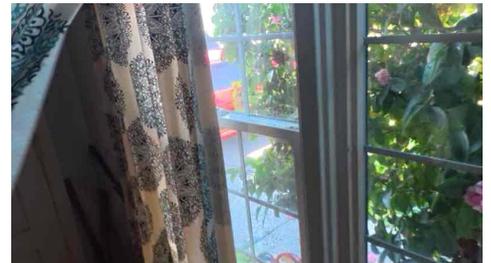
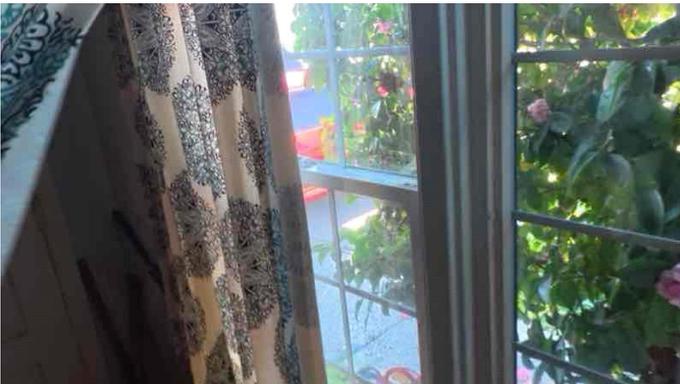
Photo 21

28. One or more of the windows at the living room are not fully serviceable because their lift mechanism is missing or damaged. We recommend these windows be repaired and their full functional use restored. (See Photo 21)

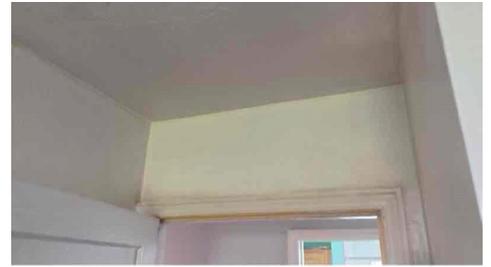
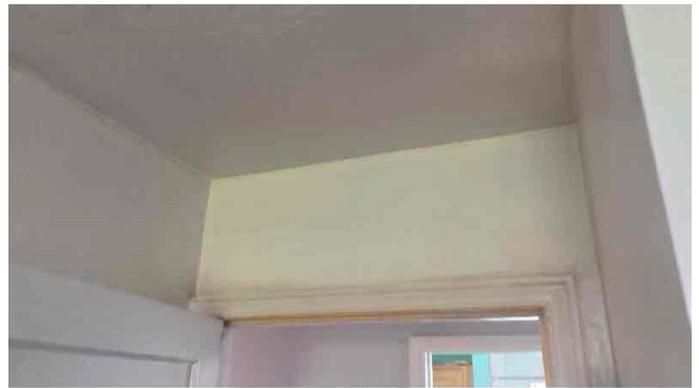
Photo 04

29. California law requires that all homes have a State Fire Marshall approved Carbon Monoxide Detector be installed outside of the sleeping areas in the hallway and on each level of the home including basements. At the time of this inspection a Carbon Monoxide Detector could not be located. We recommend consulting with the owner to see if a Carbon Monoxide Detector exists and if not they should be installed in all required locations. (See Photo 4)

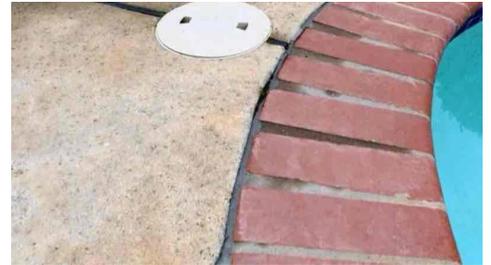
Photo 41

30. Portions of the pool decking have settled and/or heaved relative to the pool structure/coping. The settled and/or heaved areas present a trip hazard. This condition should be corrected to improve safety. The decking should be monitored for further settlement and/or heaving. Exterior grade sealer will help to limit moisture intrusion. We recommend consulting a licensed pool contractor and/or a licensed soils and drainage engineer for further evaluation and repairs. (See Photo 41)

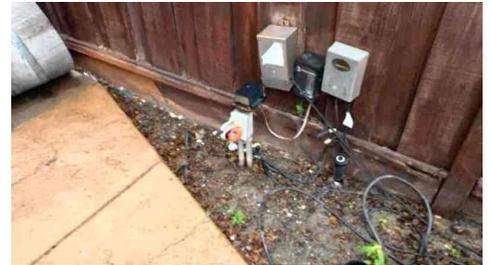
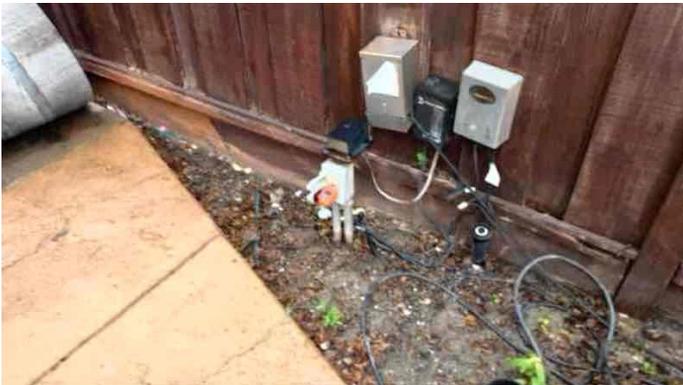
Photo 43

31. Electrical components and/or wiring was noted within five feet of the pool. It is recommended that all electrical components be relocated according to present safety standards. We recommend further evaluation and repair by a licensed electrician. (See Photo 43)

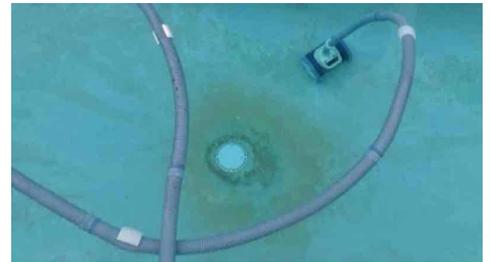
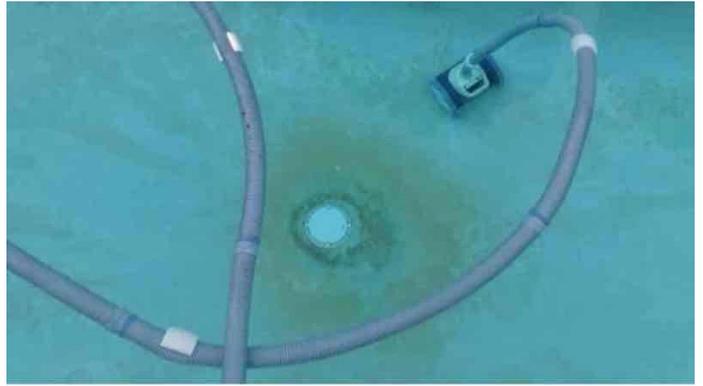
Photo 40

32. The pool/spa has less than two drains and/or returns as required by current safety standards. Standards change over time and from municipality to municipality. Older pool and spa systems can be retrofitted with specialty covers which is considered an improvement. We recommend the services of a licensed pool contractor. (See Photo 40)

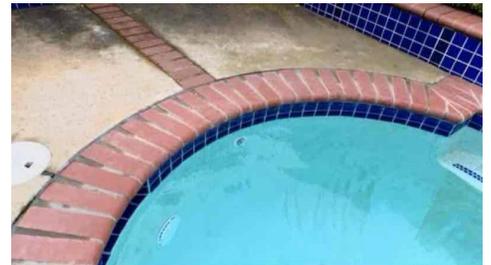
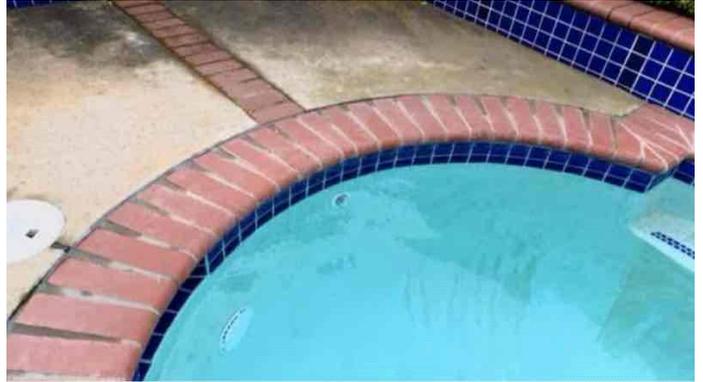
Photo 42

33. The lights at the pool did not respond to normal operating controls. We recommend the lights and related circuits be further evaluated and repaired by a licensed pool/spa contractor. (See Photo 42)

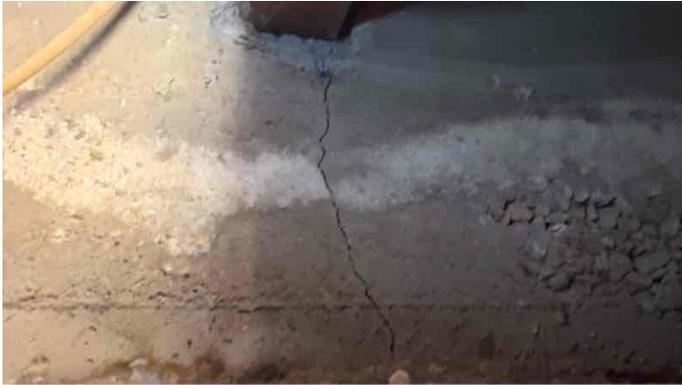
Photo 01

- ! 1. Vertical cracking was observed in the foundation walls of the structure indicating movement and/or settlement of the structure may have occurred. The rate of movement cannot be predicted during a one-time inspection. A thorough evaluation of this condition is beyond our qualifications. For additional information we recommend contacting a licensed foundation contractor for further evaluation. (See Photo 1) (See Photo 2)

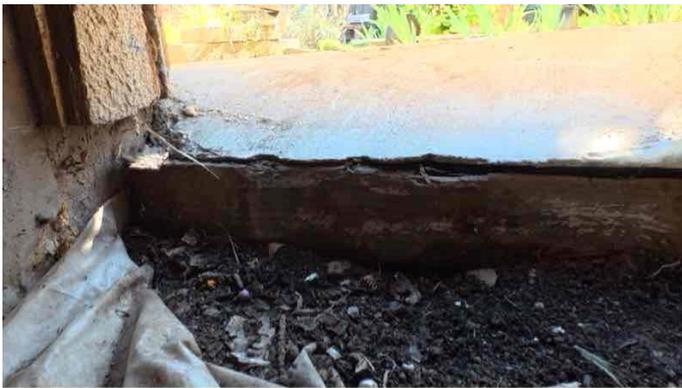
Photo 03

- ! 3. The exterior crawl space access door and/or framing is deteriorated. We recommend all deteriorated wood members be replaced. (See Photo 7) (See Photo 3)

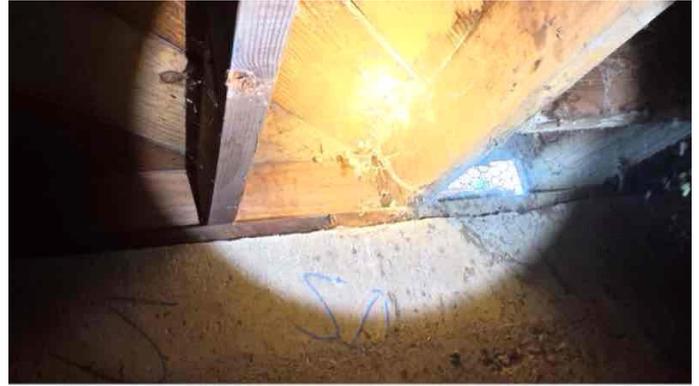
Photo 16

- ! 2. The subfloor wood members at the front of the crawlspace show evidence of water damage. We recommend the services of a licensed structural pest control operator for investigation of this condition. (See Photo 17) (See Photo 16)

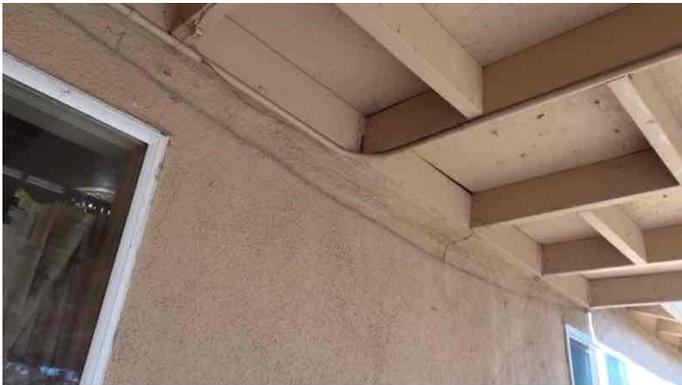
Photo 27

14. The patio cover is improperly attached to the structure with nails/screws. This condition could pose a safety hazard with lateral forces or seismic activity. We recommend the patio cover be secured to the structure with proper flashing and bolts according to local building codes. (See Photo 27)

- ! 8. The patio cover is improperly attached to the structure with nails/screws. This condition could pose a safety hazard with lateral forces or seismic activity. We recommend the patio cover be secured to the structure with proper flashing and bolts according to local building codes. (See Photo 27)

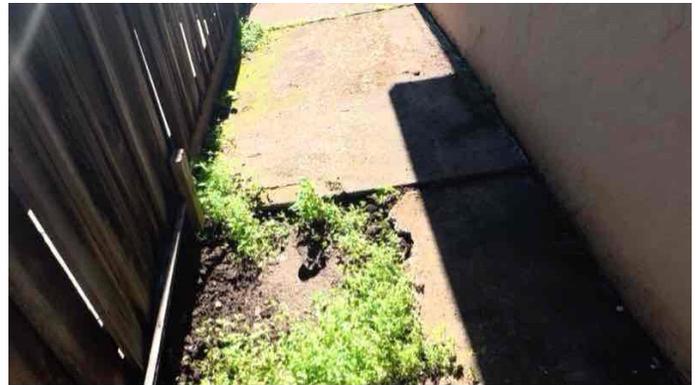
Photo 28

10. The cracked, heaved, or uneven walkway sections at the left side pose a potential trip hazard. We recommend corrective action to improve safety and reduce the risk of injury. A qualified contractor should assess the affected areas and perform necessary repairs to ensure a level walking surface. (See Photo 28)

- ! 4. The cracked, heaved, or uneven walkway sections at the left side pose a potential trip hazard. We recommend corrective action to improve safety and reduce the risk of injury. A qualified contractor should assess the affected areas and perform necessary repairs to ensure a level walking surface. (See Photo 28)

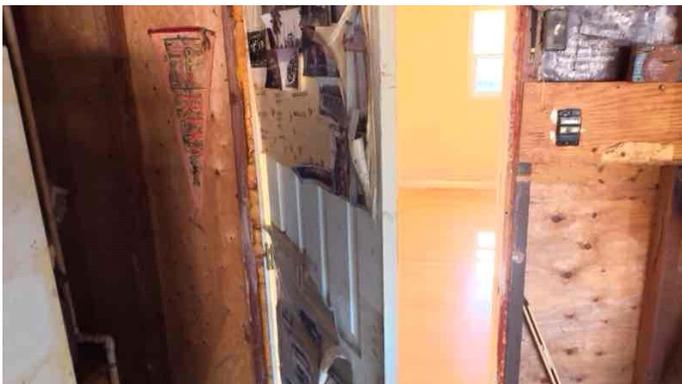
Photo 29

13. The door between the garage and the house did not have an automatic closing mechanism. For improved safety the door between the garage and the interior of the house should be fitted with an automatic closing mechanism, and be rated for a minimum of one hour of fire resistance. This will reduce the potential of toxic automobile gases entering the house and serves as a fire break. (See Photo 29)

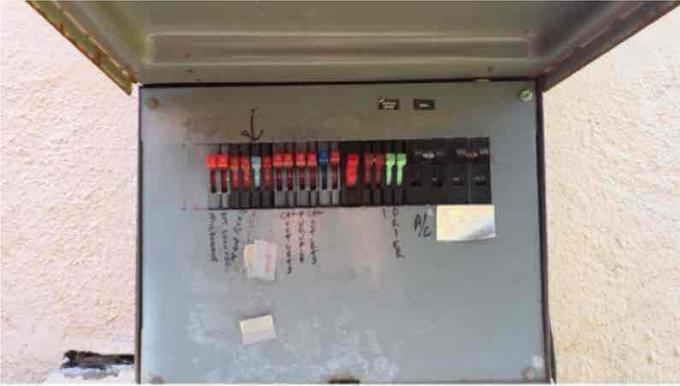
Photo 31

3. We have observed a "Zinsco/Sylvania" electrical service panel(s) on the property. This type of panel has a history of circuit breakers failing to trip or overheating in response to an over current or short circuit. Failure of a circuit breaker to trip does not afford the protection that is intended and required. These brands have been obsolete for decades, and are a safety hazard. We recommend a licensed electrician be retained for additional information and recommendations. An electrician is likely to recommend full replacement of the panel. (See Photo 31) (See Photo 33)

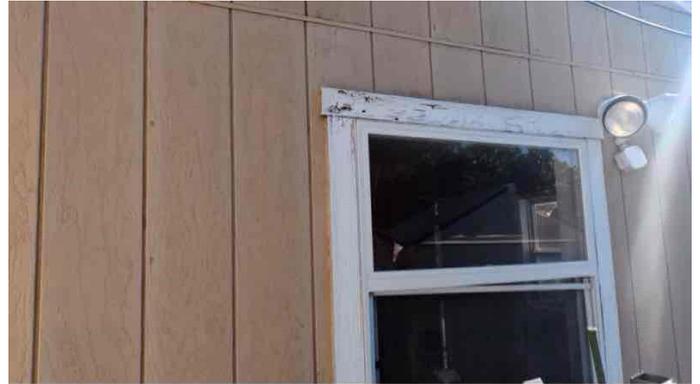
Photo 34

12. Water damage was observed to the exterior window trim at the rear addition. We recommend the services of a licensed general contractor and/or structural pest control company. (See Photo 34)

- ! 6. Water damage was observed to the exterior window trim at the rear addition. We recommend the services of a licensed general contractor and/or structural pest control company. (See Photo 34)

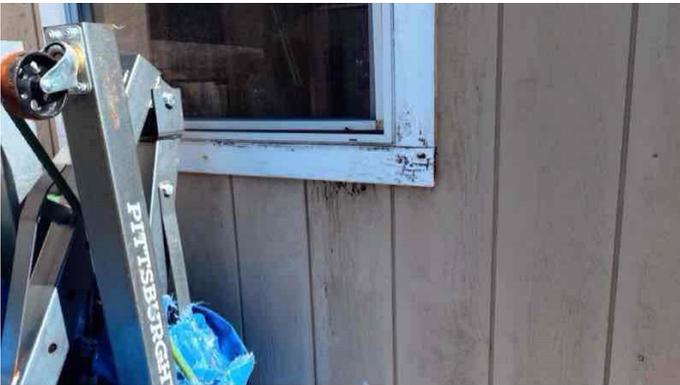
Photo 35

11. Water damage was observed to the wood siding at the rear addition exterior walls. We recommend the services of a licensed general contractor and/or structural pest control company. (See Photo 35)

- ! 5. Water damage was observed to the wood siding at the rear addition exterior walls. We recommend the services of a licensed general contractor and/or structural pest control company. (See Photo 35)

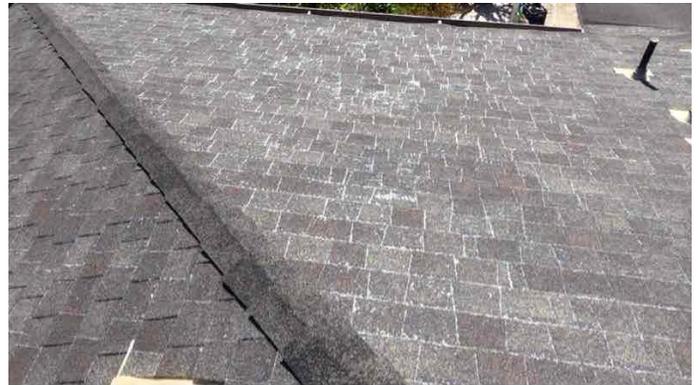
Photo 36

1. Portions of the surface granulation are deteriorated and surface cracks are developing. For further evaluation of this condition, we recommend consulting with a licensed roof contractor. (See Photo 36)
