## HOME INSPECTION REPORT

2623 Anywhere Street, Hometown

672013

February 26, 2026

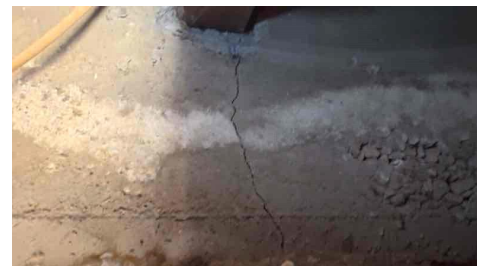
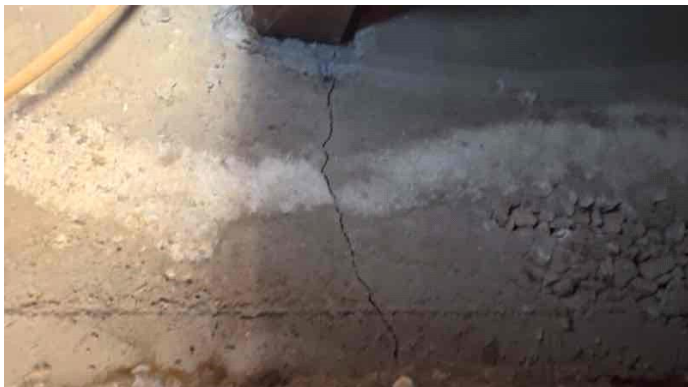
Photo 01

1. Vertical cracking was observed in the foundation walls of the structure indicating movement and/or settlement of the structure may have occurred. The rate of movement cannot be predicted during a one-time inspection. A thorough evaluation of this condition is beyond our qualifications. For additional information we recommend contacting a licensed foundation contractor for further evaluation. (See Photo 1) (See Photo 2)

- ! 1. Vertical cracking was observed in the foundation walls of the structure indicating movement and/or settlement of the structure may have occurred. The rate of movement cannot be predicted during a one-time inspection. A thorough evaluation of this condition is beyond our qualifications. For additional information we recommend contacting a licensed foundation contractor for further evaluation. (See Photo 1) (See Photo 2)

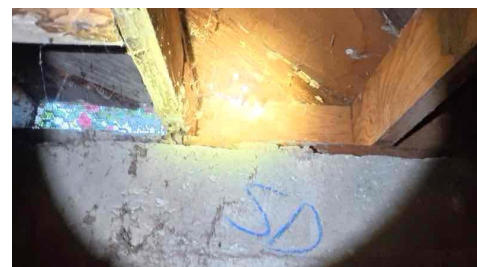
Photo 17

2. The subfloor wood members at the front of the crawlspace show evidence of water damage. We recommend the services of a licensed structural pest control operator for investigation of this condition. (See Photo 17) (See Photo 16)

- ! 2. The subfloor wood members at the front of the crawlspace show evidence of water damage. We recommend the services of a licensed structural pest control operator for investigation of this condition. (See Photo 17) (See Photo 16)

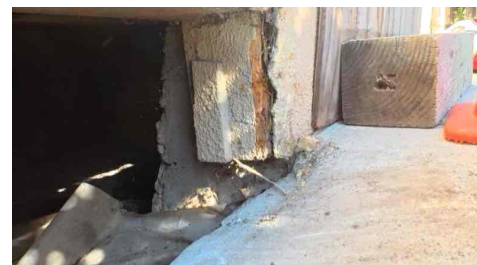
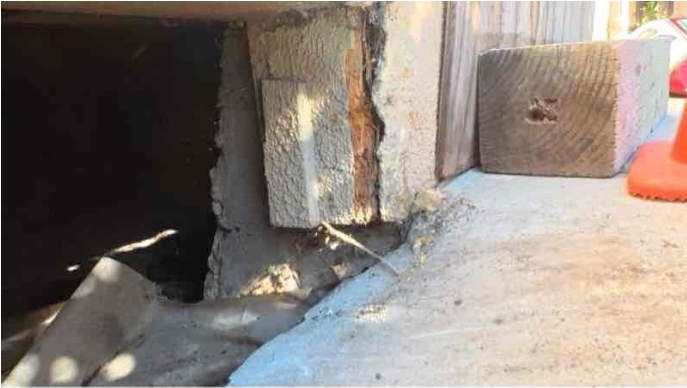
Photo 07

3. The exterior crawl space access door and/or framing is deteriorated. We recommend all deteriorated wood members be replaced. (See Photo 7) (See Photo 3)

- ! 3. The exterior crawl space access door and/or framing is deteriorated. We recommend all deteriorated wood members be replaced. (See Photo 7) (See Photo 3)

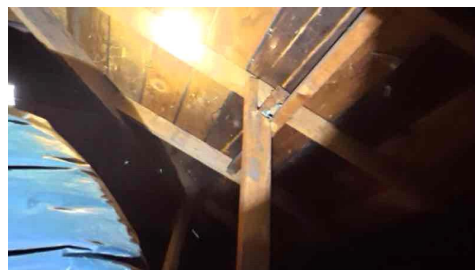
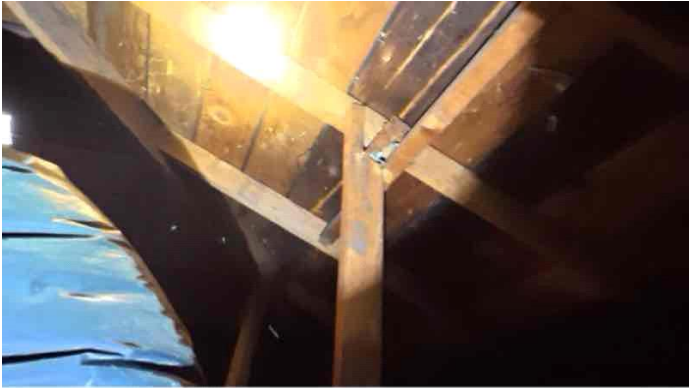
Photo 08

4. One or more roof supports, rafters or joists adjacent to the attic access are disconnected, cracked, and/or damaged. This may affect the integrity of the roof. We recommend this area be investigated and improved by a qualified licensed contractor. (See Photo 8)

- ! 4. One or more roof supports, rafters or joists adjacent to the attic access are disconnected, cracked, and/or damaged. This may affect the integrity of the roof. We recommend this area be investigated and improved by a qualified licensed contractor. (See Photo 8)

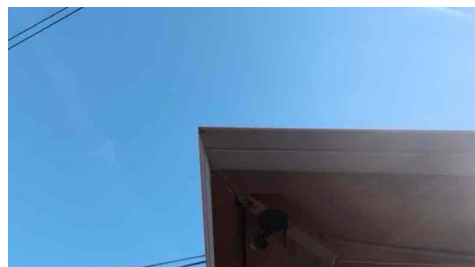
Photo 37

5. Leaks were noted in the downspouts and/or gutters at the rear. During wet weather conditions these areas are more obvious and during dry weather conditions they are noted from the stains at the areas where the leaks have occurred. We recommend all leaks be repaired. (See Illustration 2D) (See Photo 37)

- ! 2. Leaks were noted in the downspouts and/or gutters at the rear. During wet weather conditions these areas are more obvious and during dry weather conditions they are noted from the stains at the areas where the leaks have occurred. We recommend all leaks be repaired. (See Illustration 2D) (See Photo 37)

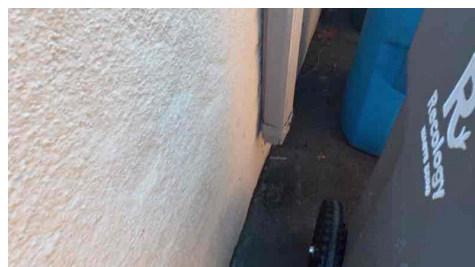
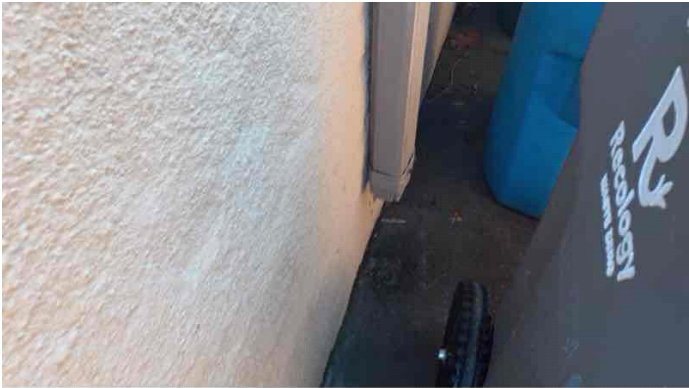
Photo 38

6. A missing downspout leader at the right side gutters should be replaced to direct the flow of water away from the structure. (See Photo 38)

- ! 3. A missing downspout leader at the right side gutters should be replaced to direct the flow of water away from the structure. (See Photo 38)
4. A gap was observed at the top of the rear jack flashing. Gaps around all jack (cone) flashing should be sealed to prevent moisture entry.

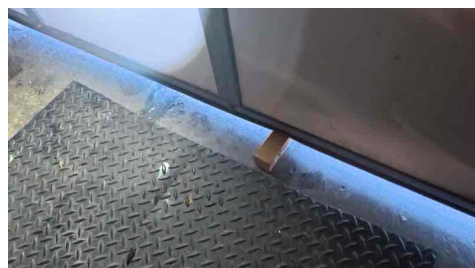
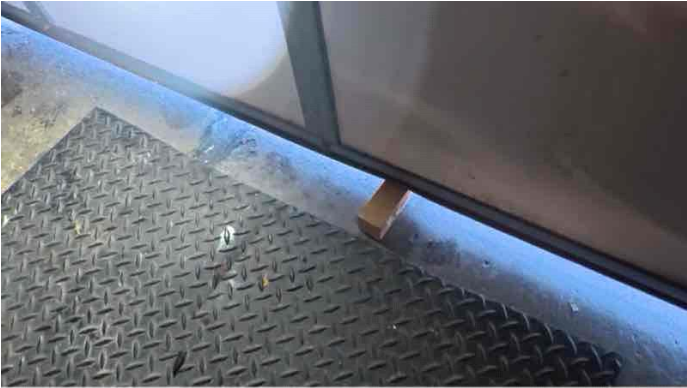
Photo 19

7. The automatic reverse safety feature of the garage door opener did not activate when the door made contact with a 2x2-inch block placed under the center of the door during testing. This feature is an important safety requirement designed to prevent injury or damage if an obstruction is present. The photo-eye sensors were tested separately and found to be operational. We recommend that the garage door opener be adjusted, repaired, or replaced as necessary to restore proper function of the automatic reverse mechanism. A qualified garage door service technician should evaluate and correct this condition for improved safety. (See Photo 19)

- ! 3. The automatic reverse safety feature of the garage door opener did not activate when the door made contact with a 2x2-inch block placed under the center of the door during testing. This feature is an important safety requirement designed to prevent injury or damage if an obstruction is present. The photo-eye sensors were tested separately and found to be operational. We recommend that the garage door opener be adjusted, repaired, or replaced as necessary to restore proper function of the automatic reverse mechanism. A qualified garage door service technician should evaluate and correct this condition for improved safety. (See Photo 19)

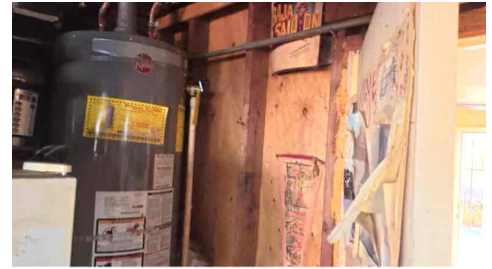
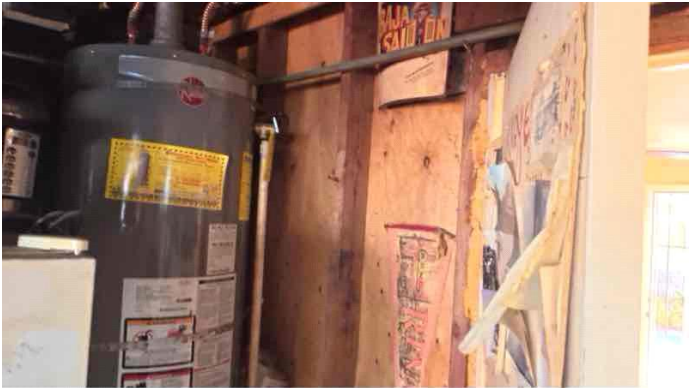
Photo 30

8. Damaged, open or missing wall and/or ceiling finishes of attached garages should be repaired and sealed where they abut the interior of a house. This reduces the potential of toxic automobile gases entering the house and serves as a fire break. Current standards require all walls/ceilings common to the finished living spaces be covered with 5/8" fire resistant sheetrock double taped at all seams. (See Illustration 3A) (See Photo 30)

- ! 1. Damaged, open or missing wall and/or ceiling finishes of attached garages should be repaired and sealed where they abut the interior of a house. This reduces the potential of toxic automobile gases entering the house and serves as a fire break. Current standards require all walls/ceilings common to the finished living spaces be covered with 5/8" fire resistant sheetrock double taped at all seams. (See Illustration 3A) (See Photo 30)

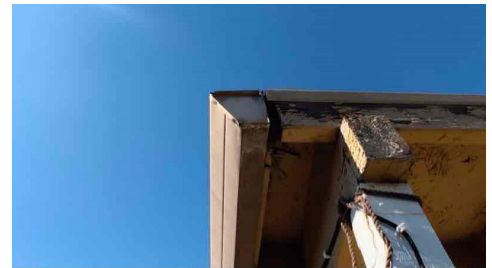
Photo 26

9. Evidence of water damage was noted at the patio cover. Consult a licensed structural pest control company regarding necessary repairs. (See Photo 26)

- ! 4. Evidence of water damage was noted at the patio cover. Consult a licensed structural pest control company regarding necessary repairs. (See Photo 26)

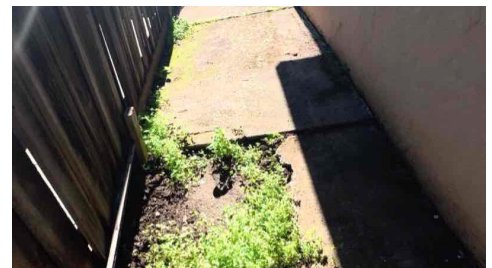
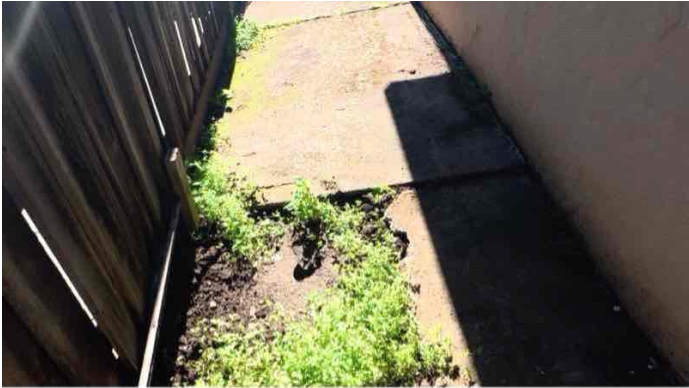
Photo 28

10. The cracked, heaved, or uneven walkway sections at the left side pose a potential trip hazard. We recommend corrective action to improve safety and reduce the risk of injury. A qualified contractor should assess the affected areas and perform necessary repairs to ensure a level walking surface. (See Photo 28)

- ! 5. The cracked, heaved, or uneven walkway sections at the left side pose a potential trip hazard. We recommend corrective action to improve safety and reduce the risk of injury. A qualified contractor should assess the affected areas and perform necessary repairs to ensure a level walking surface. (See Photo 28)

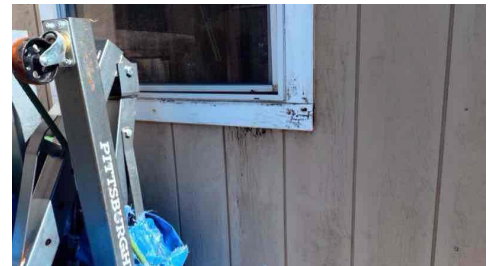
Photo 35

11. Water damage was observed to the wood siding at the rear addition exterior walls. We recommend the services of a licensed general contractor and/or structural pest control company. (See Photo 35)

- ! 6. Water damage was observed to the wood siding at the rear addition exterior walls. We recommend the services of a licensed general contractor and/or structural pest control company. (See Photo 35)

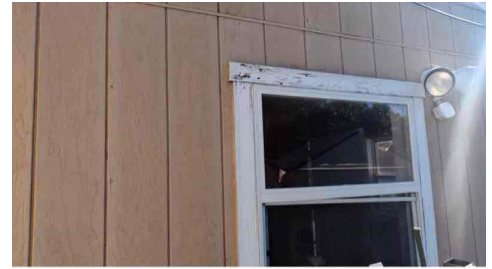
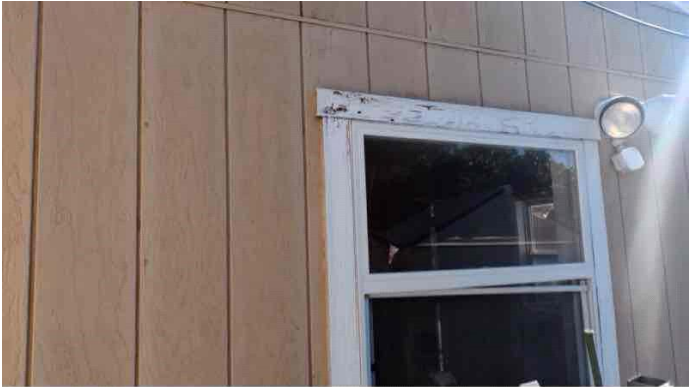
Photo 34

12. Water damage was observed to the exterior window trim at the rear addition. We recommend the services of a licensed general contractor and/or structural pest control company. (See Photo 34)

- ! 7. Water damage was observed to the exterior window trim at the rear addition. We recommend the services of a licensed general contractor and/or structural pest control company. (See Photo 34)

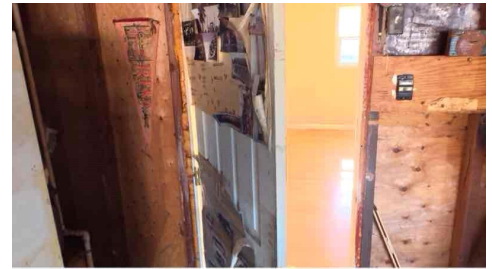
Photo 29

13. The door between the garage and the house did not have an automatic closing mechanism. For improved safety the door between the garage and the interior of the house should be fitted with an automatic closing mechanism, and be rated for a minimum of one hour of fire resistance. This will reduce the potential of toxic automobile gases entering the house and serves as a fire break. (See Photo 29)

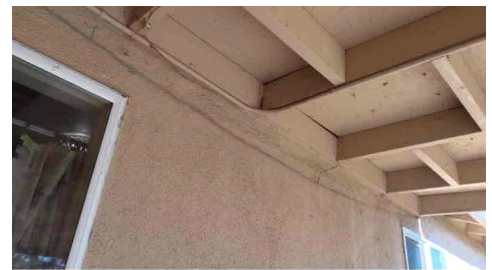
Photo 27

14. The patio cover is improperly attached to the structure with nails/screws. This condition could pose a safety hazard with lateral forces or seismic activity. We recommend the patio cover be secured to the structure with proper flashing and bolts according to local building codes. (See Photo 27)

- ! 8. The patio cover is improperly attached to the structure with nails/screws. This condition could pose a safety hazard with lateral forces or seismic activity. We recommend the patio cover be secured to the structure with proper flashing and bolts according to local building codes. (See Photo 27)

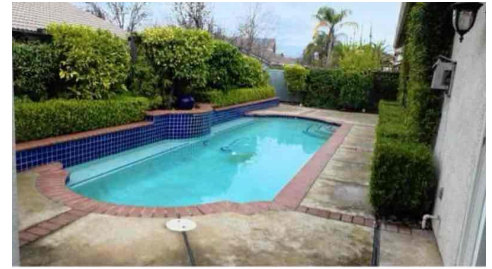
Photo 39

15. The home has fewer than two drowning prevention safety features that are in good repair, fully operable as designed, and, if applicable, appropriately labeled, as required by Section 115922 of the California Health and Safety Code.

The owner is advised to contact the appropriate trades to rectify this condition. (See Photo 39)

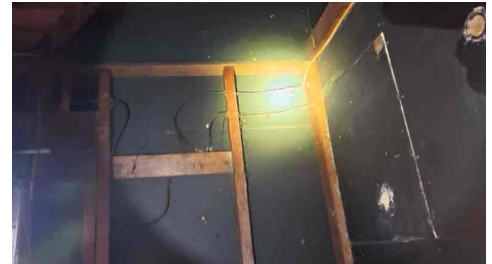
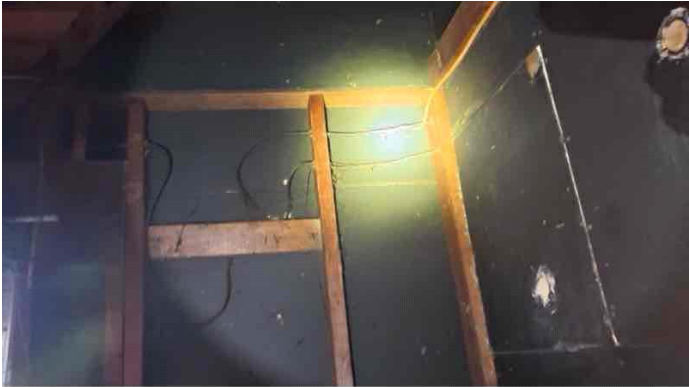
Photo 18

16. Running splices, which are improper connections outside of a junction box, were observed in the garage. We recommend connections be joined with approved connectors inside a junction box to prevent accidental contacts or mechanical damage. (See Photo 18) (See Photo 13)

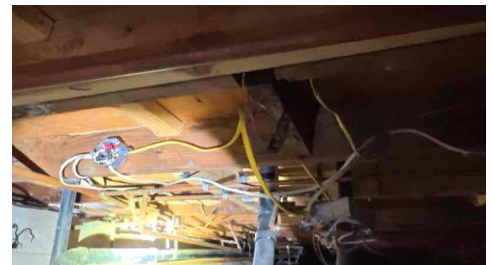
Photo 09

17. Exposed electric connections or open junction boxes at the crawlspace adjacent to the hall bathroom should be corrected. All electric connections should be made inside approved junction boxes fitted with proper cover plates. (See Photo 9)

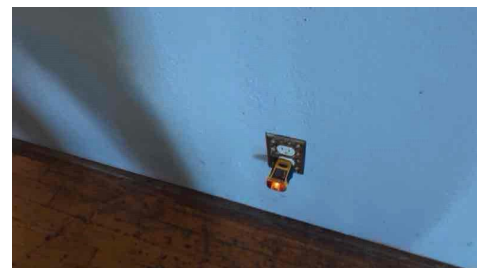
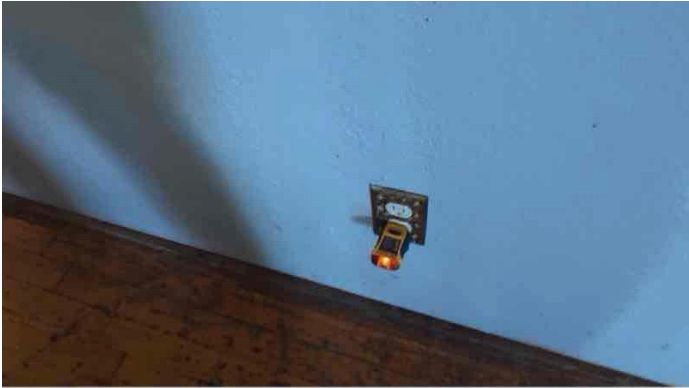
Photo 20

18. Ungrounded "3-prong" outlets at the interior should be improved. A grounded cable or ground wire could be installed at these outlets, the outlet labeled as ungrounded or the original "2-prong" receptacle could be reinstalled. Based upon our inspection of a representative number of outlets, we recommend testing of every outlet. Repairs or rewiring are recommended at all deficient locations. For additional information we recommend a licensed electrician be consulted. (See Illustration 4O) (See Photo 20)

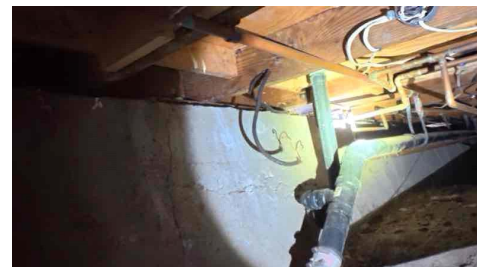
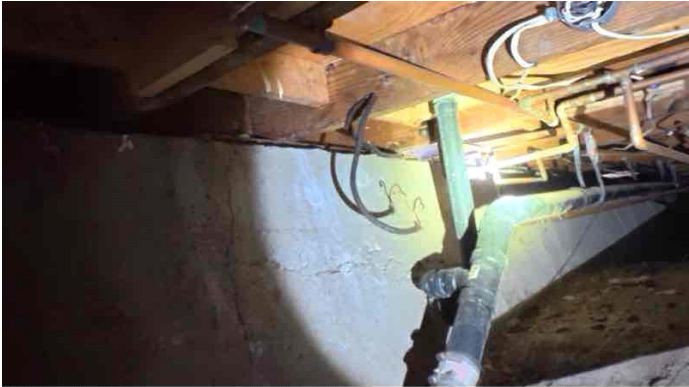
Photo 10

19. Abandoned wiring was noted in the crawlspace adjacent to the hall bathroom. We recommend the wiring be disconnected at its source or terminated in an approved manner in a covered junction box. (See Photo 10) (See Photo 13)

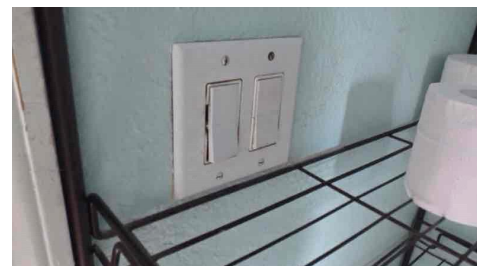
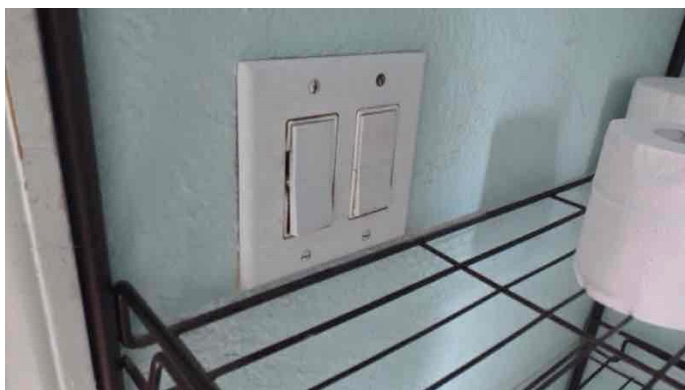
Photo 06

20. A switch at the hall bathroom is faulty or damaged. We recommend it be replaced. (See Photo 6)

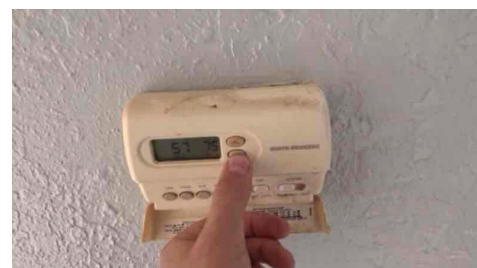
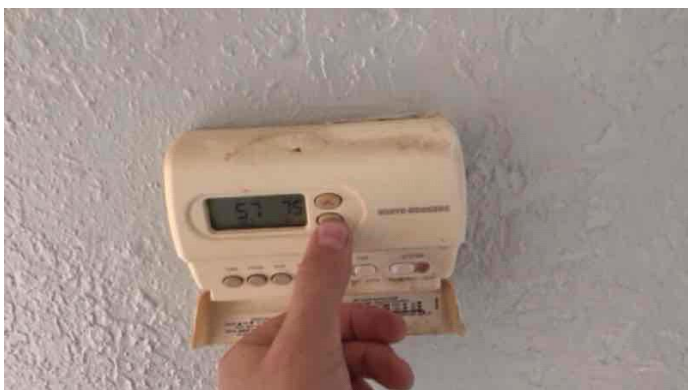
Photo 05

21. The heater thermostat was observed to be damaged at the time of inspection. Some of the controls were not functioning as intended, which may prevent proper operation and temperature regulation. We recommend repair or replacement by a qualified HVAC contractor as needed. (See Photo 5)

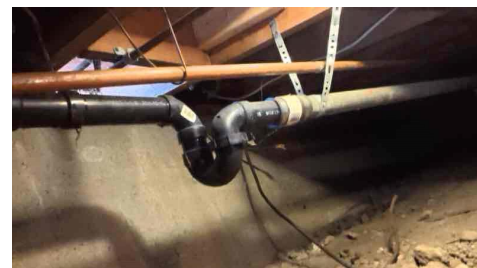
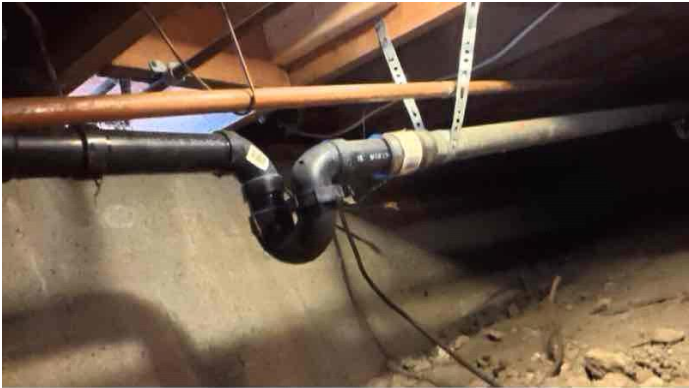
Photo 14

22. The drain piping at the rear right side of the crawlspace does not have sufficient slope for proper drainage. We recommend this condition be corrected. (See Photo 14)

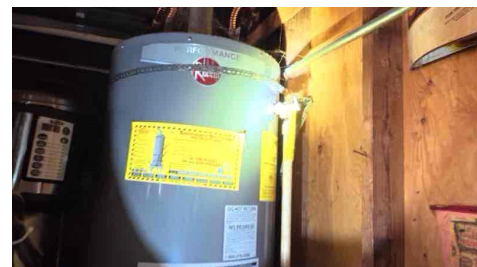
Photo 23

23. The water heater tank has been strapped in an improper manner and/or with improper material. We recommend the restraint be improved as per state codes. Specifically California state code is as follows.

5. Straps should be secured to adjacent wall or stud and from opposing directions
  6. Straps should be secured to the wall or studs using 1/4" diameter by 3" long lag bolts with washers. (See Illustration 8N) (See Photo 23)

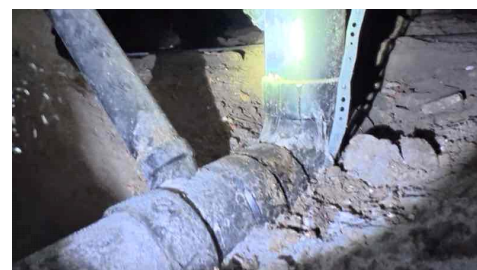
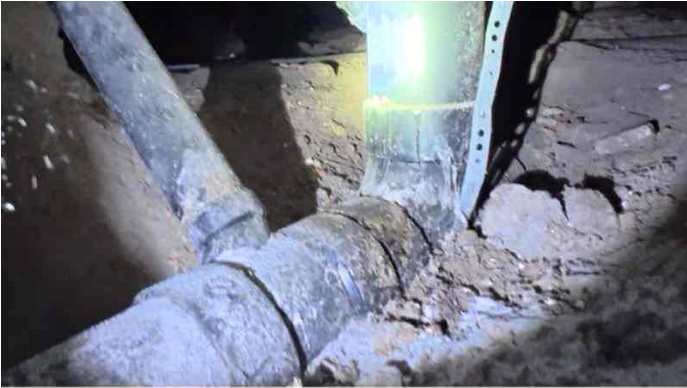
Photo 11

24. There is a cracked and leaking plastic drain pipe at the crawlspace under the hall bathroom. This is a potential health hazard. We recommend the piping in question be repaired or replaced. (See Photo 11) (See Photo 12)

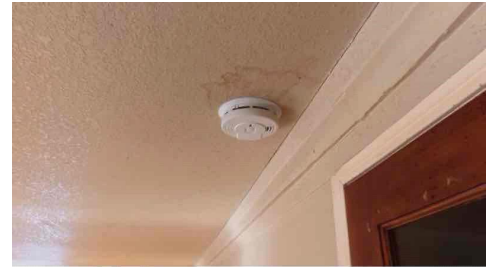
Photo 22

26. The ceiling at the rear bedroom shows evidence of water stains. It is recommended that the source of these stains be identified and corrected and the surface be refinished. (See Photo 22)

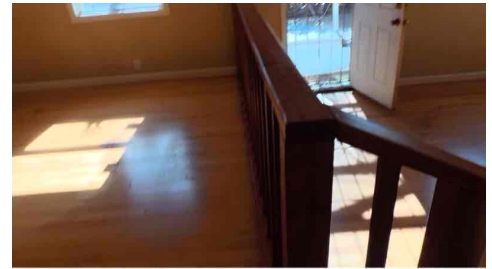
Photo 25

27. The railing at the rear addition is loose. We recommend it be repaired or replaced. (See Photo 25)

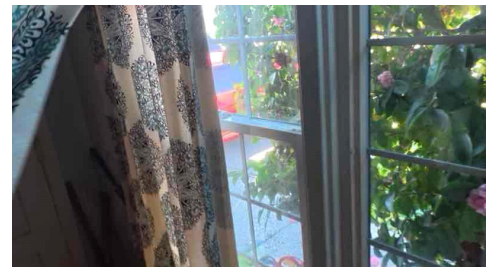
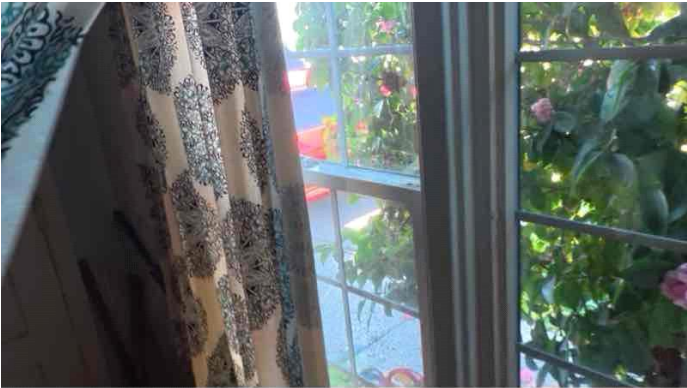
Photo 21

28. One or more of the windows at the living room are not fully serviceable because their lift mechanism is missing or damaged. We recommend these windows be repaired and their full functional use restored. (See Photo 21)

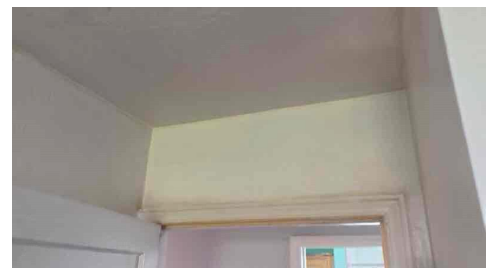
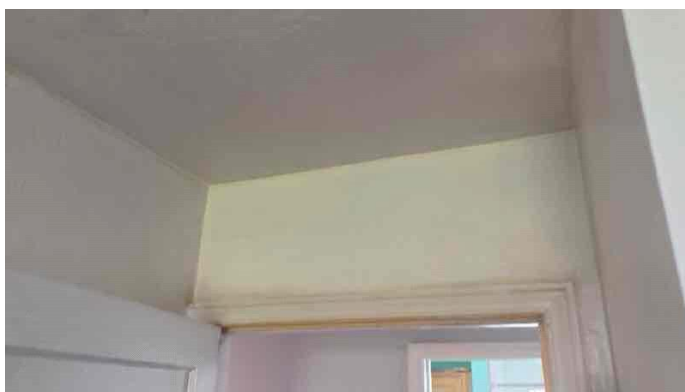
Photo 04

29. California law requires that all homes have a State Fire Marshall approved Carbon Monoxide Detector be installed outside of the sleeping areas in the hallway and on each level of the home including basements. At the time of this inspection a Carbon Monoxide Detector could not be located. We recommend consulting with the owner to see if a Carbon Monoxide Detector exists and if not they should be installed in all required locations. (See Photo 4)

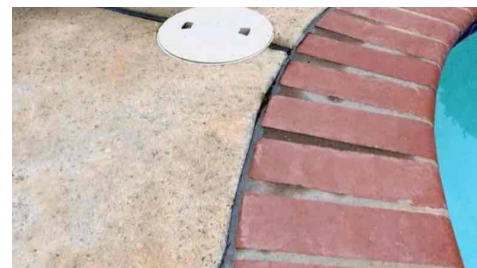
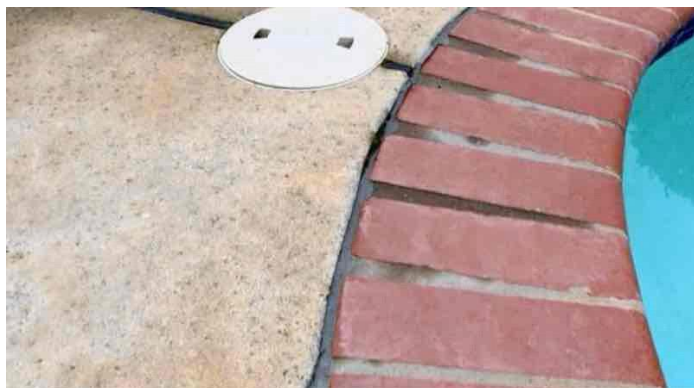
Photo 41

30. Portions of the pool decking have settled and/or heaved relative to the pool structure/coping. The settled and/or heaved areas present a trip hazard. This condition should be corrected to improve safety. The decking should be monitored for further settlement and/or heaving. Exterior grade sealer will help to limit moisture intrusion. We recommend consulting a licensed pool contractor and/or a licensed soils and drainage engineer for further evaluation and repairs. (See Photo 41)

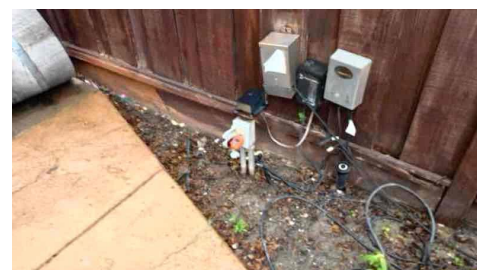
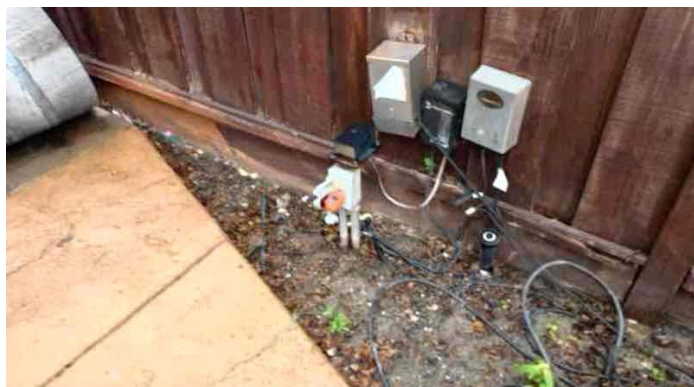
Photo 43

31. Electrical components and/or wiring was noted within five feet of the pool. It is recommended that all electrical components be relocated according to present safety standards. We recommend further evaluation and repair by a licensed electrician. (See Photo 43)

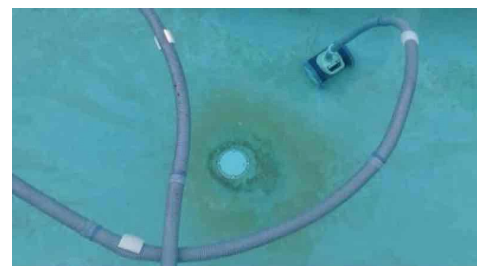
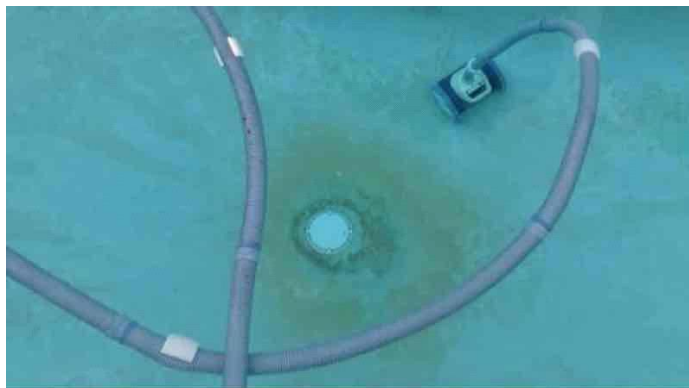
Photo 40

32. The pool/spa has less than two drains and/or returns as required by current safety standards. Standards change over time and from municipality to municipality. Older pool and spa systems can be retrofitted with specialty covers which is considered an improvement. We recommend the services of a licensed pool contractor. (See Photo 40)

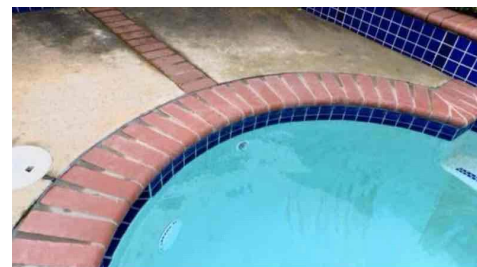
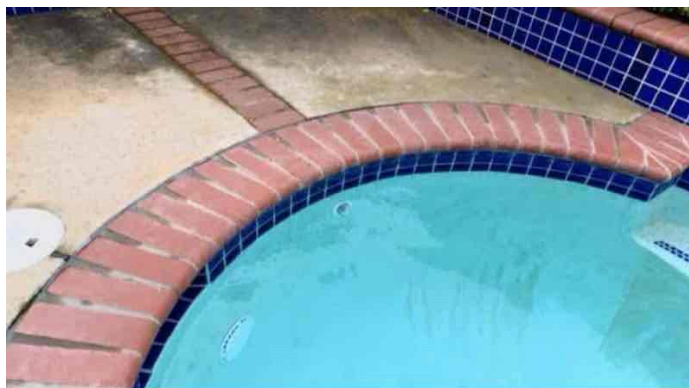
Photo 42

33. The lights at the pool did not respond to normal operating controls. We recommend the lights and related circuits be further evaluated and repaired by a licensed pool/spa contractor. (See Photo 42)

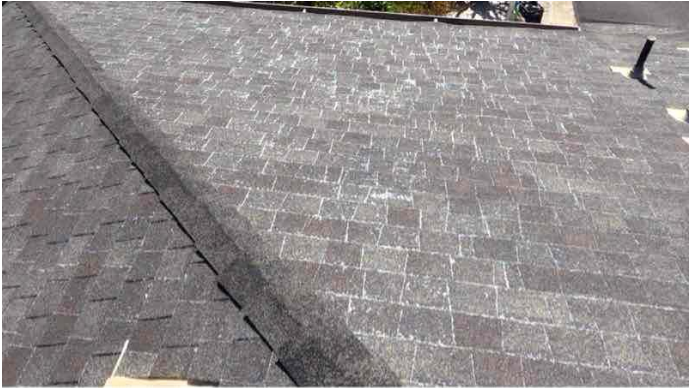
Photo 36

1. Portions of the surface granulation are deteriorated and surface cracks are developing. For further evaluation of this condition, we recommend consulting with a licensed roof contractor. (See Photo 36)
