Sewer Lateral Inspection Report

2623 Anywhere Street, Hometown

Travis Palser
February 26, 2026

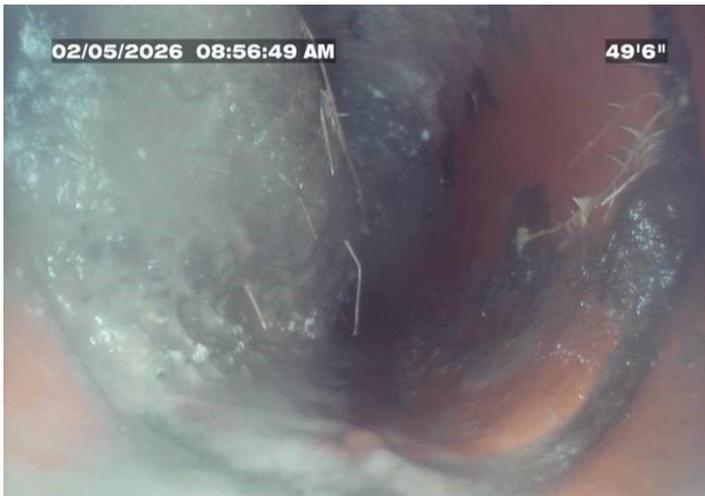
Distance	Code	Remarks	Photo
1 feet	JOM	Joint offset medium	5
1 feet	CP	clay to ABS	6
25 feet	JOS	Joint offset small	4
36 feet	JOS	Joint offset small	3
39 feet	RMB	Roots medium	2
50 feet	RBJ	Rootball	1

5. At 39 feet, medium root intrusion was noted inside the pipe causing less than 10% obstruction of the pipe.
6. At 50 feet, ball root intrusion was noted, causing greater than 50% diameter of the pipe.
7. The pipe material changed as noted in the inspection log, ABS and clay are currently in use.

A spot repair of defective item(s) as noted in the summary will be performed. We will excavate the soil to a depth of 5 feet to gain access to the defective segment(s) of the pipe. Up to 5 feet of pipe will be removed and new plastic piping will be installed in its place using the appropriate connectors. All soil removed will then be backfilled and compacted.

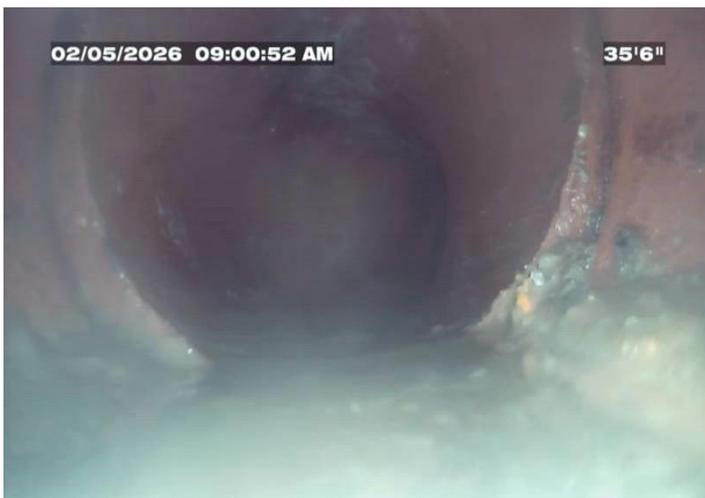
Photo 3

1. A 3 inch or greater cleanout to access the sewer lateral could not be located near the street or building. Installation of an exterior sewer lateral cleanout within five feet of the structure and near the property line are typically required by local ordinances.
2. Only a portion of the sewer lateral was inspected from where the lateral exits the building foundation to 56 feet. Further inspection of the sewer lateral is recommended when access to the rest of the lateral pipe has been provided.
3. At 36 and 25 feet, a small offset was noted at the pipe joint.
4. At 1 foot, a medium offset was noted at the pipe joint.
