HomeGuard Incorporated

Dear HomeGuard Customer,

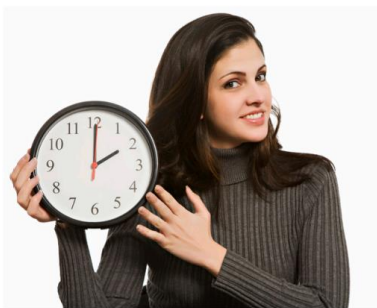
**We get the work
done when you
need it!**

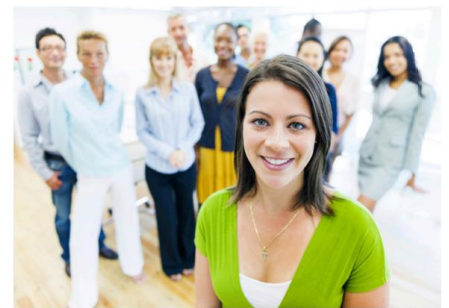
**HomeGuard
stands behind its
repairs!**

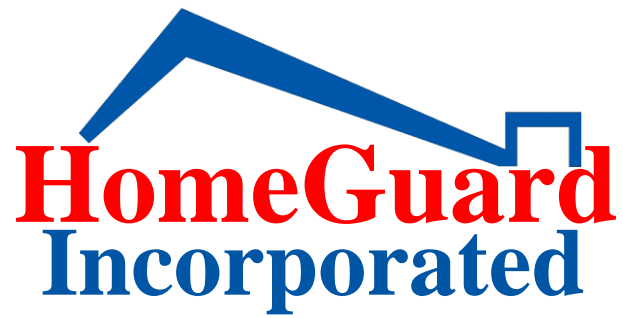
Sewer Lateral Inspection Report
