## Home Inspection Report

**2623 Anywhere Street, Hometown**

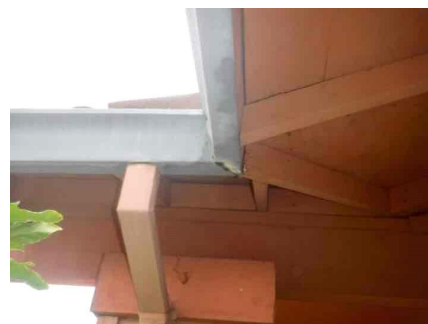
1. Leaks were noted in the downspouts and/or gutters at the front. During wet weather conditions these areas are more obvious and during dry weather conditions they are noted from the stains at the areas where the leaks have occurred. We recommend all leaks be repaired. (See Illustration 2D) (See Photo 2)

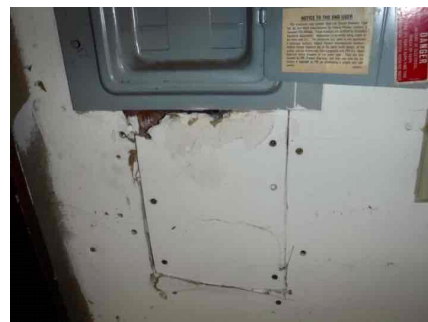
2. Damaged, open or missing wall and/or ceiling finishes of attached garages should be repaired and sealed where they abut the interior of a house. This reduces the potential of toxic automobile gases entering the house and serves as a fire break. Current standards require all walls/ceilings common to the finished living spaces be covered with 5/8" fire resistant sheetrock double taped at all seams. (See Illustration 3A) (See Photo 14)

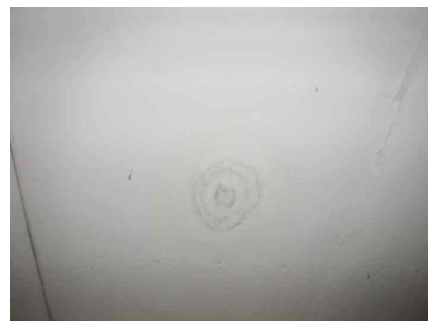
3. Water stains were noted on the ceiling of the garage. This is usually an indication of past plumbing or roof leaks. This area should be further evaluated by the appropriate trades. (See Photo 12)

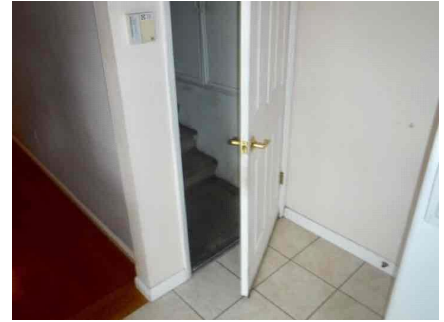
7. The raised section of the driveway presents a trip hazard. This condition should be corrected for improved safety. (See Photo 4)
8. The wood retaining wall at the left side shows evidence of substantial water damage. It is difficult to determine when rebuilding will become necessary. Rebuilding may be necessary in the short term. Further evaluation of this condition by the appropriate tradesperson is recommended. (See Illustration 3Y) (See Photo 6)

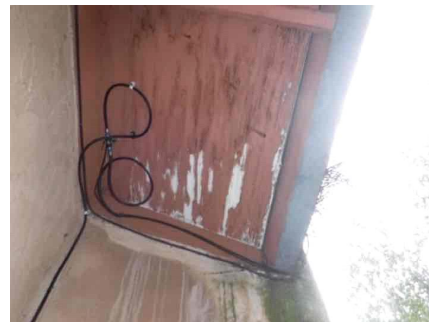
9. Water damage was observed to the roof eaves/sheathing at the rear. We recommend the services of a licensed general contractor and/or structural pest control company. (See Photo 7)

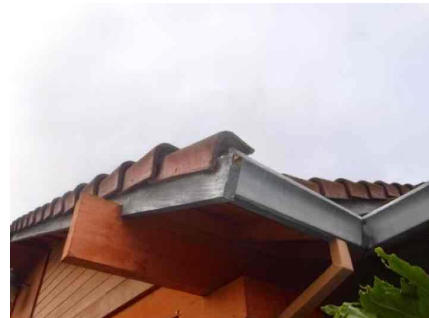
10. Water damage was observed to the rafters at various locations. We recommend the services of a licensed general contractor and/or structural pest control company. (See Photo 3)

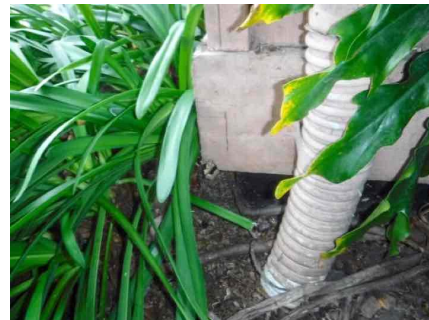
11. Water damage was observed to the exterior trim at various locations. We recommend the services of a licensed general contractor and/or structural pest control company. (See Photo 5) (See Photo 1)

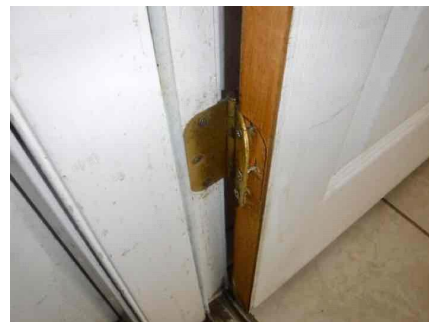
12. Door hinges for the garage passage door are loose or broken. We recommend they be repaired or replaced as necessary. (See Photo 10)

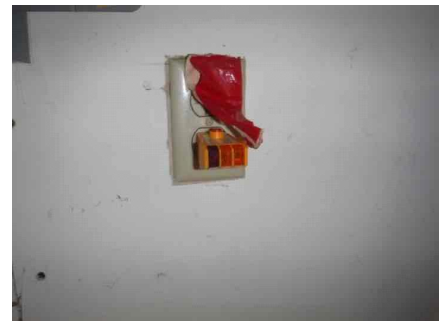
14. One or more outlets at the garage were inoperative at the time of our inspection. Possibly due to turned off switches which were not located during our inspection. These outlets and circuits should be investigated and corrected as necessary. Based upon our inspection of a representative number of outlets, we recommend testing of every outlet at a later date. Repairs or rewiring are recommended at all deficient locations. (See Photo 13)

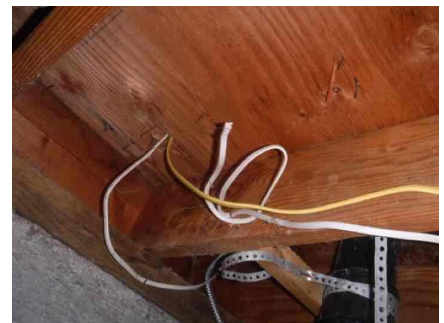
15. Abandoned wiring was noted in the crawlspace under the master bathroom. We recommend the wiring be disconnected at its source or terminated in an approved manner in a covered junction box. (See Photo 21)

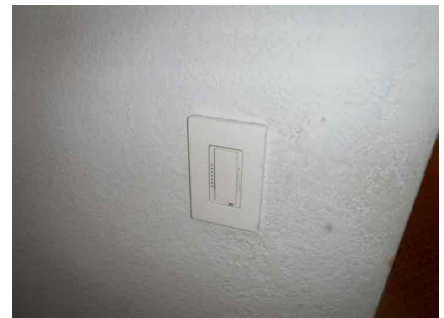
16. A switch at the master bedroom is faulty or damaged. We recommend it be replaced. (See Photo 17)

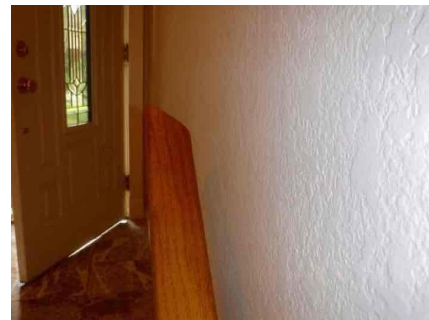
17. The ends of the railing at the interior should return or connect to the wall. This will eliminate any loose clothing or straps from hanging up on the ends of the railing. It is recommended that this condition be corrected for improved safety. (See Photo 19)

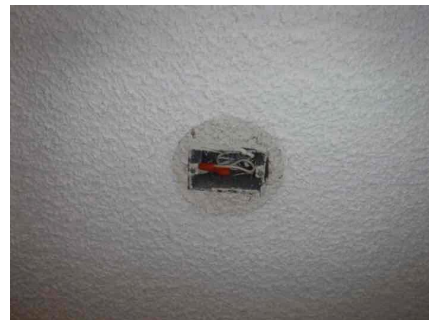
18. The installation of smoke detectors where missing or removed is required for added safety. (See Photo 20)

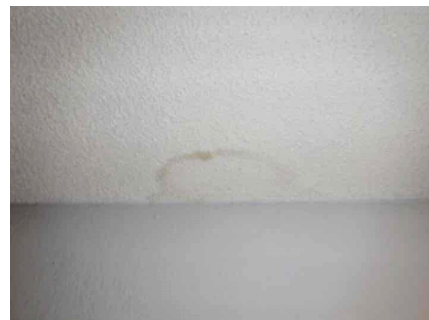
19. The ceiling at the master bedroom hall shows evidence of water stains. It is recommended that the source of these stains be identified and corrected and the surface be refinished. (See Photo 16)

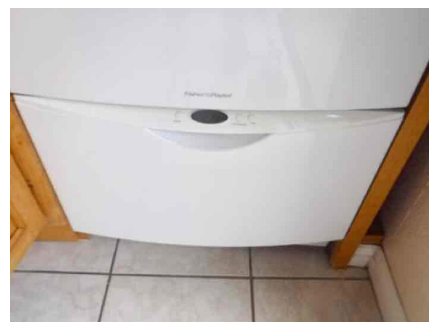
20. At the time of our inspection the lower drawer dishwasher was inoperative or did not respond to normal operating controls. For attention to the conditions noted and/or cost estimates, if necessary, we recommend the advice of a qualified appliance technician. (See Photo 15)

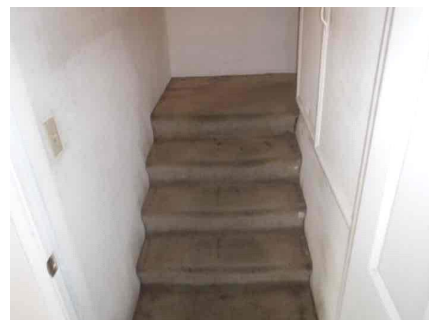
21. There is no railing where needed at the garage stairs. For improved safety, it is recommended that appropriate railing be installed. (See Photo 11)

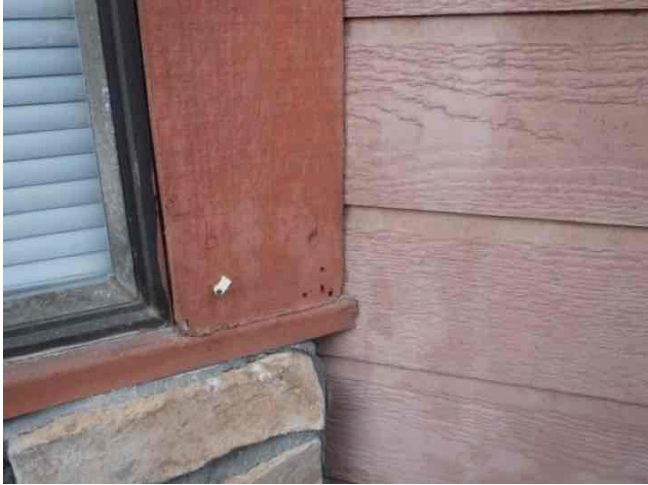
***No relative importance should be placed on the photographs provided in this report. The photographs in this report do not necessarily illustrate all of the damage in any particular finding. Also, not all problem areas will be supported with photographs. Please contact HomeGuard if you have any questions.***

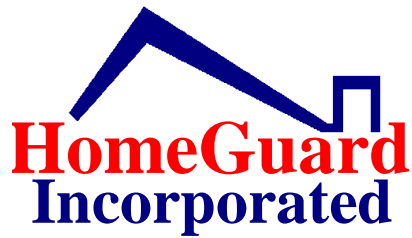
Invoice Date: 2/21/2019
