Dear HomeGuard Customer,

Sincerely Yours,

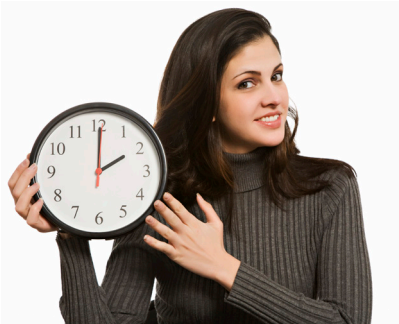
**We get the work done  
when you need it!**

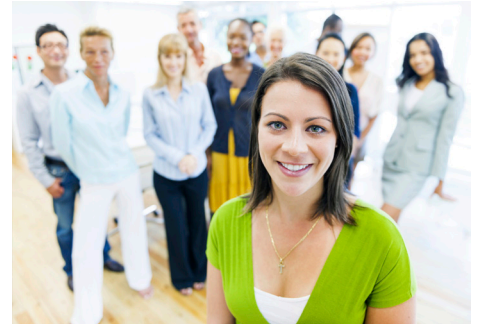
**HomeGuard stands  
behind its repairs!**

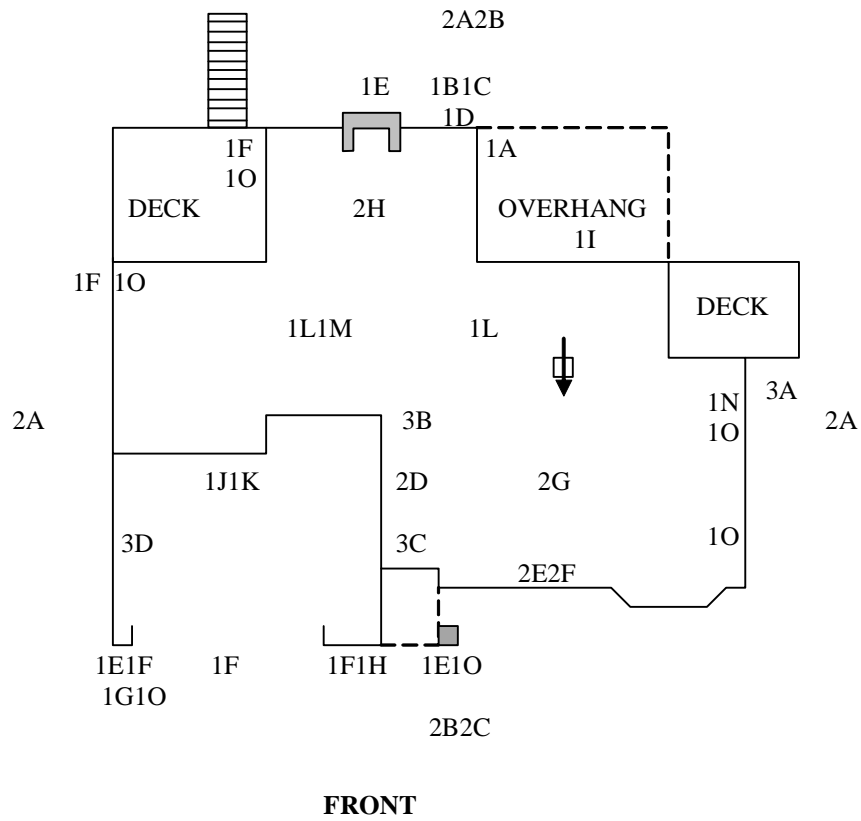
Building No.	Street	City	ZIP	Date of Inspection	Number of Pages
2623	Anywhere Street	Hometown	99999	1/1/2020	Page 3 of 14

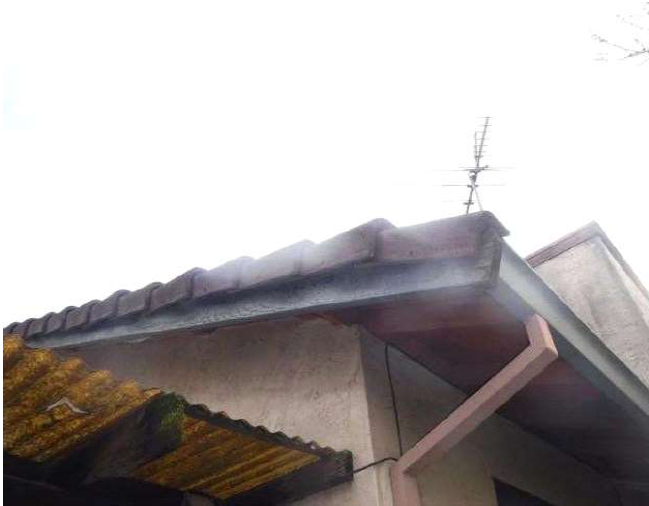
Pictures are provided to assist in clarifying some of the findings made in this report. No relative importance should be placed on these pictures. There are likely to be significant comments that do not have pictures associated with them. The pictures in this report do not illustrate all of the damage associated with a particular item. Please read the report thoroughly and contact the inspector if you have any specific questions.
