Dear HomeGuard Customer,

Sincerely Yours,

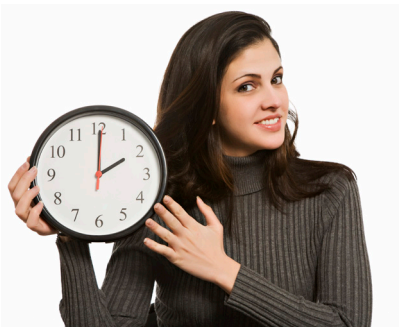
**We get the work done
when you need it!**

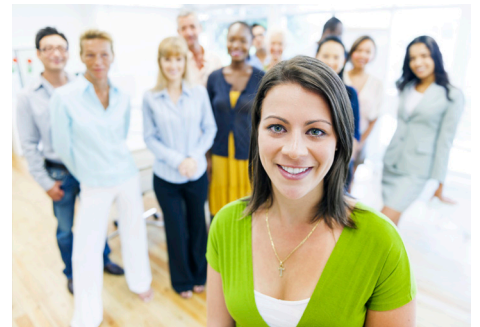
**HomeGuard stands
behind its repairs!**

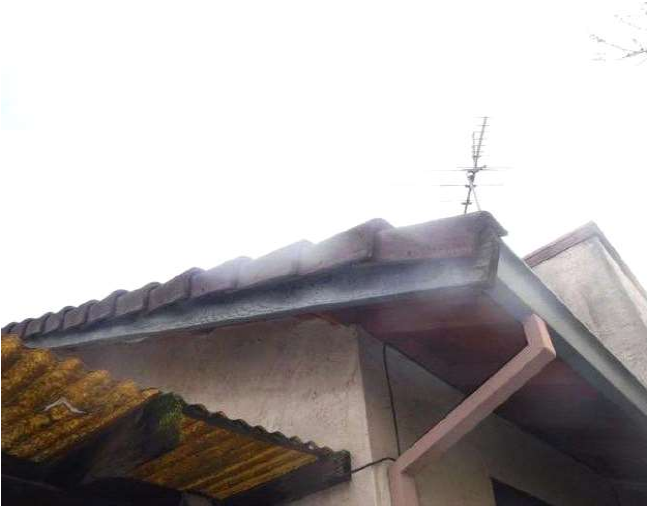
Pictures are provided to assist in clarifying some of the findings made in this report. No relative importance should be placed on these pictures. There are likely to be significant comments that do not have pictures associated with them. The pictures in this report do not illustrate all of the damage associated with a particular item. Please read the report thoroughly and contact the inspector if you have any specific questions.
