HomeGuard Incorporated

Dear HomeGuard Customer,

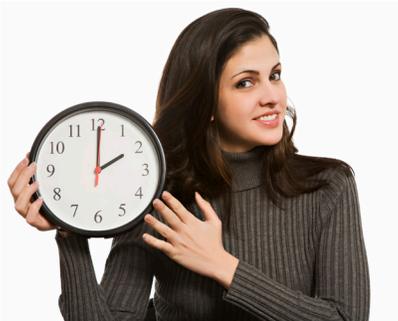
**We get the work done
when you need it!**

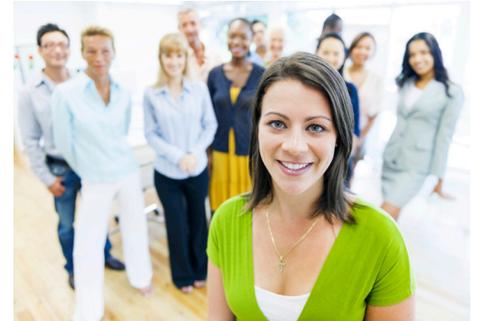
**HomeGuard stands
behind its repairs!**

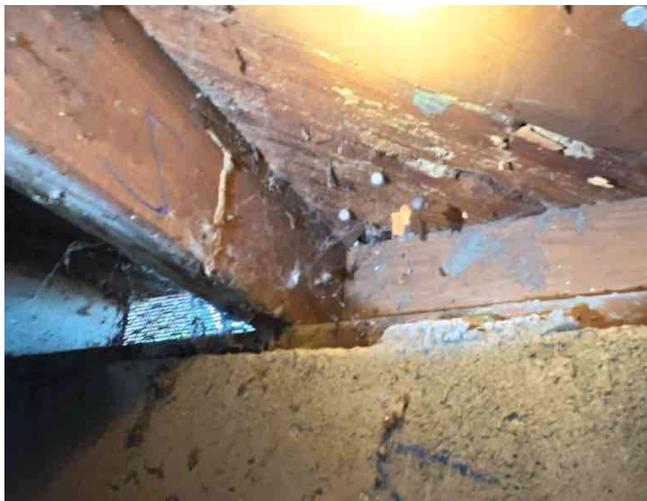
Pictures are provided to assist in clarifying some of the findings made in this report. No relative importance should be placed on these pictures. There are likely to be significant comments that do not have pictures associated with them. The pictures in this report do not illustrate all of the damage associated with a particular item. Please read the report thoroughly and contact the inspector if you have any specific questions.
