Home Inspection Report

2623 Anywhere Street, Hometown

Ordered by: John Doe
2623 Anywhere Street
Hometown, CA 99999

Travis Palser
February 28, 2020

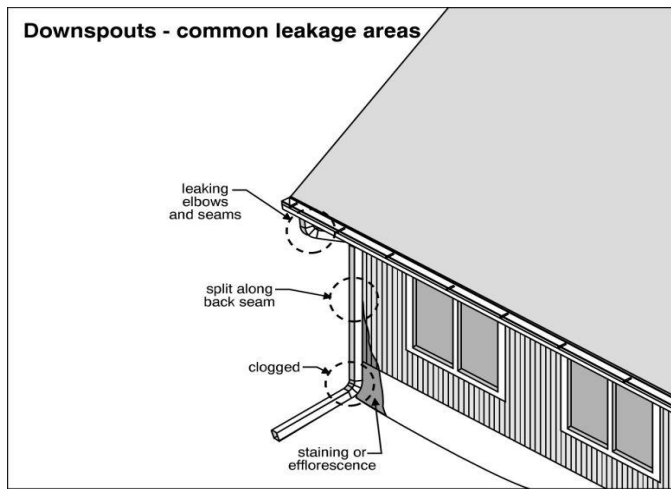
Illustration 2D

1. Leaks were noted in the downspouts and/or gutters at the front. During wet weather conditions these areas are more obvious and during dry weather conditions they are noted from the stains at the areas where the leaks have occurred. We recommend all leaks be repaired. (See Illustration 2D) (See Photo 7)

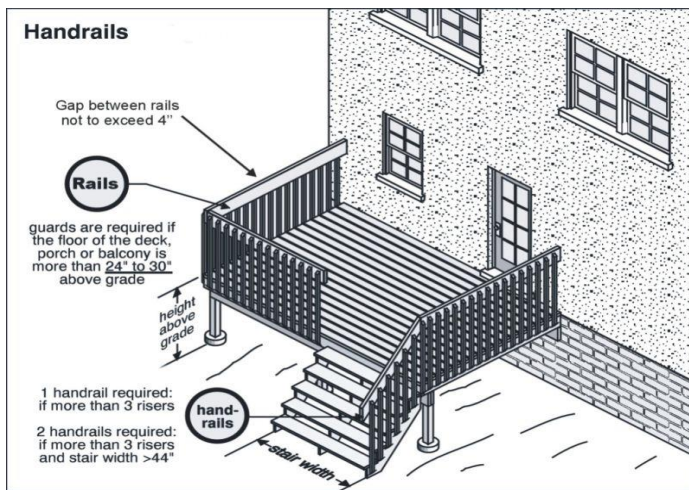
Illustration 3N

5. The openings in the deck railing(s) are larger than 4" inches and contain horizontal infill. It is recommended that this be corrected for improved safety. (See Illustration 3N) (See Photo 14)

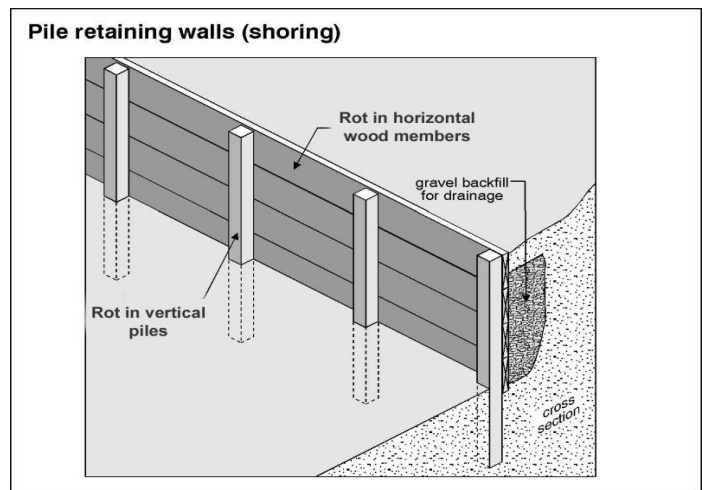
Illustration 3Y

8. The wood retaining wall at the left side shows evidence of substantial water damage. It is difficult to determine when rebuilding will become necessary. Rebuilding may be necessary in the short term. Further evaluation of this condition by the appropriate tradesperson is recommended. (See Illustration 3Y) (See Photo 3)
