## Home Inspection Report

**2623 Anywhere Street, Hometown**

Travis Palser  
April 5, 2019

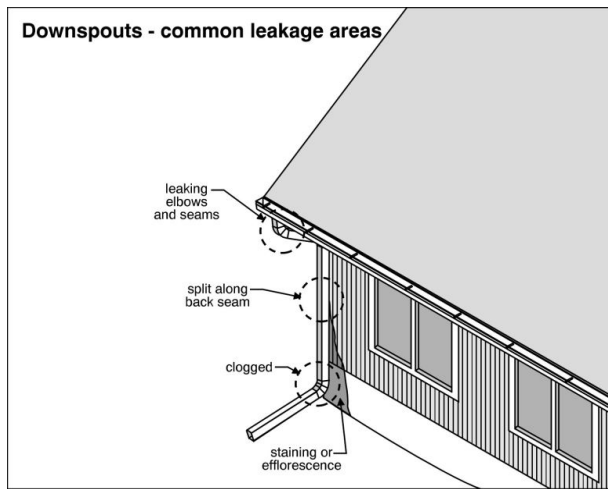
Illustration 2D

1. Leaks were noted in the downspouts and/or gutters at the front. During wet weather conditions these areas are more obvious and during dry weather conditions they are noted from the stains at the areas where the leaks have occurred. We recommend all leaks be repaired. (See Illustration 2D) (See Photo 7)

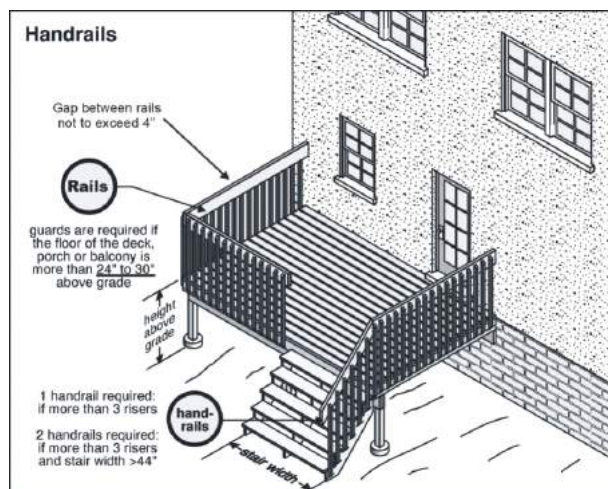
Illustration 3N

5. The openings in the deck railing(s) are larger than 4" inches and contain horizontal infill. It is recommended that this be corrected for improved safety. (See Illustration 3N) (See Photo 13)

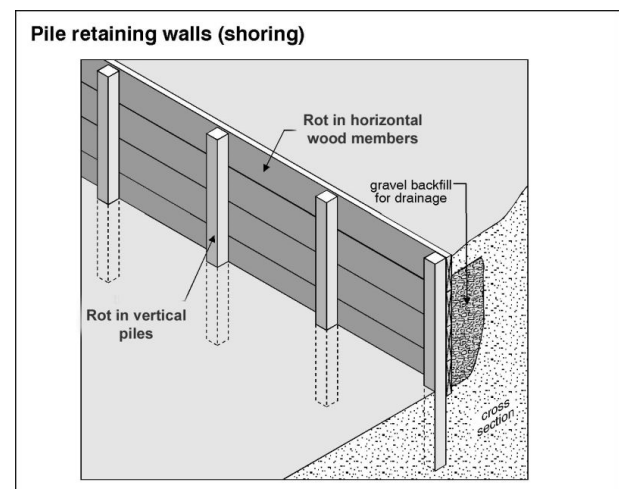
Illustration 3Y

8. The wood retaining wall at the left side shows evidence of substantial water damage. It is difficult to determine when rebuilding will become necessary. Rebuilding may be necessary in the short term. Further evaluation of this condition by the appropriate tradesperson is recommended. (See Illustration 3Y) (See Photo 3)
