Home Inspection Report

2623 Anywhere Street, Hometown

Ordered by: John Doe
2623 Anywhere Street
Hometown, CA 99999

Travis Palser
January 1, 2020

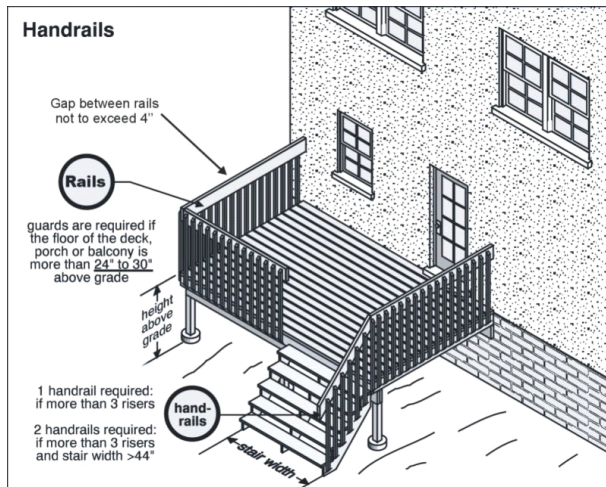
Illustration 3N

5. The openings in the deck railing(s) are larger than 4" inches and contain horizontal infill. It is recommended that this be corrected for improved safety. (See Illustration 3N) (See Photo 13)

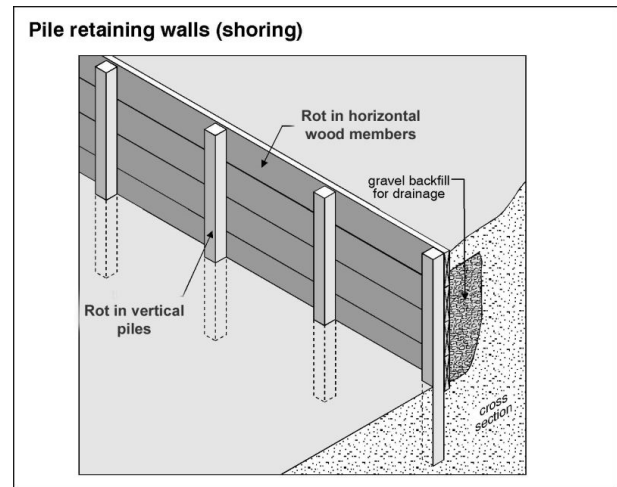
Illustration 3Y

8. The wood retaining wall at the left side shows evidence of substantial water damage. It is difficult to determine when rebuilding will become necessary. Rebuilding may be necessary in the short term. Further evaluation of this condition by the appropriate tradesperson is recommended. (See Illustration 3Y) (See Photo 3)
