HOME INSPECTION REPORT

2623 Anywhere Street, Hometown

672013

February 26, 2026

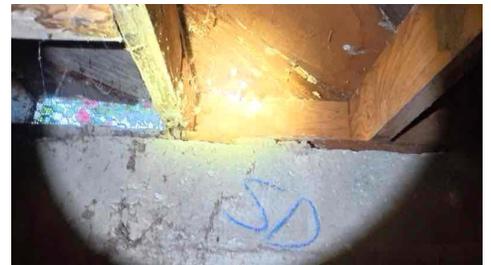
Photo 17

- ! 2. The subfloor wood members at the front of the crawlspace show evidence of water damage. We recommend the services of a licensed structural pest control operator for investigation of this condition. (See Photo 17) (See Photo 16)

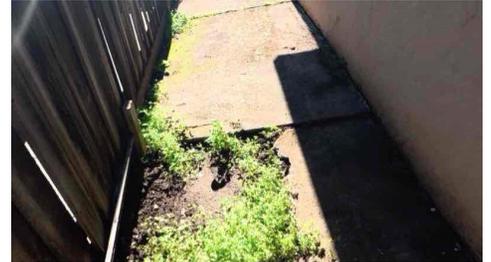
Photo 28

10. The cracked, heaved, or uneven walkway sections at the left side pose a potential trip hazard. We recommend corrective action to improve safety and reduce the risk of injury. A qualified contractor should assess the affected areas and perform necessary repairs to ensure a level walking surface. (See Photo 28)

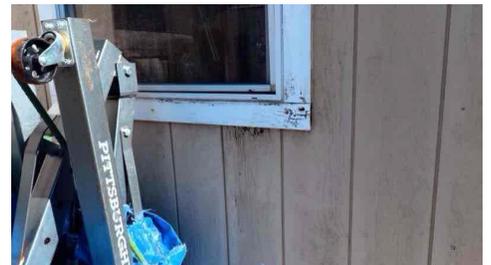
Photo 35

11. Water damage was observed to the wood siding at the rear addition exterior walls. We recommend the services of a licensed general contractor and/or structural pest control company. (See Photo 35)

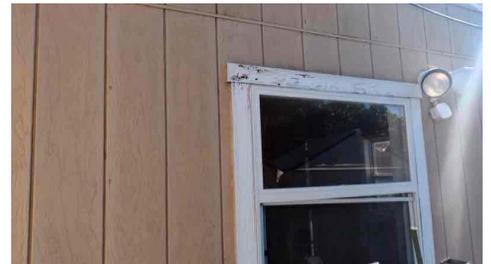
Photo 34

12. Water damage was observed to the exterior window trim at the rear addition. We recommend the services of a licensed general contractor and/or structural pest control company. (See Photo 34)

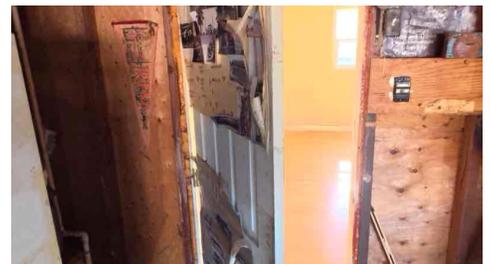
Photo 29

13. The door between the garage and the house did not have an automatic closing mechanism. For improved safety the door between the garage and the interior of the house should be fitted with an automatic closing mechanism, and be rated for a minimum of one hour of fire resistance. This will reduce the potential of toxic automobile gases entering the house and serves as a fire break. (See Photo 29)

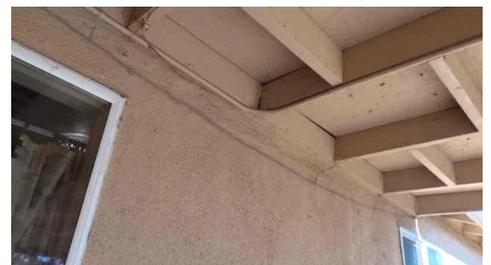
Photo 27

14. The patio cover is improperly attached to the structure with nails/screws. This condition could pose a safety hazard with lateral forces or seismic activity. We recommend the patio cover be secured to the structure with proper flashing and bolts according to local building codes. (See Photo 27)

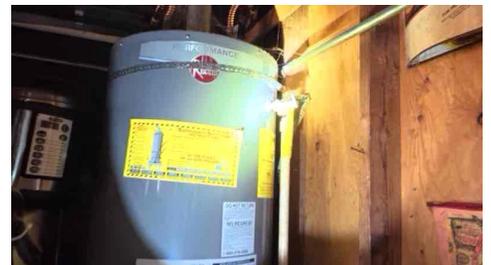
Photo 23

3. Straps may consist of either metal bands/tape at least 24 gauge or half-inch diameter metal conduit.
 4. Straps must wrap around the body of the water heater and any gaps between the wall and tank should be blocked to prevent movement.

5. Straps should be secured to adjacent wall or stud and from opposing directions
 6. Straps should be secured to the wall or studs using 1/4" diameter by 3" long lag bolts with washers. (See Illustration 8N) (See Photo 23)

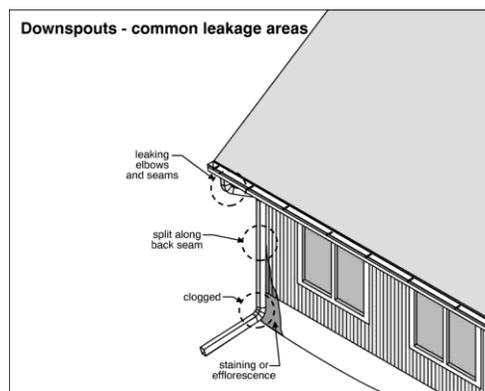
Illustration 2D

5. Leaks were noted in the downspouts and/or gutters at the rear. During wet weather conditions these areas are more obvious and during dry weather conditions they are noted from the stains at the areas where the leaks have occurred. We recommend all leaks be repaired. (See Illustration 2D) (See Photo 37)

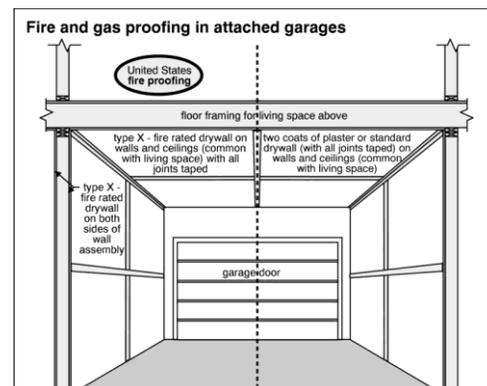
Illustration 3A

8. Damaged, open or missing wall and/or ceiling finishes of attached garages should be repaired and sealed where they abut the interior of a house. This reduces the potential of toxic automobile gases entering the house and serves as a fire break. Current standards require all walls/ceilings common to the finished living spaces be covered with 5/8" fire resistant sheetrock double taped at all seams. (See Illustration 3A) (See Photo 30)

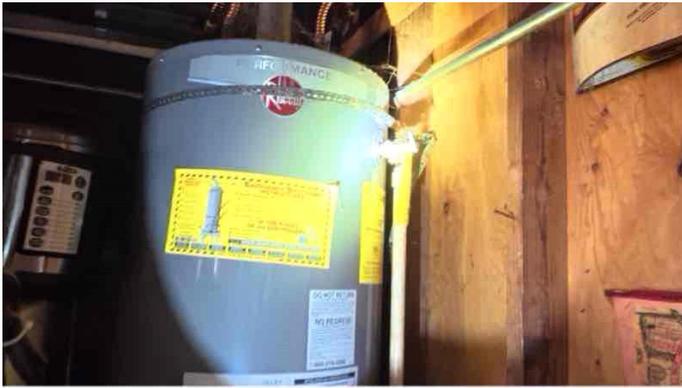
Photo 23

5. Straps should be secured to adjacent wall or stud and from opposing directions
 6. Straps should be secured to the wall or studs using 1/4" diameter by 3" long lag bolts with washers. (See Illustration 8N) (See Photo 23)

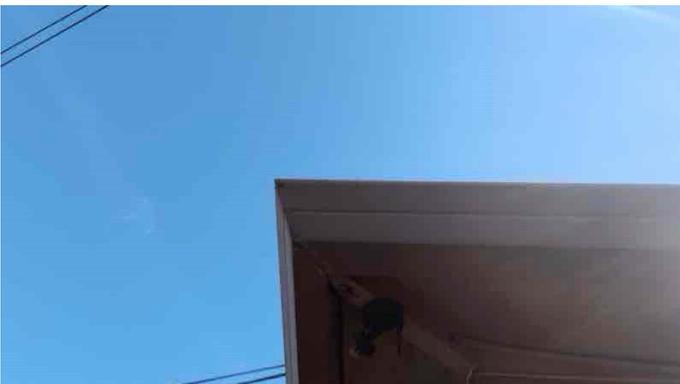
Photo 37

- ! 2. Leaks were noted in the downspouts and/or gutters at the rear. During wet weather conditions these areas are more obvious and during dry weather conditions they are noted from the stains at the areas where the leaks have occurred. We recommend all leaks be repaired. (See Illustration 2D) (See Photo 37)

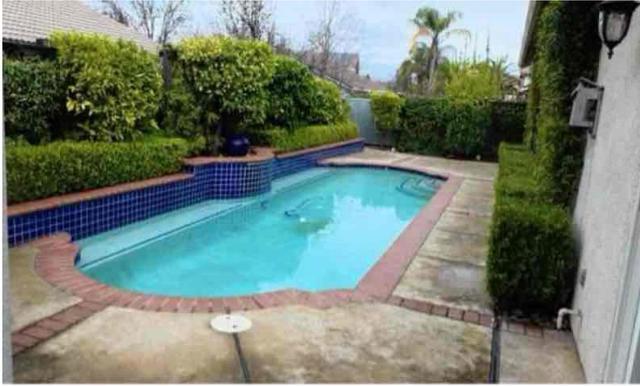
Photo 39

The owner is advised to contact the appropriate trades to rectify this condition. (See Photo 39)

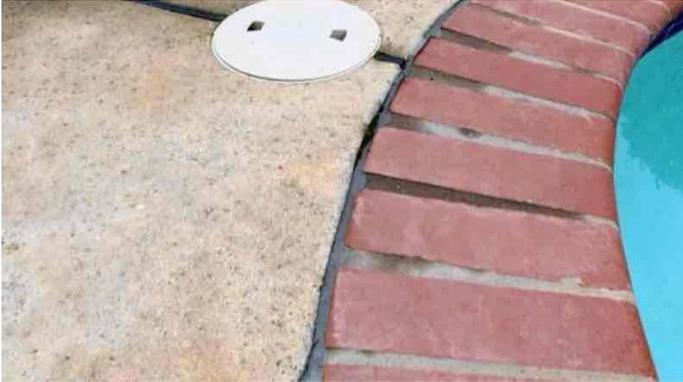
Photo 41

30. Portions of the pool decking have settled and/or heaved relative to the pool structure/coping. The settled and/or heaved areas present a trip hazard. This condition should be corrected to improve safety. The decking should be monitored for further settlement and/or heaving. Exterior grade sealer will help to limit moisture intrusion. We recommend consulting a licensed pool contractor and/or a licensed soils and drainage engineer for further evaluation and repairs. (See Photo 41)
