## HOME INSPECTION REPORT

2623 Anywhere Street, Hometown

672013

February 26, 2026

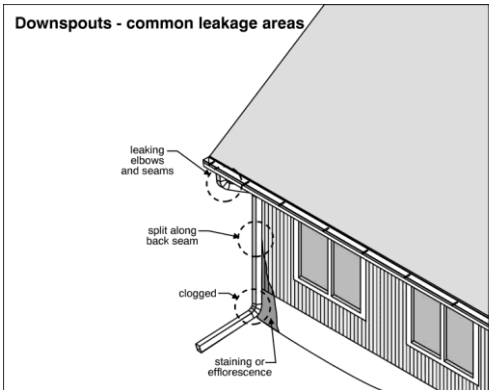
Illustration 2D

5. Leaks were noted in the downspouts and/or gutters at the rear. During wet weather conditions these areas are more obvious and during dry weather conditions they are noted from the stains at the areas where the leaks have occurred. We recommend all leaks be repaired. (See Illustration 2D) (See Photo 37)

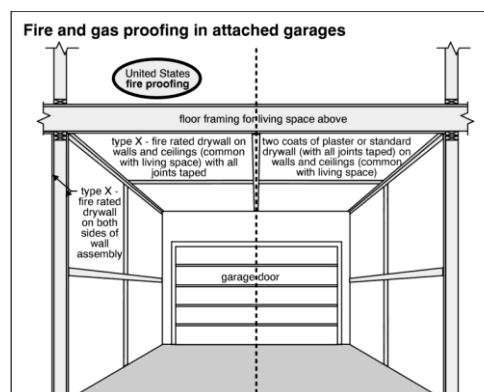
Illustration 3A

8. Damaged, open or missing wall and/or ceiling finishes of attached garages should be repaired and sealed where they abut the interior of a house. This reduces the potential of toxic automobile gases entering the house and serves as a fire break. Current standards require all walls/ceilings common to the finished living spaces be covered with 5/8" fire resistant sheetrock double taped at all seams. (See Illustration 3A) (See Photo 30)

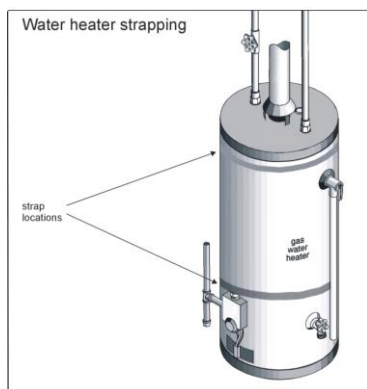
Illustration 8N (Please note this diagram refers to two strap installations)

5. Straps should be secured to adjacent wall or stud and from opposing directions
  6. Straps should be secured to the wall or studs using 1/4" diameter by 3" long lag bolts with washers. (See Illustration 8N) (See Photo 23)

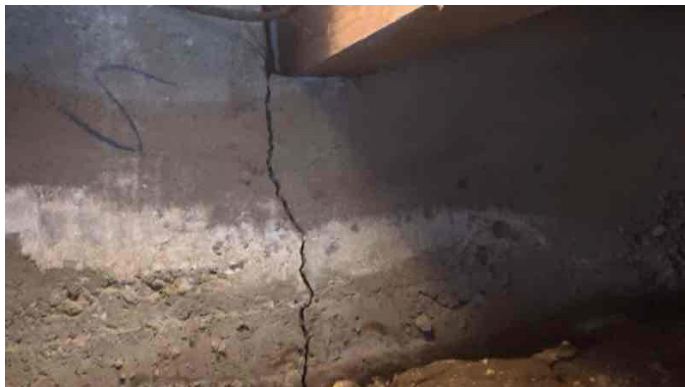
Photo 02

1. Vertical cracking was observed in the foundation walls of the structure indicating movement and/or settlement of the structure may have occurred. The rate of movement cannot be predicted during a one-time inspection. A thorough evaluation of this condition is beyond our qualifications. For additional information we recommend contacting a licensed foundation contractor for further evaluation. (See Photo 1) (See Photo 2)

Estimated Repair Range: \$300 - \$1500

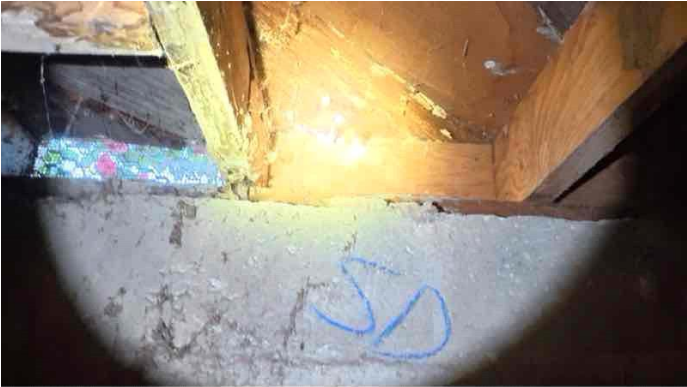
Photo 17

2. The subfloor wood members at the front of the crawlspace show evidence of water damage. We recommend the services of a licensed structural pest control operator for investigation of this condition. (See Photo 17) (See Photo 16)

Estimated Repair Range: \$750 - \$1500

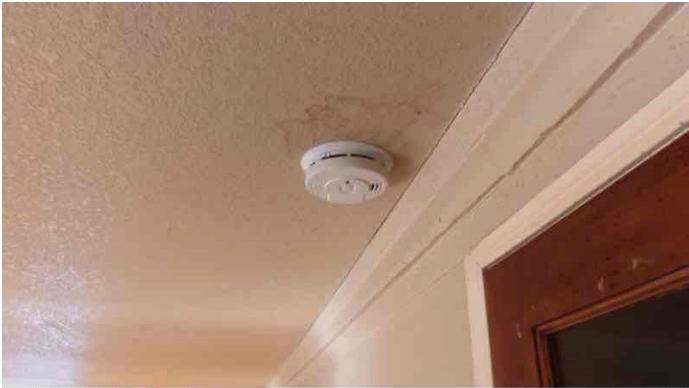
Photo 22

26. The ceiling at the rear bedroom shows evidence of water stains. It is recommended that the source of these stains be identified and corrected and the surface be refinished. (See Photo 22)

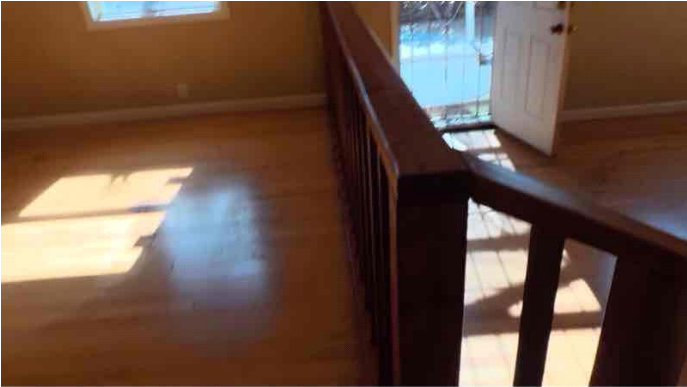
Photo 25

27. The railing at the rear addition is loose. We recommend it be repaired or replaced. (See Photo 25)

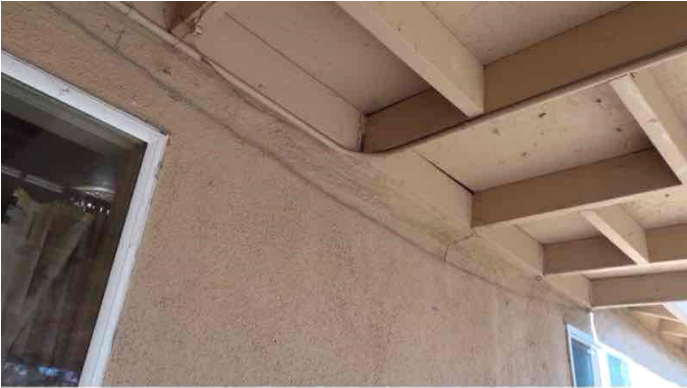
Photo 27

14. The patio cover is improperly attached to the structure with nails/screws. This condition could pose a safety hazard with lateral forces or seismic activity. We recommend the patio cover be secured to the structure with proper flashing and bolts according to local building codes. (See Photo 27)

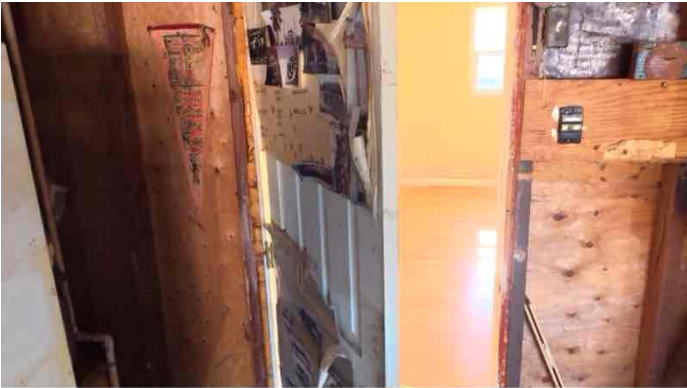
Photo 29

13. The door between the garage and the house did not have an automatic closing mechanism. For improved safety the door between the garage and the interior of the house should be fitted with an automatic closing mechanism, and be rated for a minimum of one hour of fire resistance. This will reduce the potential of toxic automobile gases entering the house and serves as a fire break. (See Photo 29)

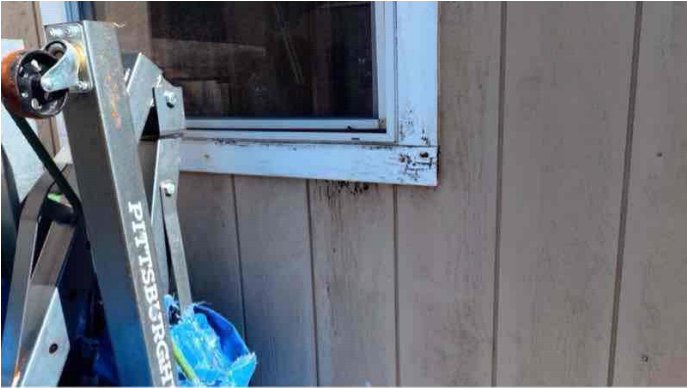
Photo 35

11. Water damage was observed to the wood siding at the rear addition exterior walls. We recommend the services of a licensed general contractor and/or structural pest control company. (See Photo 35)

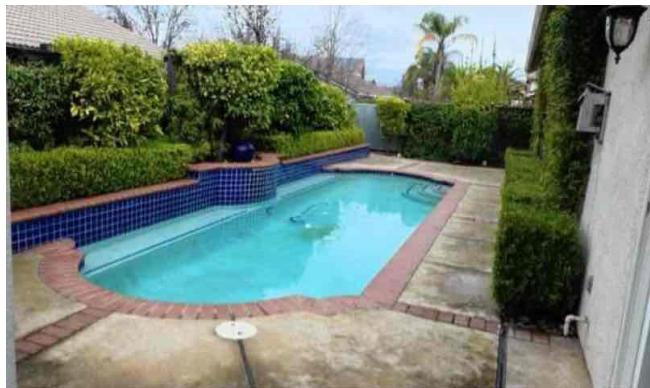
Photo 39

The owner is advised to contact the appropriate trades to rectify this condition. (See Photo 39)
